2002 MX5 Mk.2.5 ARIZONA SE

MOT Welding Repairs

& Suspension Upgrade

This blog highlights the MOT work carried out on my Mazda MX5 Arizona Mark 2.5 special edition. Welding & suspension upgrade 2022.

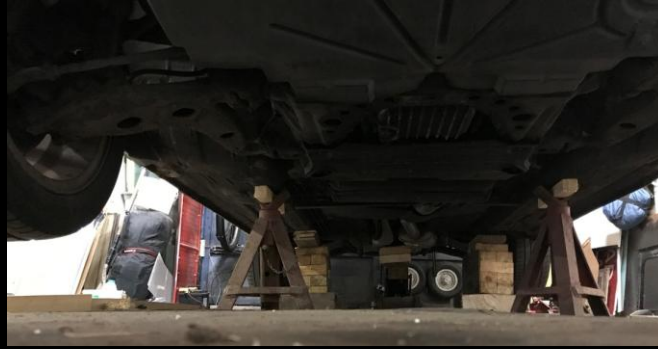
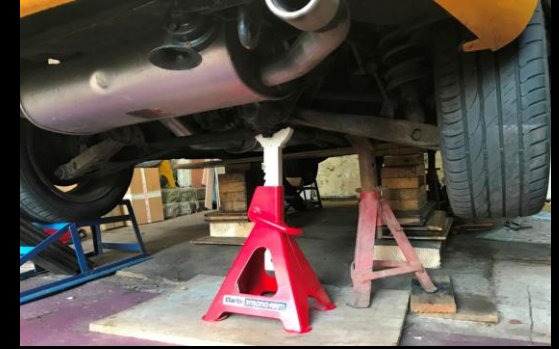
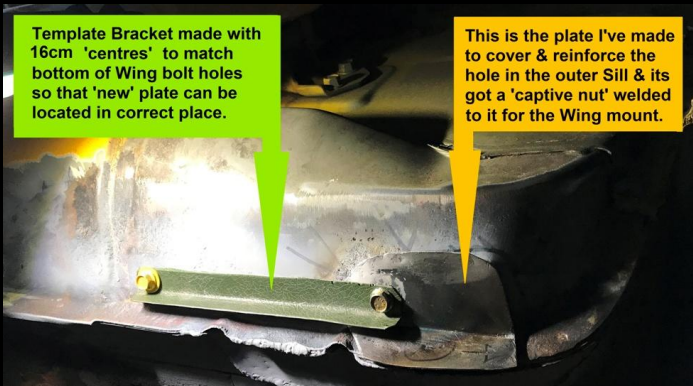
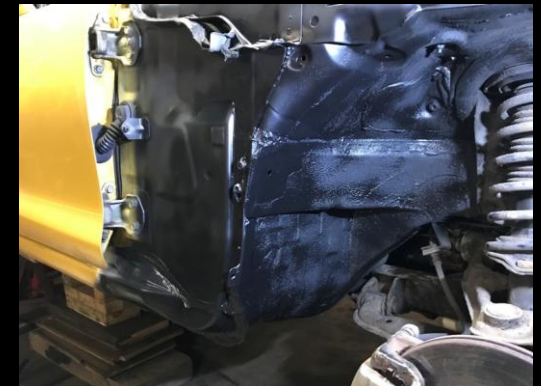
More Holes than Swiss Cheese. Rust, rust & even more rust . . . not to mention needing a new Tyre as well.

Now THAT was a SHOCK to this old body system of mine. I certainly didn't expect the under-body section to be THIS BAD ! WOW! I was gutted. From NORMAL view, standing by the car (at street level) none of this ROT was visible or evident. So WHAT A SURPRISE (and not in a good way)!

The following pages below show a series of photographs plotting my progress addressing the welding repairs & bodywork needed to get my once beautiful MX5 back up to MOT Standards & looking as good as a 20 year old car can look. After 'jacking the car up' on axle stands (& extra blocks of wood for added safety) I then started work on the front off-side corner by removing the wing for better access to the O/S rusty sill, jacking point and to repair the bottom of the wing.

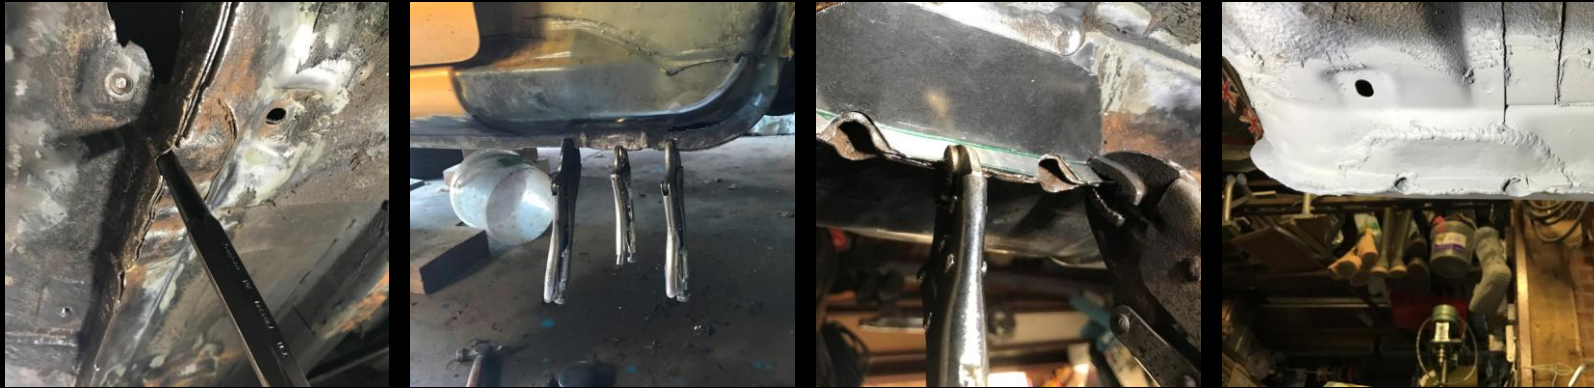
The next stage was to 'open-up' the 'Sill drainage holes' that had been crunched-closed over many years of improper 'jacking-up' use & misuse (NOT by me I might add). This is one of the reasons why the sills are in such bad condition. The drainage holes being *closed* meant that any ingress of water &/or road detritus could not 'drain out' as intended by Mazda. I 'enlarged' these drainage holes using a tapered Drift-Punch, making each hole bigger than originally designed, thereby alleviating future problems (providing I instigate & maintain a regular cleaning-out programme for these newly enlarged drainage holes).

I also added a shaped plate to the sill (photos 2 & 3 left) to give extra strength to the front jacking point and welded it in place. RESULT = stronger JP.

After welding I treated it all to the same phosphoric acid, zinc primer, tiger seal & stone chip under-seal coating that will be carried-out on all four corners of the car once all of the welding has been completed.

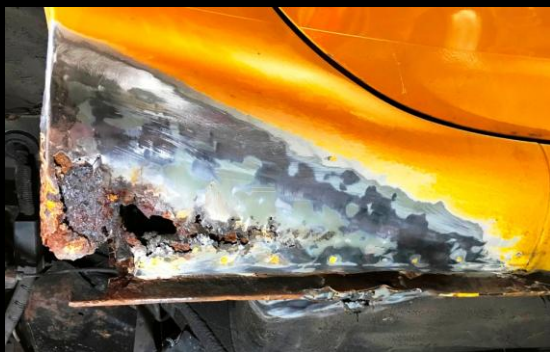
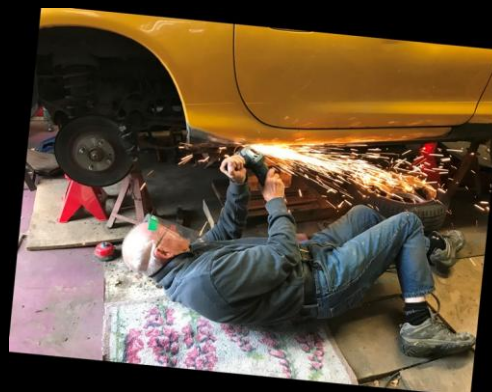
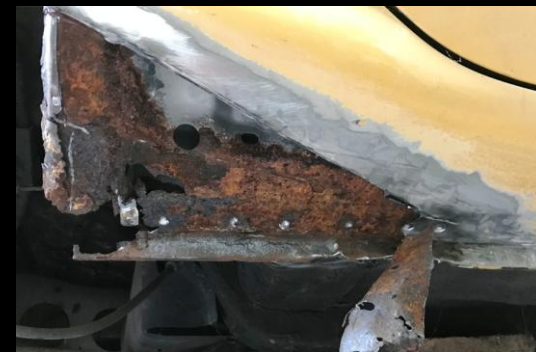
ROUND TWO: The off-side REAR sills & jacking point tackled. The 1st two rows of photos show the rusty sills (inner & outer) being cut-out and ground back to good metal followed by fabrication & welding. The end-plate & inner sill sections of the rear quarterpanel are now fully welded up and treated as before.

Once all of the bad metal was removed and replaced with new metal which took a fair bit of fabrication work and panel-beating to achieve the original shapes and strength in the seams and support gussets before welding the whole lot back together again and the usual phosphoric acid & zinc applied, etc. to each section.

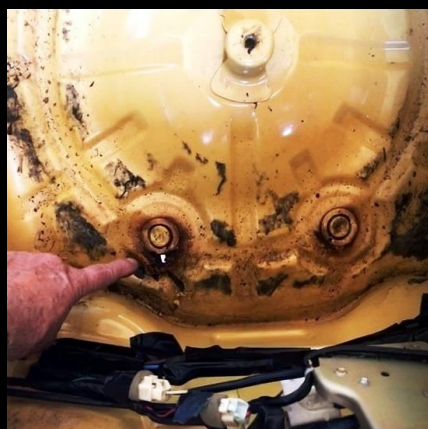
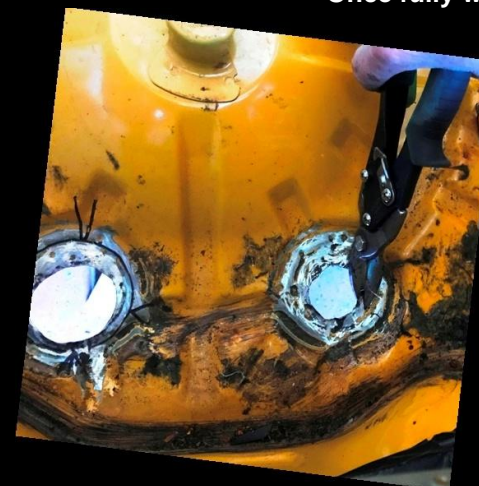
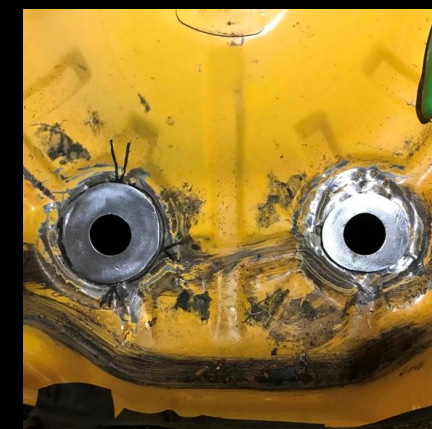
First photo left shows the corrosion inside the boot around the two drain-hole rubber bungs.

These 'bungs' can be removed to drain-off any excess water that may find its way into the boot. If water is allowed to collect there the result is often corrosion around these holes.

The next photos (right) show the rusty metal being cut-out & the end photo shows two new drain-plug plates inserted ready for welding. Once sealed with Tiger Seal, two new bungs will be fitted.

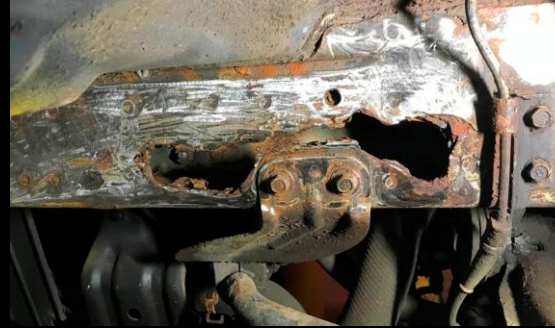
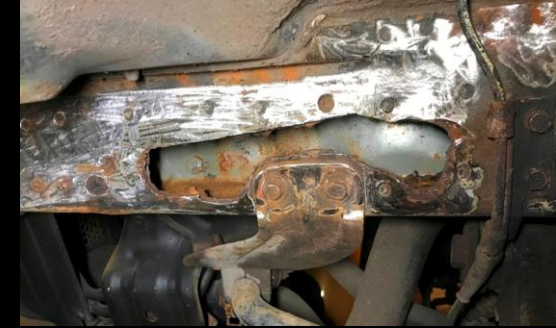
Just as I was thinking "I've nearly completed all of the welding on all four corners" (apart from welding the bottom of the near-side front wing) I discovered the front chassis rail was also badly corroded. This didn't appear to be in need of immediate attention until I probed more deeply but because the corrosion is within 30 centimeters of main structural parts (i.e. suspension roll bar mounting, wishbone and shock absorber mountings) it is obvious that this should constitute an MOT 'Fail', so it was a no-brainer to tackle this chassis rail now whilst the car is still 'in the air' on axle stands, so I decided to tackle & weld this section too.

This section is quite an important structural part of the car supporting the front suspension & steering. The bad news is: to get at it properly I have to remove the Radiator, Power Steering pipework, various other fittings, wiring & hoses in the engine bay just to get access to the inner chassis member. I made a new chassis rail out of 14 guage steel plate (captive nuts welded in place to support the anti-roll bar bracket and other fittings) exactly where Mazda designed & intended.

Now the inner & outer rear sills & jacking-points are welded up fully, the next step was to start on the front near-side chassis rail. The front bumper was removed to gain access to the rotten chassis rail. The first challenge encountered was the plastic fittings that broke-off 'one by one' as I tried to release the bumper. This thing is fighting back all of the way! I made new metal captive nuts to replace the broken plastic fittings and as mentioned above, I had to drain-off the coolant and remove the radiator, plus unbolt the power steering unit and induction air-filter housing, pipe work & wiring. To remove the anti roll bar bracket I had to unbolt the two bolts on each side of the bracket (which sheered off) and drill-out two spot-welds that further secure the anti-roll-bar bracket to the chassis rail.

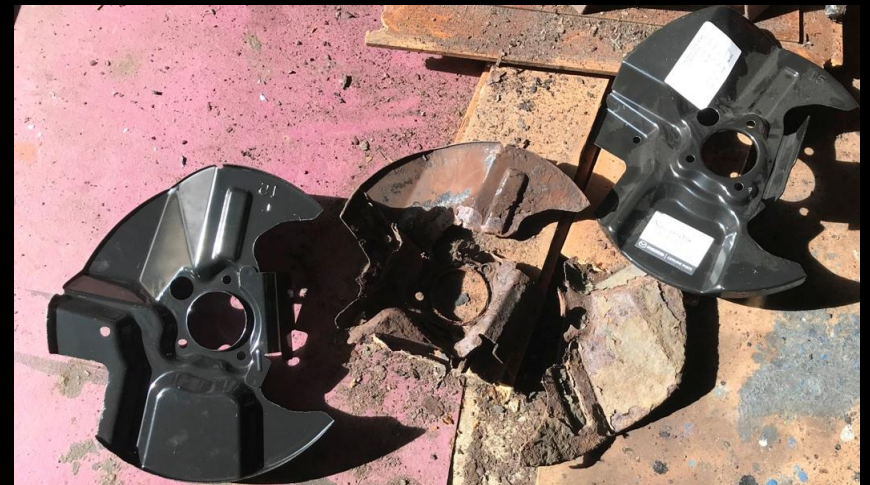
Photo below:
Shows the old rusty front disc back-plates (totally corroded) situated between the two new shiny Mazda supplied brake back-plates (seen here on either side of the rusty remains).

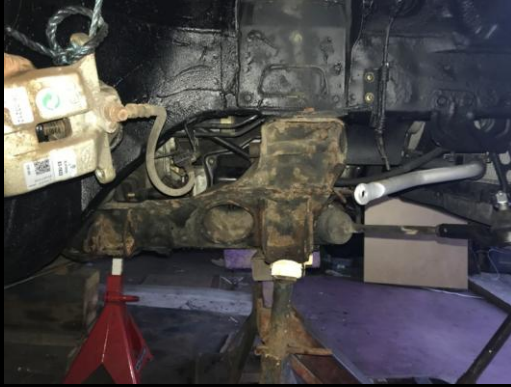
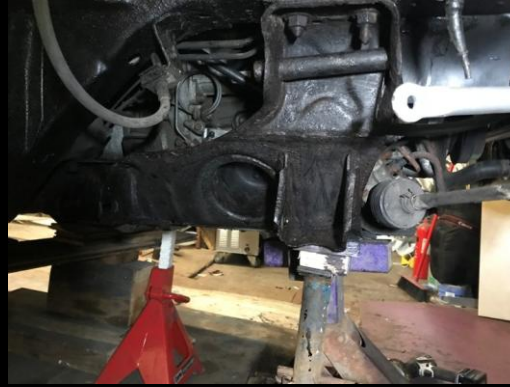
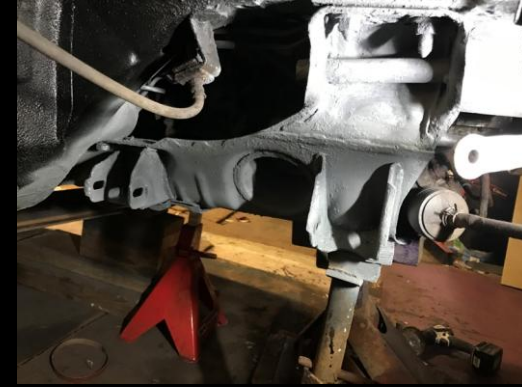
Front off-side chassis sub-frame. First photo below (left) shows the rusty sub-frame (suspension wishbones & shocker removed). Second photo (middle) shows sub-frame wirebrushed & de-rusted with liberal coating of phosphoric acid, turning the ferrus oxide into a sealed & stable 'ferrus-phosphate'. The end photo (right) sub-frame now zinc primed & ready for the stone chip guard underseal top coat. It's coming along slowly but surely (time and work commitments willing).

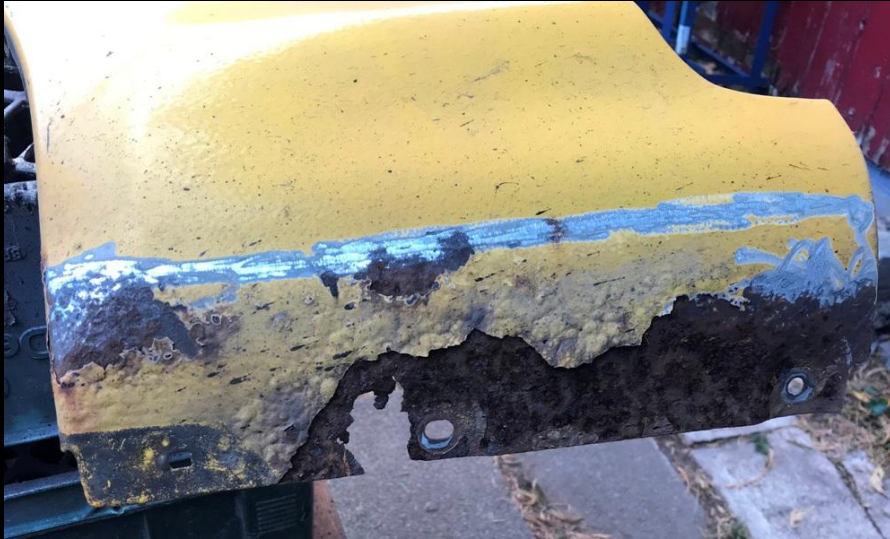
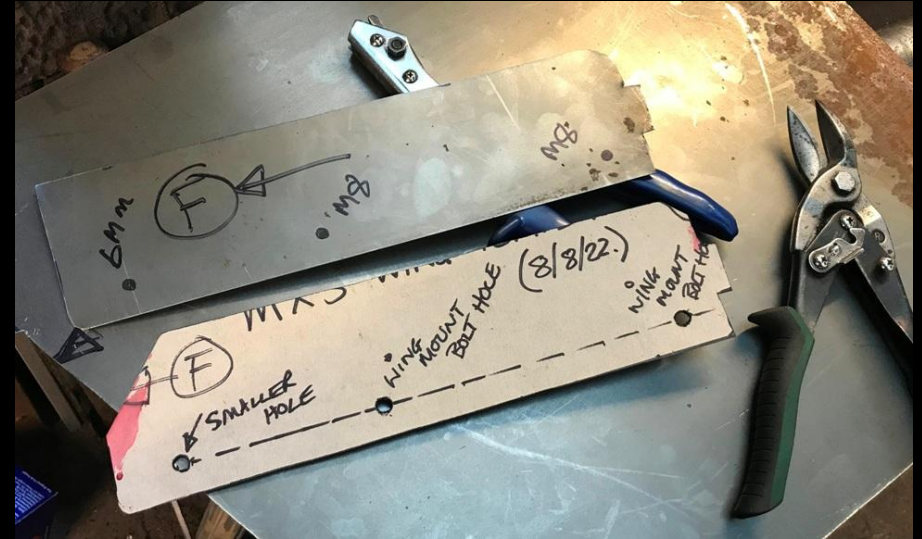
Next job on my list: To remove the badly corroded metal from the bottom of the near-side front wing (just as I did with the other side). I managed to use the cardboard template I made for the other wing, but 'trimmed-it-down' a tad, to suit the requirements of 'this' wing. I'm using the same sized 20 guage mild steel plate that I used on the other side. Not forgetting, this repair is saving me a total of two hundred and forty quid (for the price of two ebay wings). And . . . I am really enjoying doing all of this work. Now that was an unexpected & pleasant surprise. Probably because there is no rush to get it done & me taking my time too.

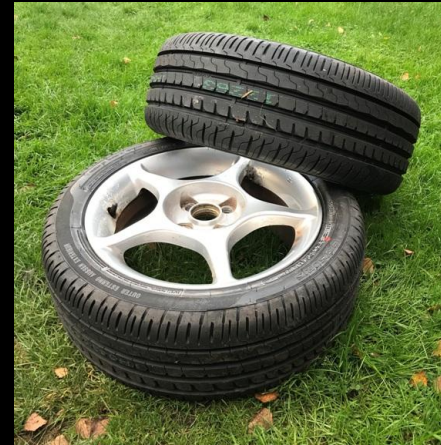
The rear tyre that was an obvious 'immediated MOT fail' because of the large 'bulge' on the inside tyre-wall (see first photo below left). Again this was out of sight. I'm convinced this damage was caused when I unavoidably struck a very large Road Pot Hole at speed a few months ago. Our bloody Roads are crap!

Third photo (below right) shows my new Avon 190/50R/15 ZV7 tyres that I decided to buy. These two new tyres now match the front tyres which are also Avons.

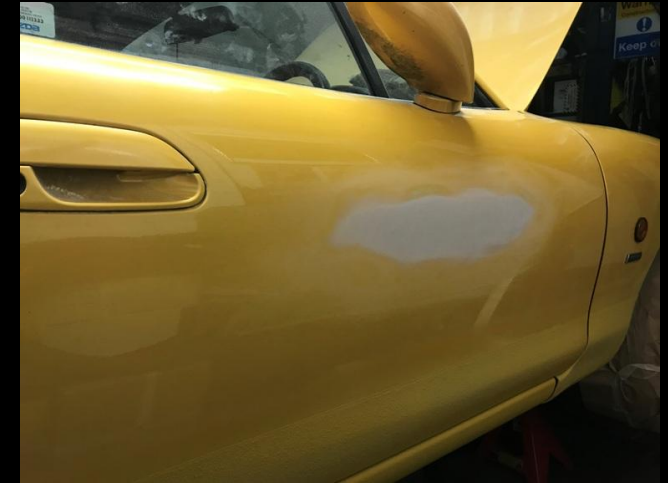
two small annoying dents in the driver's side door have been there for years

And . . . finally, after having two small annoying dents in the drivers-side-door (for several years now) I decided it was time to 'get rid of them'. See close-up photo (above centre), but only because I already have body filler, primer & paint, etc. to finish-off the cosmetic work (following welding repairs) so I thought . . . "I might as well tackle these 'two annoying dents' at the same time". The photos below: show the driver's side-door repair. After a bit of panel-beating, followed by the application of a small amount of body filler, then sanding-down & multi-priming. I added the yellow base coat to the o/s door and other primed areas on the front wing & rear wheel arches just to neaten everything-up and make it a bit more presentable ready for the MOT.
