Land Rover Defender

TD5 - 110

County Station Wagon

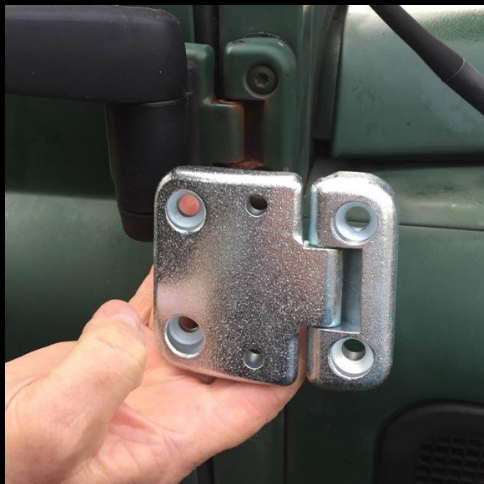
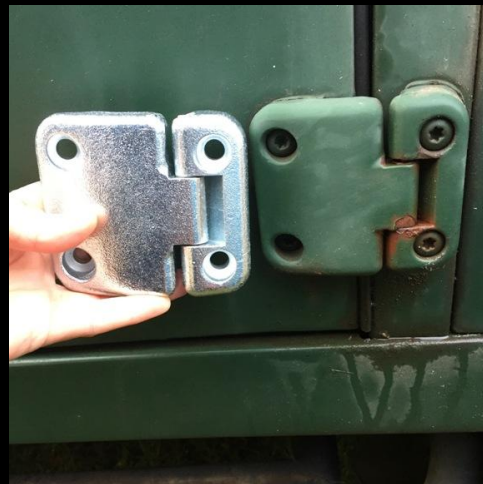
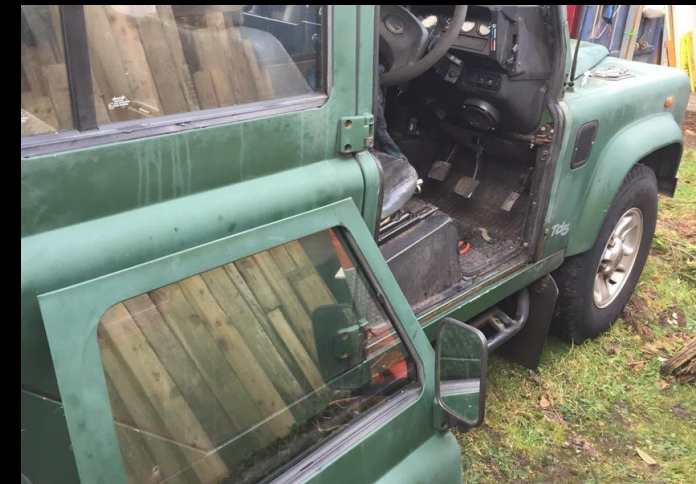
First Job on our *works-agenda* was to fix both Front Doors. Neither of them fit properly as the Door Hinges are both knackered (worn & broken hinge pins). Neither Front Doors would lock easily (it was possible to lock them, but with great difficulty). So our first priority was to make this 'Landy' as *secure* as possible. We tried getting new hinge pins, but ended-up buying new hinges instead. As you can imagine on an eighteen year old vehicle (that's seen its fair share of hard graft and outdoor living) most fittings & *nuts'n'bolts* was well and truly rusted & stuck-fast. After plenty of encouragement (i.e. a Big hammer and lots of WD40 & heat) we managed to extract & re-fit the new hinges into place. Job Done!

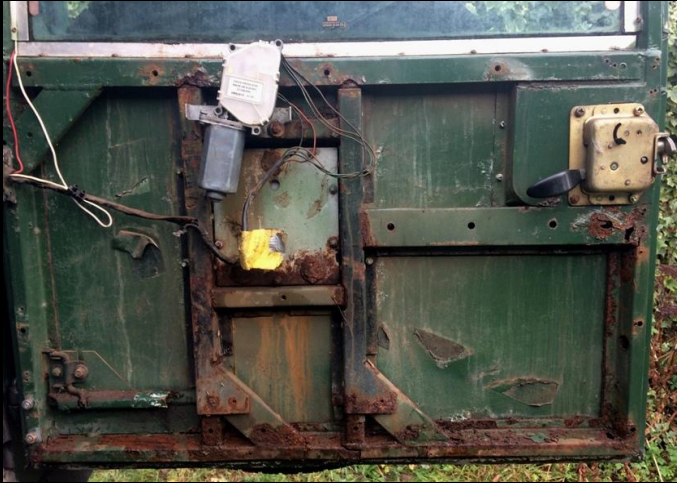
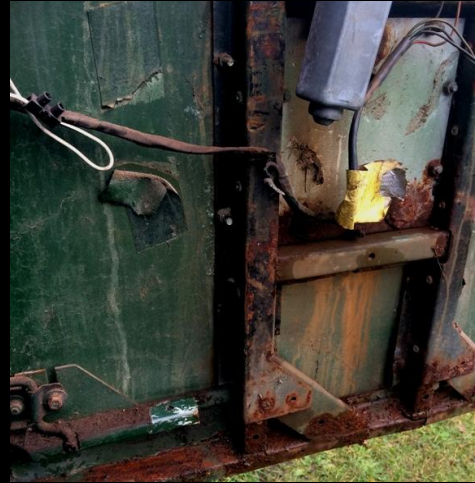
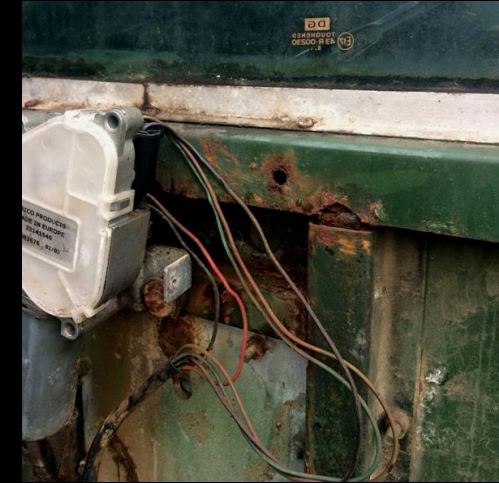
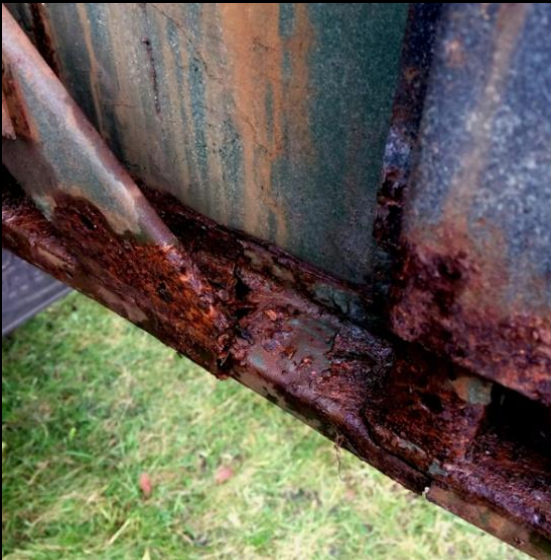
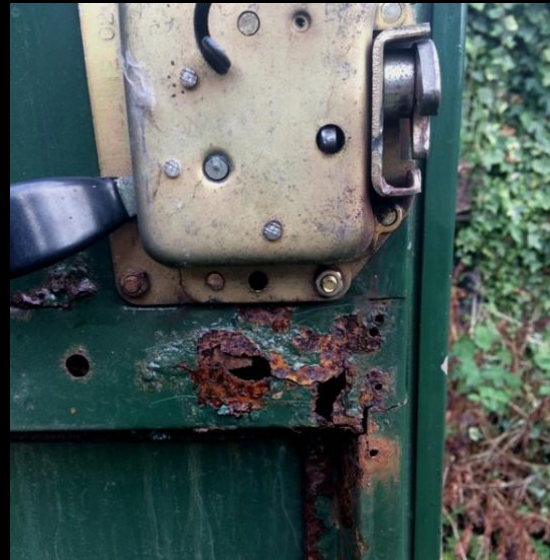
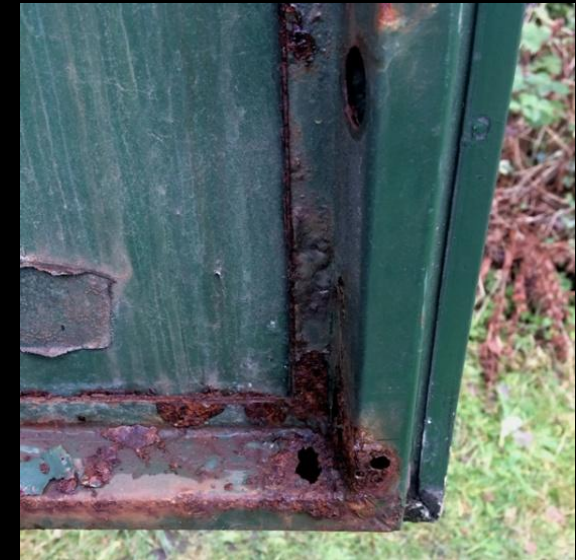
The next job(s), on the following page(s): was to remove the rear door 'Cardboard Door panel' to get to the rear door lock (in order to replace the old key barrel with the new key barrel). Unfortunately, when the original rear door card-panel was removed we discovered the true condition of the rear door. To our dismay we found a very rusty and cracked door frame-work in need of immediate remedial repair. Complete Rear Door replacement is not an option at this stage.

Okay! So, there's a bit of 'Rust' here and there . . . Oh! And there . . . Oh! and there too . . . but that's what owning a 'Fixer-up' is all about 😊

"It really does look a lot worse than it actually is" (this is my MANTRA at the moment, and if I keep repeating it, over & over again, I might even start to believe it soon). I'm sure the weight of the Spare Wheel (which is fitted to the outside of the rear door) has compounded matters and has contributed to these serious fractures and cracks (a combination of rust-corrosion, plus continuous movement fatigue and door flexing = Fractures). The Answer was to repair and strengthen-up the door & the Spare Wheel Carrier by adding *steel fabrication* to the vulnerable and damaged top & bottom fractured areas (and Wheel Carrier Bracket).

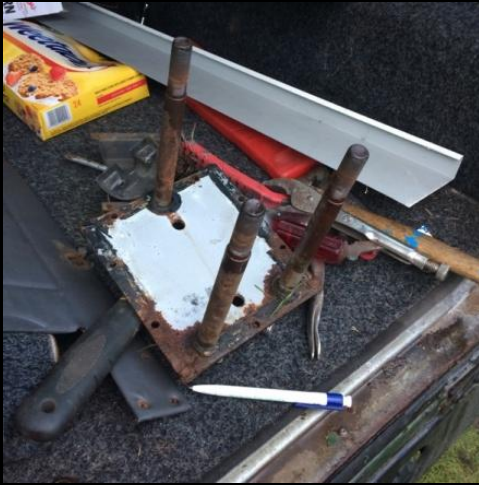
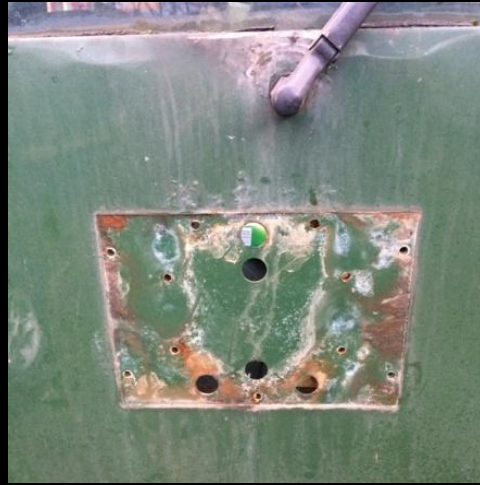
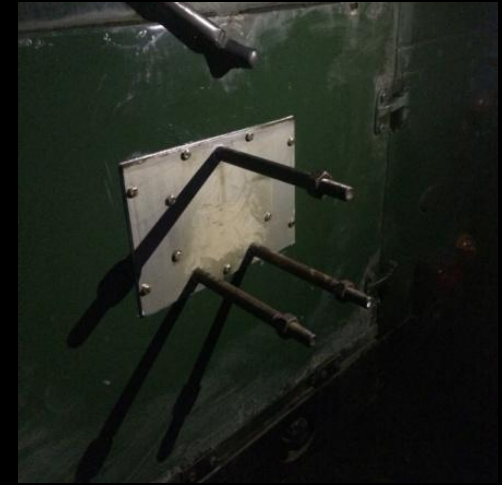
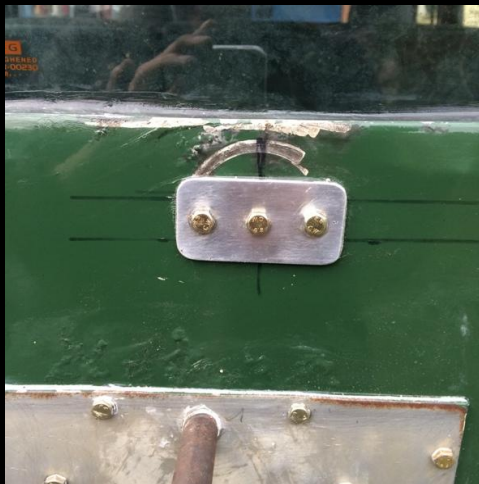
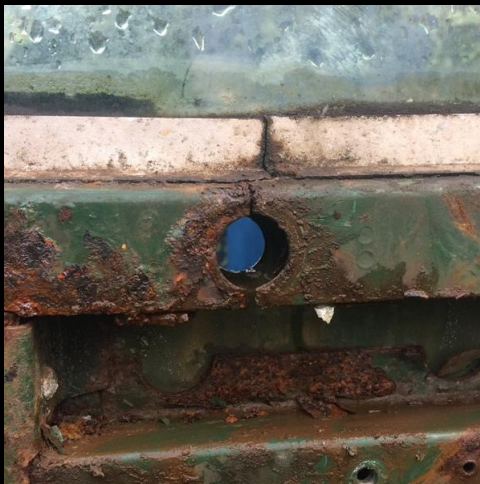
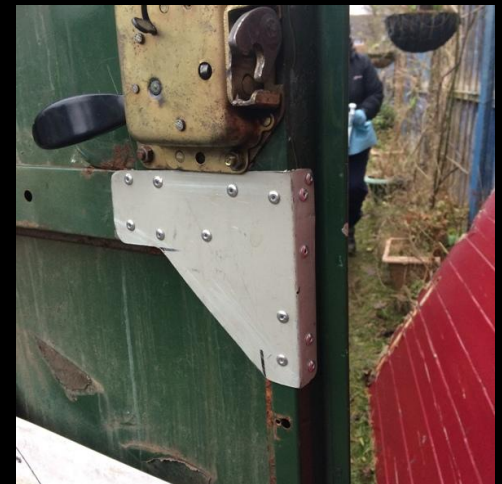
Because the rear door had developed serious fractures and splits virtually 'centre-line' to the door, it was decided to remove the rear window Wiper Motor Unit & Wiper Blade (and leave it 'Off' altogether). And to reinforce the top & bottom damaged areas of the door with 2mm & 3mm steel plate (pop-riveted & bolted together) and to make and fit a complete new 'Steel Panel' (instead of & in-place-of the original Defender 'Cardboard Door Panel' cover). The finished *result* is a very strong rear door (but at the loss of a rear wiper motor & wiper blade system).

The Spare Wheel Carrier was removed & repaired, plus a new rubber seal fitted. Galvanised Steel plate was used to reinforce the existing door cross-members, thereby effectively reinforcing the old rusty and tired door (giving us a at least a couple more years of 'use' before replacing it).

The photographs above show some of the fabricated steel gussets & plates bolted & pop-riveted into place to reinforce the rear door. The photos (next page / below left) shows a sheet of steel being used - measured-out, cut and folded (with the pop-rivet holes pre-drilled) and ready to fit on to the bottom of the rear door. Just by adding this bottom steel fabricated piece makes such a difference to the door. It is already a lot stronger than before and I'm quite pleased with the outcome. Apparently later model rear doors are *Pressed-out* in one piece, rather than *Welded* together.

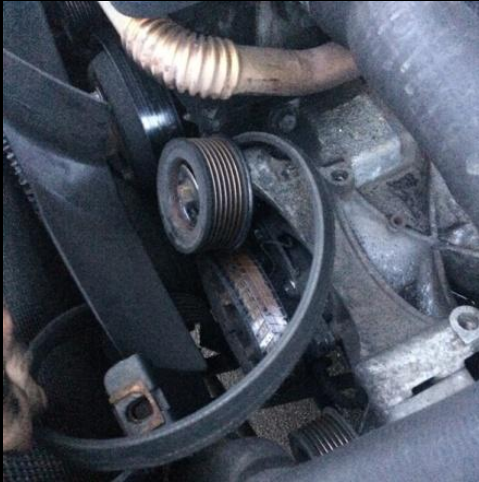
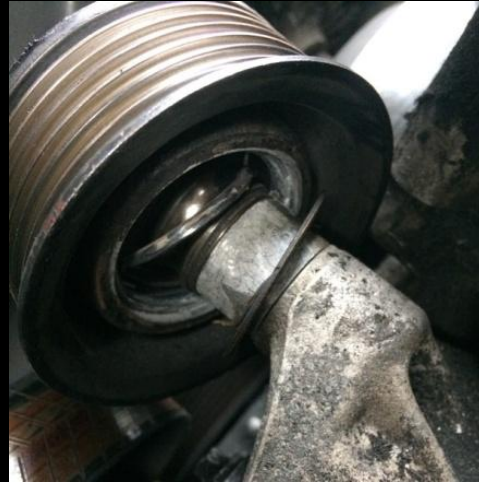
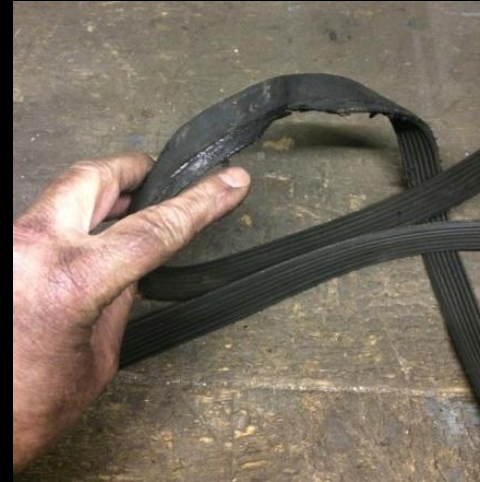
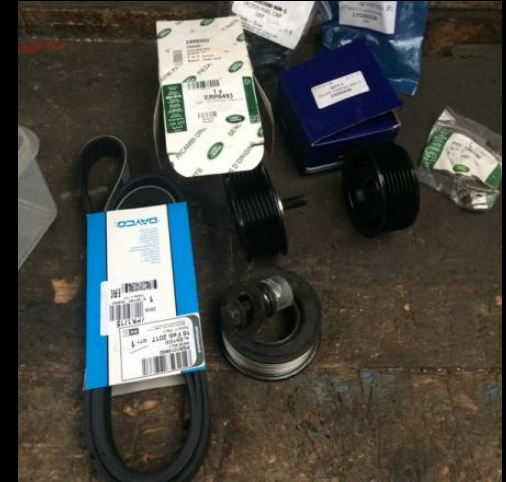
On Monday 22nd January, I drove into Town and to my dismay “there was a strange noise” coming from the engine compartment. A few miles later, the problem became apparent when the smell of burning rubber and the Red Battery Warning Light came ‘On’ following a serious mechanical malfunction! The photos below show exactly what happened . . . The Auxiliary Drive Belt ‘Idler Pulley’ bearing disintegrated!

On Tuesday 23rd, I purchased the necessary spare parts to repair this mechanical mishap, and fitted them that afternoon. I replaced Both Idler Pulley Wheels & Bearing Units (as the second pulley has probably seen just as much work as the one that failed) and obviously fitted a Brand New Serpentine Auxiliary Drive belt too.

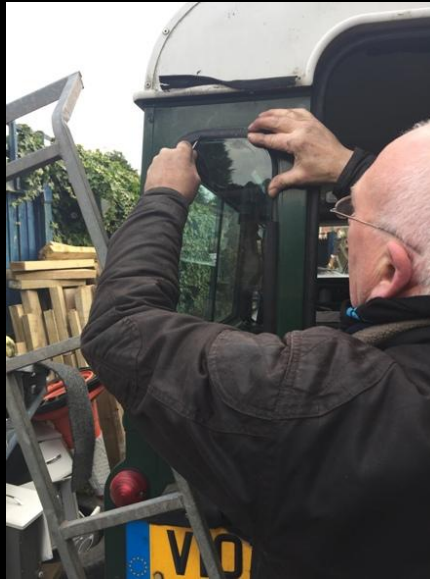
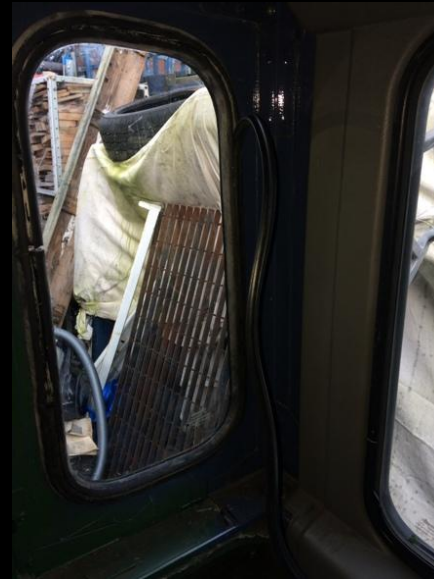
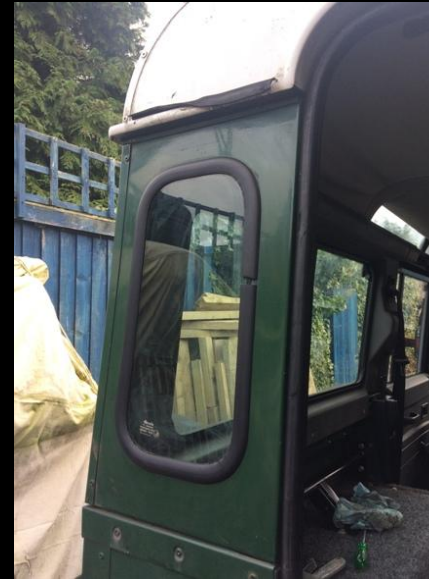
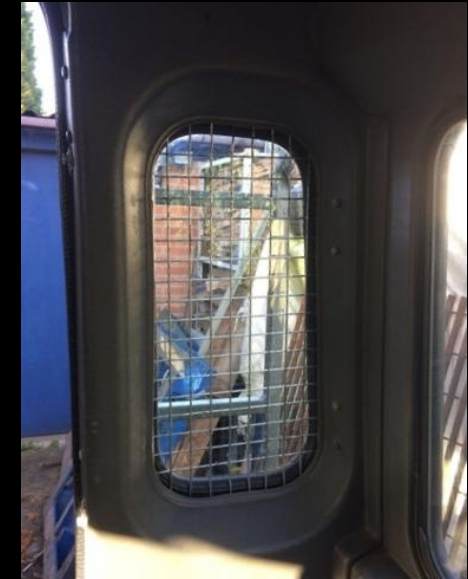
But just as one job is finished . . . yet another job appears. Something that we totally missed (when we bought this 110) was the fact that the rear 'Quarter light Window' was very close to 'falling-out'. So, I had to remove the Window completely and cleaned-up both the Seal and the Window, before refitting it back into its proper place. The Inner Seal 'Beading-Strip' took quite a bit of effort to get it back-into-place. But with the usual amount of patience and occasional swearing . . . it all went back perfectly. The job was finished-off with a home-made *Wire Security Guard*.

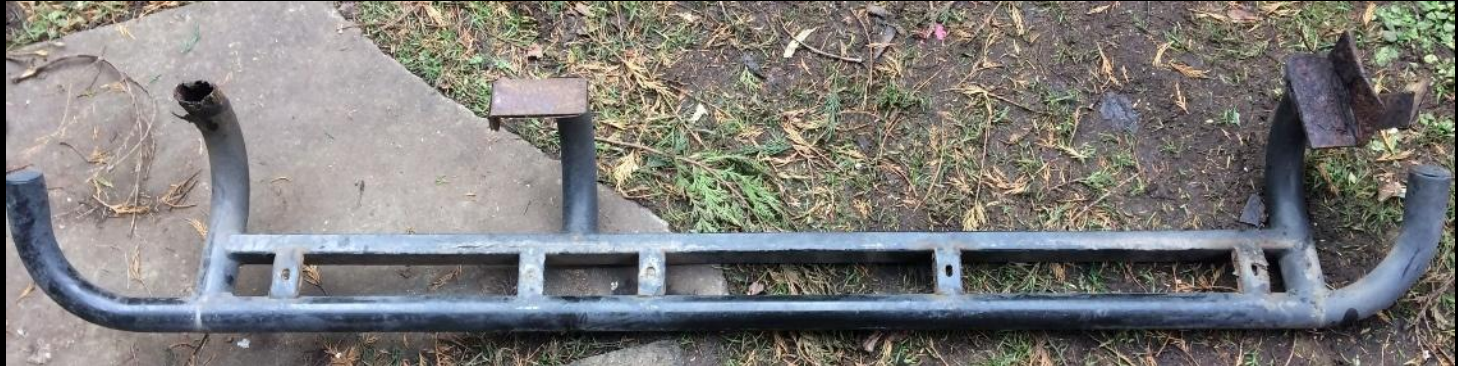
The Side Steps (on both sides) were in need of serious repair. They wobbled and creaked whenever any weight was put on them. Following closer inspection it was discovered the mounting brackets (where they bolt onto the chassis) had fractured & split due to corrosion. Plus, the nuts & bolts (that hold these Steps to the Chassis) was totally rusted & seized solid. So the next stage was remove them for structural repairs (i.e. fabricate & weld new brackets and support plates onto these old & rusty *Side Steps*) before we can re-fit them back onto the vehicle.

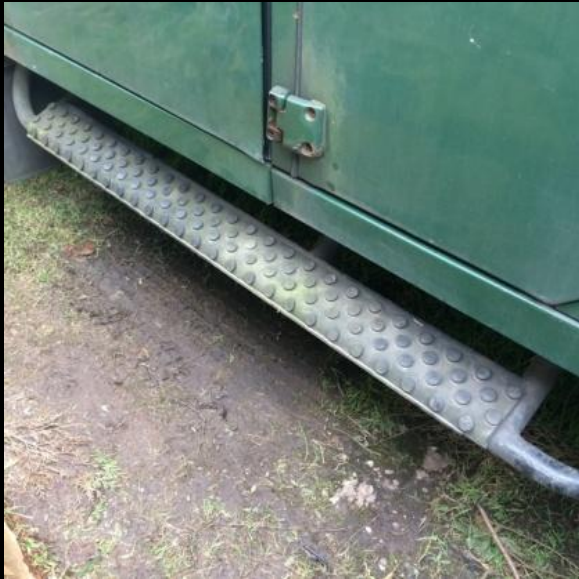
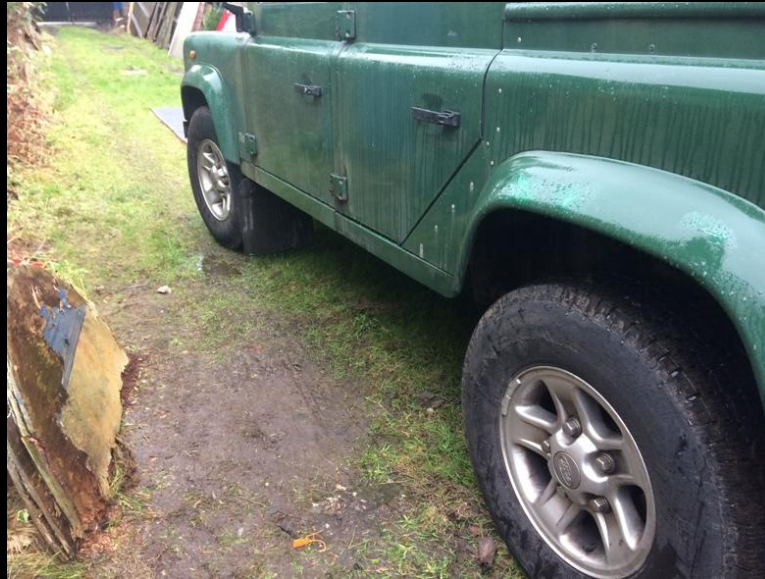
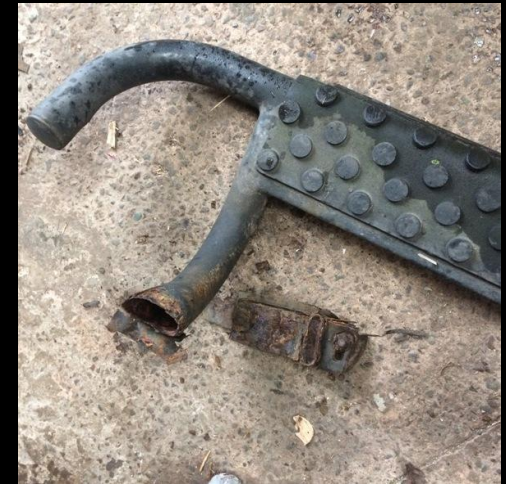
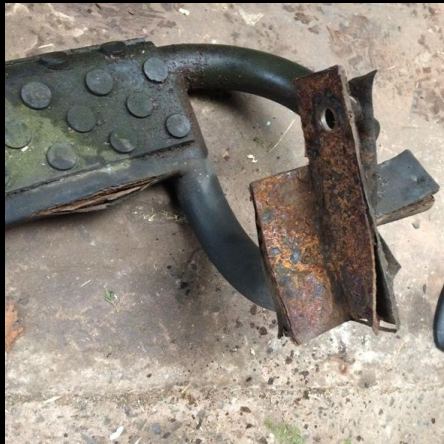
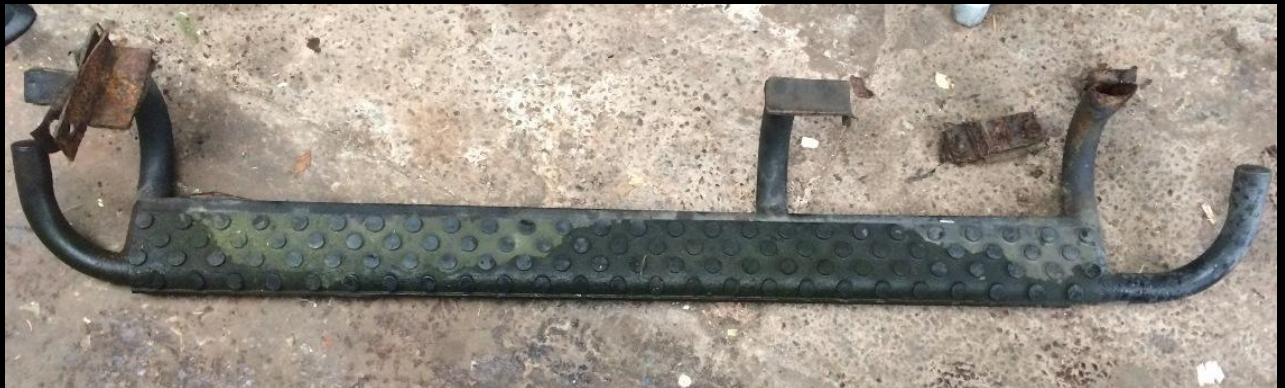
Due to the extreme corrosion of the Step mounting brackets and seized fixing nuts & bolts, we had to use a Disc-Grinder to cut them off.
