Velocette MAC 350cc

The Re-Rebuild of KJ's MAC (Part Four)

From May 2023 onwards

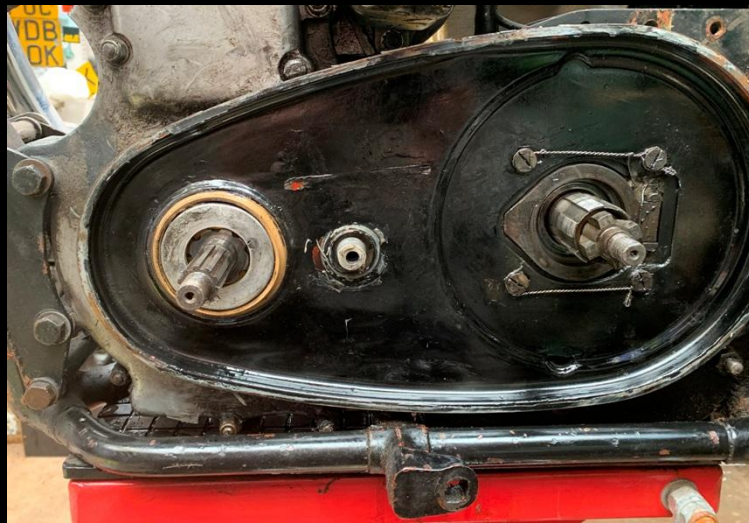
I'm pretty sure the earlier problem (lack of oil pressure) had contributed my latest engine 'rumble'. But before taking the engine out of the frame I decided to check the crank 'end-float' (with DTI) which should have no pre-load / side-to-side movement (i.e. set at Zero).

I was able to move the crankshaft backwards and forwards by twelve and a half thou" (0.0125").

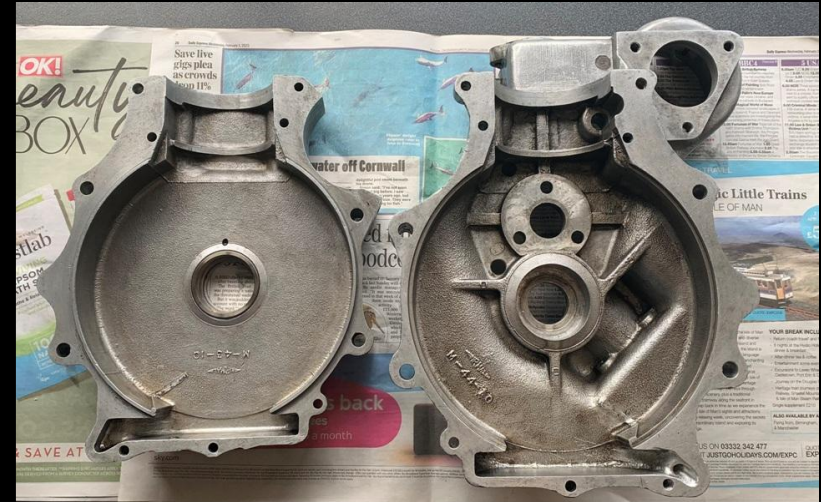
If you look closely enough at the photo (on right) you can see the 'score marks' on the 'Rollers'.

I thought that I might get away with the drive side roller bearing. But . . . on closer inspection I could feel that both bearings felt dodgy and more than likely to be as bad as each other. So I purchased two new main bearings anyway; one roller-bearing for the drive-side crankshaft and one ball-bearing for the timing-side to fit onto the new timing-side crankshaft.
For reference: Two new main bearings cost two hundred & thirty four pounds (& eighty pence).

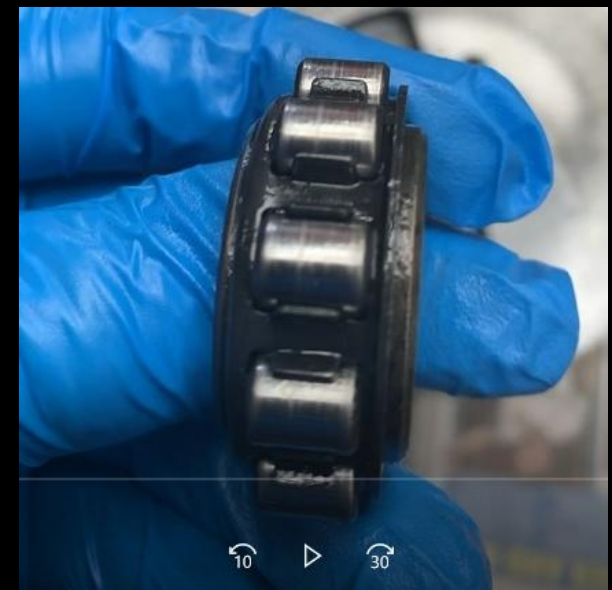
Old Main Roller Bearing

Photo left: is the Hoffman Roller bearing that I fitted to the Timing side crank (instead of a Ball Bearing). On inspection there's a very slight 'picking-up-feel' so I'm replacing it with a Ball Bearing.

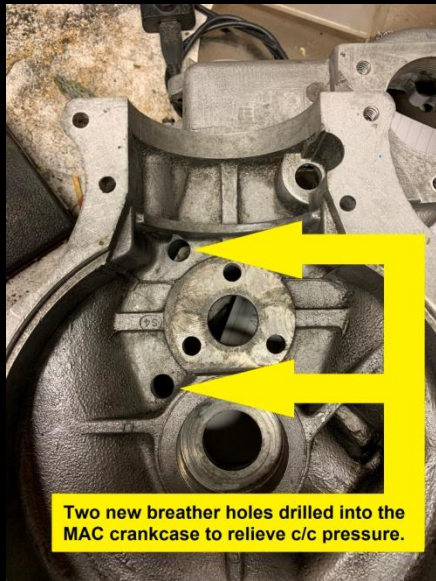
Two new breather holes drilled into the MAC crankcase to relieve c/c pressure.

I've done this to help relieve the internal crankcase pressure.

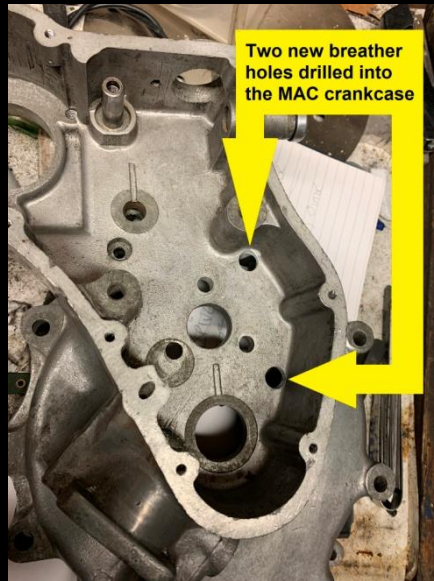
Two new breather holes drilled into the MAC crankcase

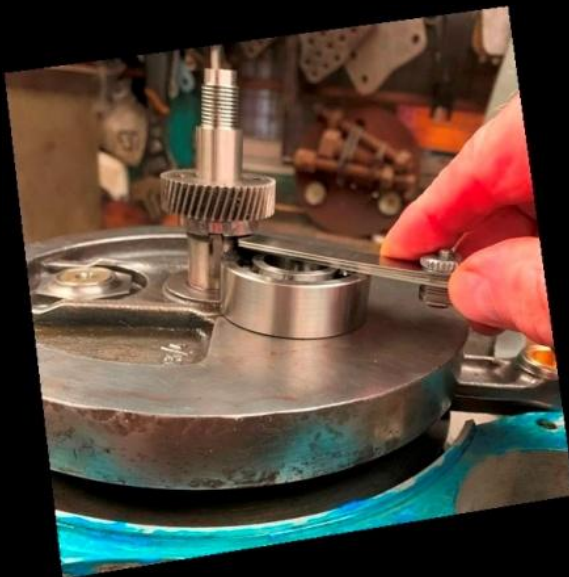
The photograph on the left shows me identifying the 'gap' between the Timing Pinion and the face of the Main Bearing. I assumed that the Pinion fitted tightly against the Main Bearing: BUT it doesn't !

I noticed this 'Gap' (photo left) when I dismantled the engine ready for the crankshaft repair. And because the original Main Bearing had 'spun' in the crankcase housing, I noticed the crank was able to be moved backwards and forwards by 0.0125" (see page two at the start of this blog), but at that stage didn't understand the reason. I thought that maybe it was because I had used Roller Bearings on both sides, allowing the crankshaft to 'float' from side to side. But that was not the cause of this 'end-float'.

Well, upon further inspection, I discovered that this movement was due to this 'Gap' between the Timing Pinion & the Main Bearing face (which coincidentally was 0.0125"). I wonder if anyone else has discovered this anomaly.

My solution; is to make a steel shim, that will fit between these two components thereby removing this 'Gap' once & for all.

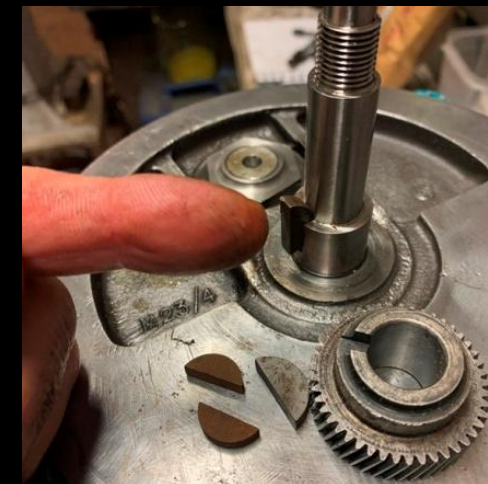
The photo above: shows me sorting-out a new woodruff key to fit the 'Slot' in the crankshaft that drives the bottom Timing Pinion. Fortunately for me I found several woodruff keys in my stores that I could easily modify.

"No Thanks" to Alpha B for loosing the original woodruff key, and/or for not even supplying me with a replacement 'Key' especially as they had to 'Grind a New Keyway' into the new shaft that was specially made from scratch by them !

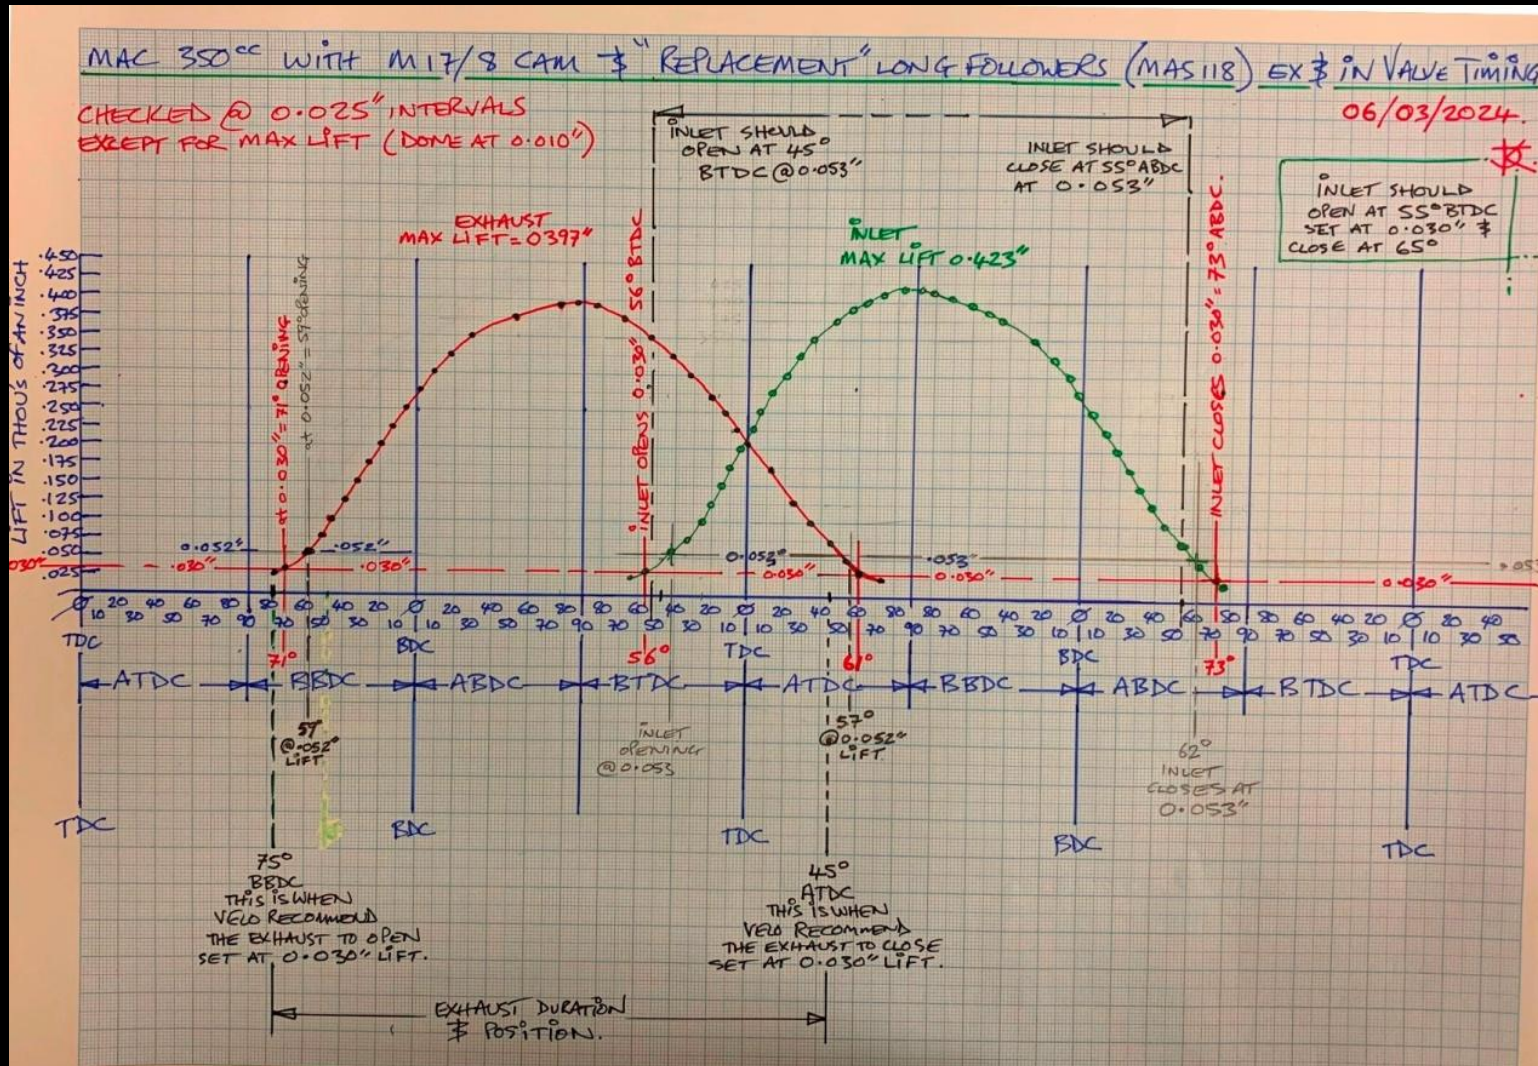
Another important issue illustrated in the attached graph is the valve 'over-lap' where the valves opening & closing point crosses the 360 degree point (or rather right through the Top Dead Centre line) which was also one of the criteria mentioned in several articles. On previously plotted 'timings' this so-called 'over-lap' crossed each other by many degrees in advance of the 360 degree point.

My final timing settings that I ended up using are as follows (all set at 0.030" lift)

- Inlet opens 56 degrees BTDC
- Inlet closes 73 degrees ABDC
- Ex. Opens at 71 degrees BBDC
- Ex. closes at 61 degrees ATDC
