Velocette MAC 350cc

Rebuild Project Part One, Year One

From October 2017

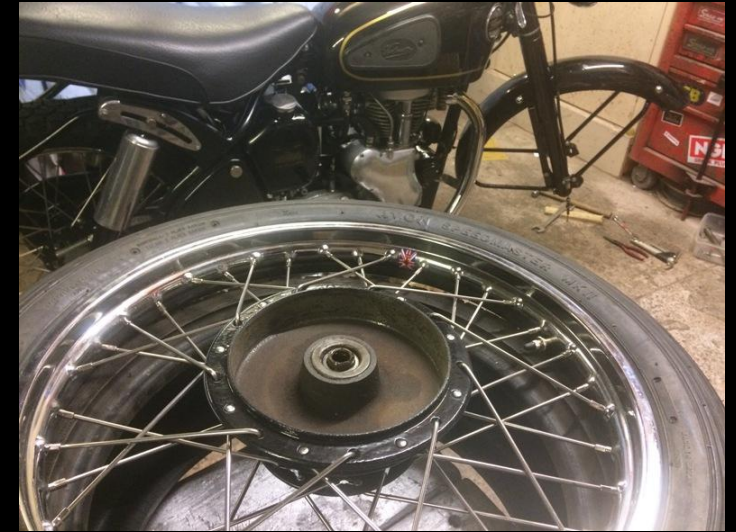
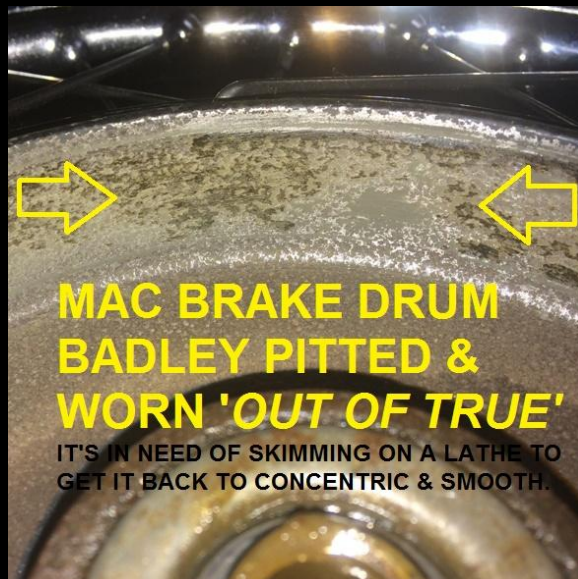
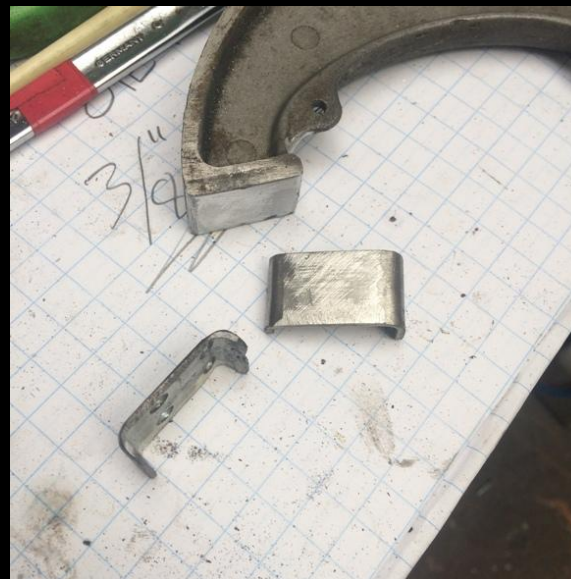
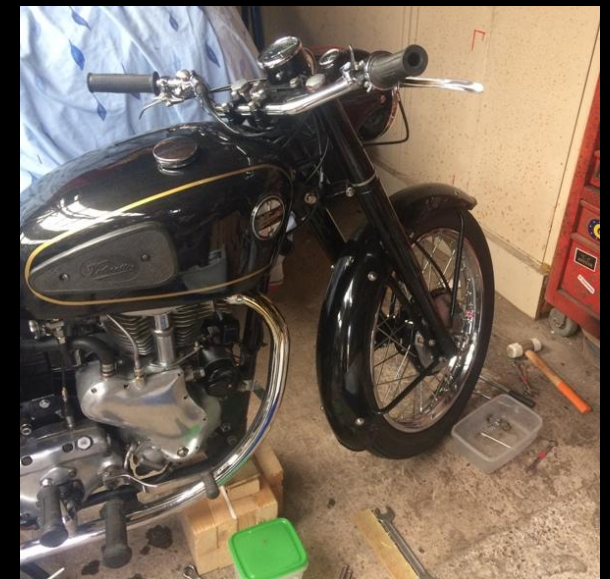
1) Wheel Out & Inspect Brakes. 2) OMG! Sit down, take an Aspirin & have a Cuppa, because the Brake Drum needs to be 'Skimmed' due to being both rusty & 'Oval'. 3) Fabricate New 'Over-Size' Shoe-Slippers & Fulcrum Spacers (as a temporary fix to get shoes to work). 4) Re-Fit Wheel & adjust Brake Cable.

Front Brake only slightly improved at this stage, but only marginally.

Sixty mph to Standstill = two days, three hours & 4 minutes approx. (only joking, because it does 'Stop' eventually, but only when an inordinate amount of pressure is applied to the front brake lever). Fortunately for me (and the general Public at large) the Rear Brake works really well.

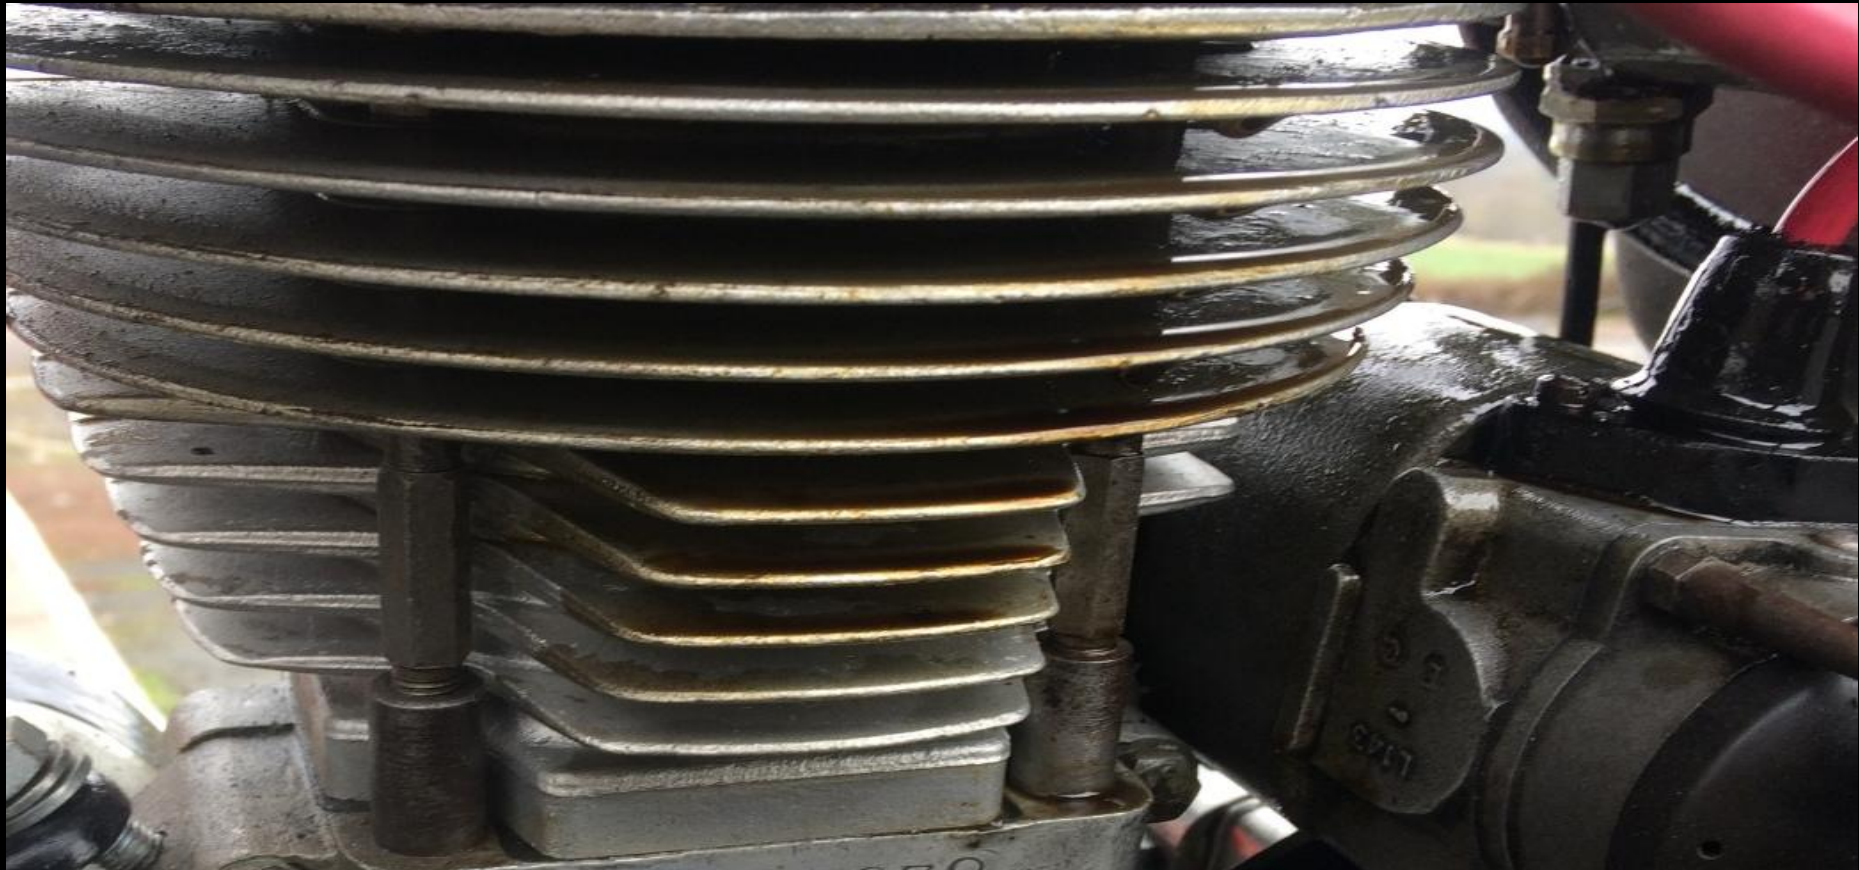
On the negative side (re; my outings): the engine *'Leaked'* Oil out at an alarming rate (but at least NOT from the Oil Tank Check-Valve now). I was not exactly sure of where it was leaking from but appeared to be coming from under the Petrol tank and around the Cylinder Head & Rocker Box.

On any old British Bike the *'Odd Oil Leak'* is *'Par-for-the-Course'* and almost inevitable in a lot of cases (even expected & accepted as the norm to some degree), But . . . Not this amount of Oil Leaking everywhere (especially after an extensive engine rebuild?).

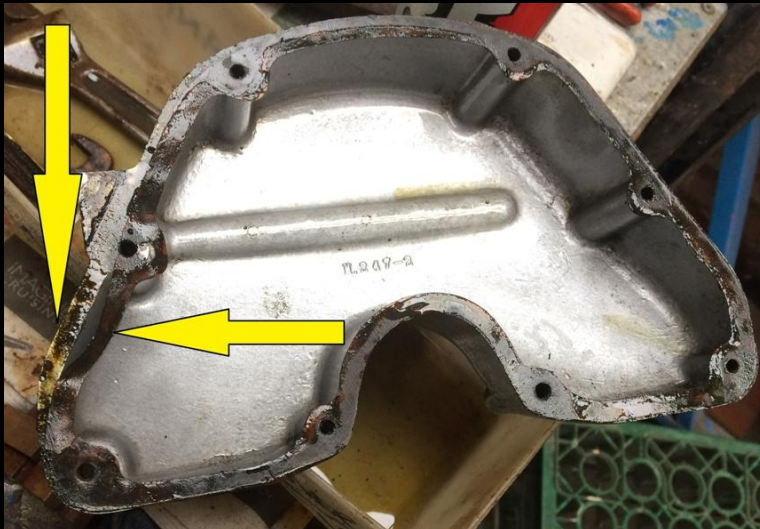
The 'obvious' answer was to start my search for this annoying oil leak at the top end of the engine – and work my way down until I could find the source of the leak. I removed the Rocker Box Cover quickly found the culprit. You can see on the photo below left - where the Rocker Box Cover 'Gasket' had moved when fitted (by previous builder) and had been pinched tight, but unfortunately – missing the sealing face of the Rocker Box – allowing oil to escape all over the engine. So, fingers crossed; my new home-made gasket does the trick & stops this oil slick.

With the Rocker Box Cover 'Off' the Bike I took the opportunity to 'Lap' the Base Surface (using fine grinding paste, oil & paraffin) this was done on a 'Flat Machined-Base Plate'. I then gave the Rocker Box a quick 'polish' on the Bench Polisher before washing the whole lot down in Petrol. Finishing-off with compressed air to blow-out & clean all of the oil ways & stud-holes prior to reassembly. Using 'Engine Blue' I marked out & cut a New Rocker Cover Gasket from brown gasket paper (photo far right).

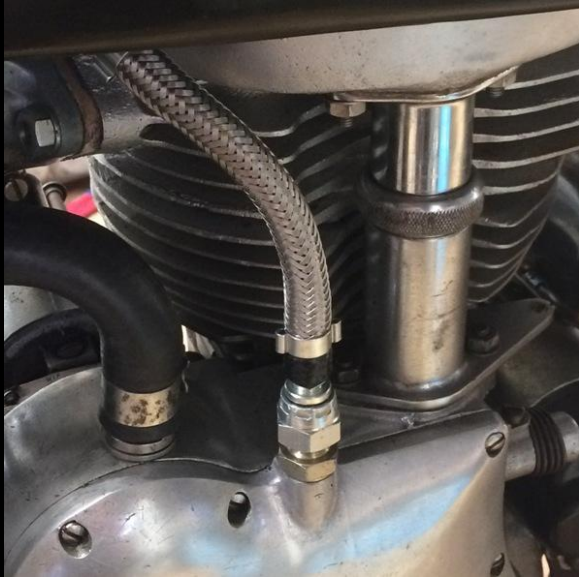
The Next Day; I did a ‘Compression Test’ (as you do) and found Cylinder Compression was below 20psi??? So, once more I removed the Rocker Box Cover I found a problem with the Exhaust Tappet. There WAS a gap – but only just! At this stage, I was convinced that I had discovered the reason why the bike started so easily when cold, but stopped as soon as the engine reached full working temperature (i.e. the Exhaust Valve not closing fully - hence the loss of compression). I presumed that the lack of cylinder compression when engine hot, was due to expansion of the valve gear, making it virtually impossible to start it with the Kick-Starter (but obviously, with a Push-start, there was just enough momentum to build up sufficient pressure inside the cylinder for it to ‘Fire-up’ and to start the engine running). Well . . . That was my theory anyway!

I reset the Exhaust Tappet to 6 thou’ just to make sure (even though the Velo Manual listed this as 5 thou’ for both Tappets) . . . and at the same time I removed the Carburettor completely and cleaned it out thoroughly (just to make extra-sure the ‘Carb’ wasn’t a contributing factor in all of this). I also fitted a new High Tension Cable & Cap, plus new Spark Plug - in an attempt to eliminate any weakness in this part of the ignition system.

I took the opportunity (whilst the Tank & Seat was 'off' the bike) to replace the original Rocker Feed Oil Pipe with a new / improved Flexible Reinforced Braided Oil Pipe and new hydraulic fittings (crimped and tightened into place).

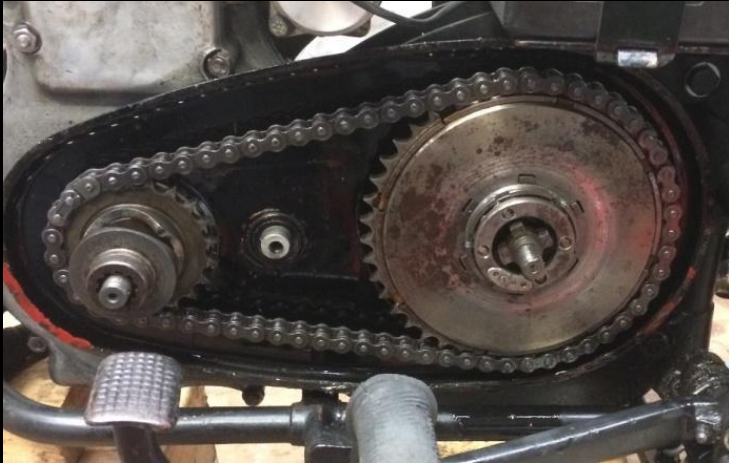
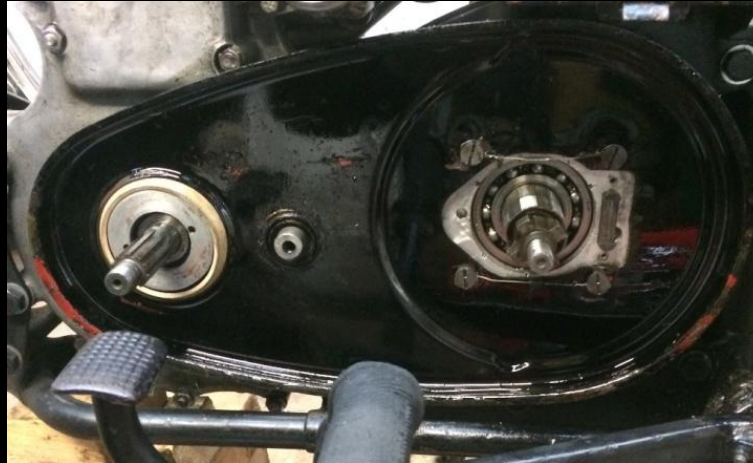
Clutch in Bits

I managed to find a bit of time in between paid-work (mid-week) to start dismantling the chain case & clutch. Upon disassembly, I discovered that the Gearbox Bearing Retaining Ring (aka Sleeve Gear Nut) 'had' come loose and I am hoping that when the Gearbox Bearing Retaining Ring is retightened, and everything goes back together again and adjusted properly, etc. etc. ALL will be well with my MAC once more. Well !!! That was 'Plan'. But, unfortunately, on closer inspection, All was NOT well with the majority of the MAC bits that I had just dismantled. The whole of the Clutch thrust bearing assembly (MAS57) was totally 'fucked' – not just the spherical thrust ring – but most other clutch parts too needed loads of TLC and/or replacing. It also needs a new primary chain.

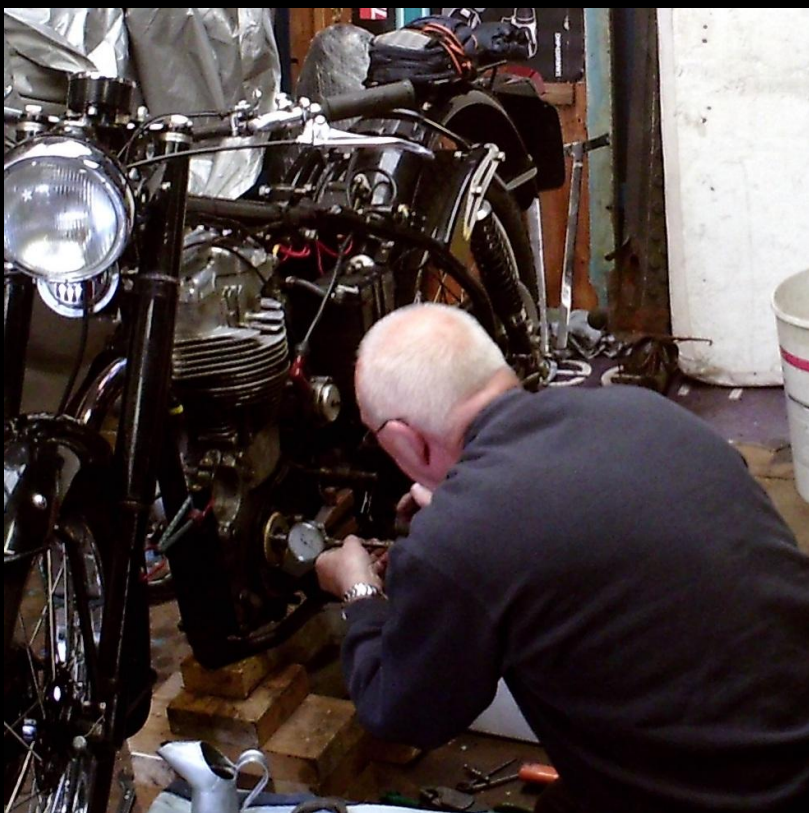
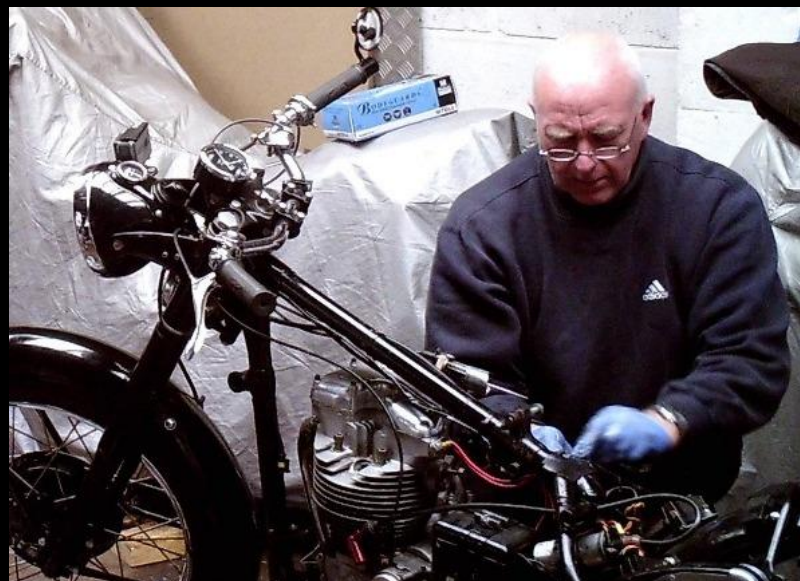
Photo (above left) shows me 'Reading' the Dial Gauge attached to the Crankshaft in order to measure how much 'Free Play Travel / End Float' there is on the Crankshaft. Sadly the Crank moved Seventeen Thousandths of an inch (.017") side-to-side.

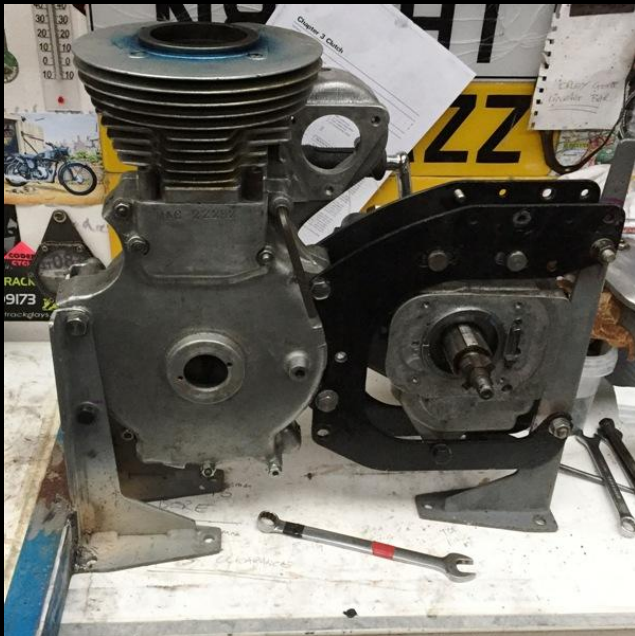
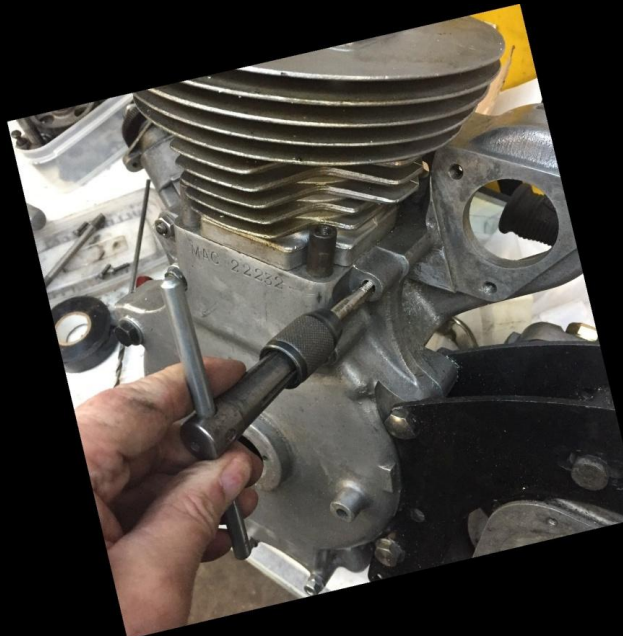
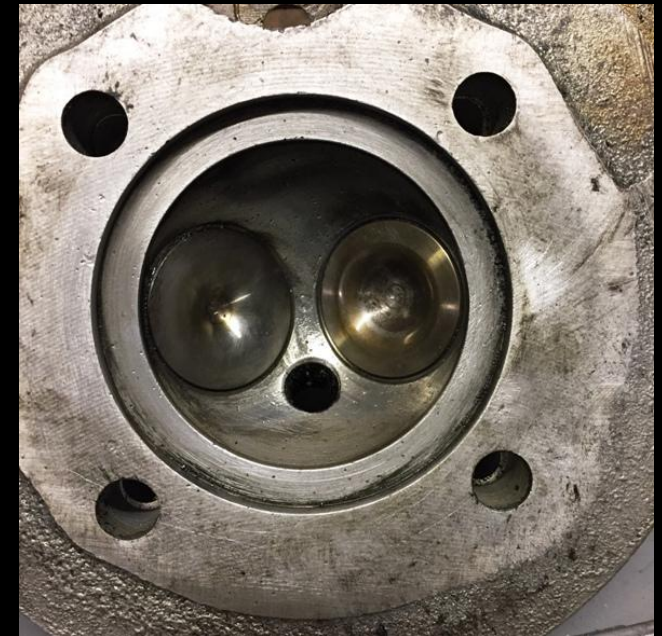
I found one crankcase bolt had been broken off, and someone had tried to drill-out the broken Stud, but without success (see the last photo below right). So! They just glued (Yes! I did say **GLUED!**) the rest of the Bolt back into the crankcase bolt-hole (to make it look as though it was bolted in).

Photo above (right) shows the partly cleaned-up and partly de-coked cylinder chamber & valves.

Home-made Engine/Gearbox Stand (photo below Left) hastily made out of recycled heavy duty wall brackets & a length of angle-iron. This 'Bench Tool' is most useful when working on the engine and/or gearbox. Plus, I managed to drill out the broken Engine Stud and 're-Tap' a new thread to 5/16" BSW (British Standard Whitworth thread – see middle photo below), the original (broken) engine stud was 1/4" diameter.
