Velocette MAC 350cc

Rebuild Project Part Two

November 2018 to November 2019

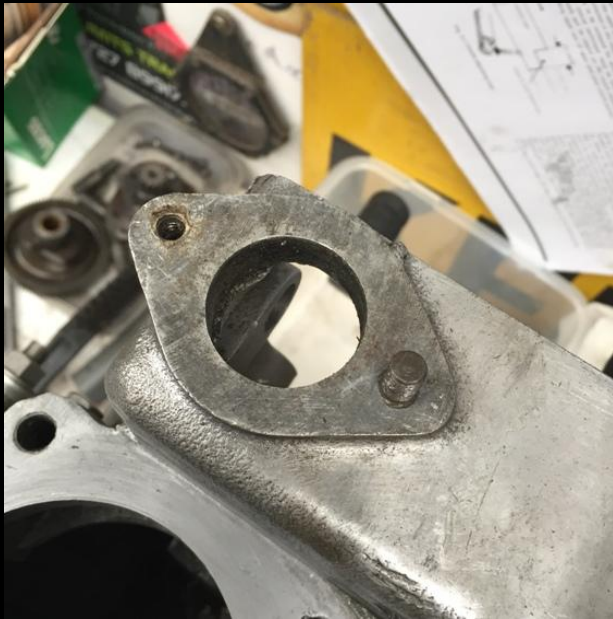
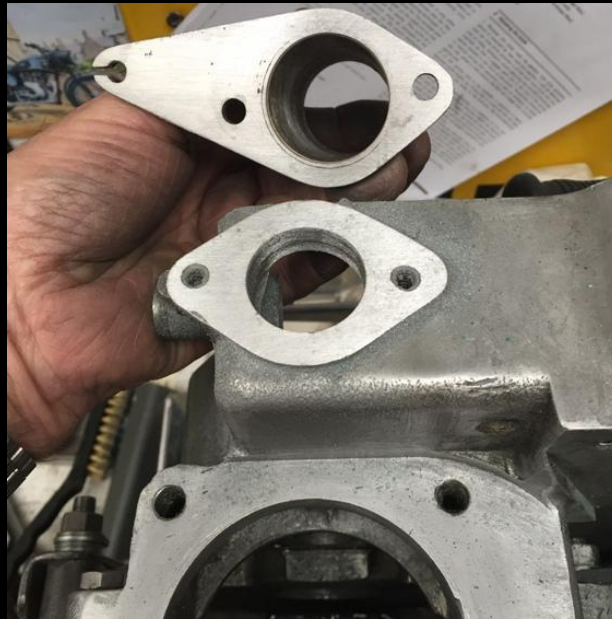
The Push Rod Tunnel and base '*leaked oil*', where the bottom pushrod tube fits, and was such a poor fit - tube wobbling about all over the place. No wonder oil was *pizzizing* from there too.

See the before & after photos (top left). I can guarantee no more oil will emanate from this part of the engine, because . . . I have rectified this problem by '*Re-Facing*' both parts '*Flat & True*' to provide a perfect fit.

I also did the same to the top Pushrod Tube & Rocker-box '*Face*'. Both ends to be sealed with Hylomar gasket sealant & new gaskets.

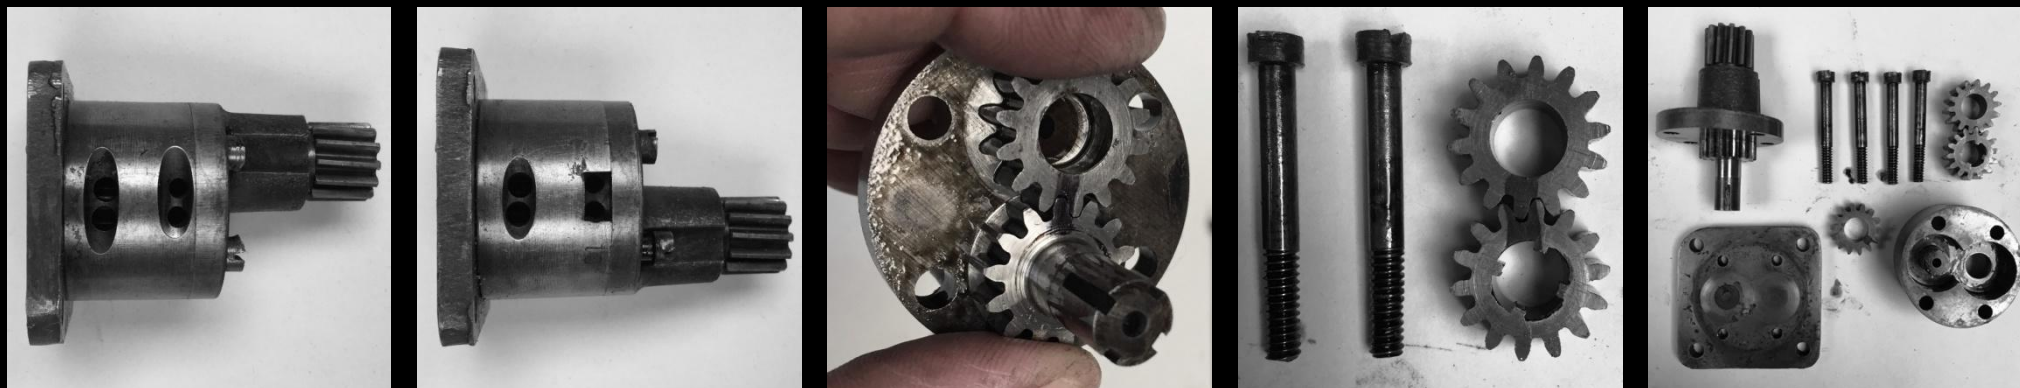
The first two photos (below Left) identified the Body of the Pump was from an 'M' Series 1936 – 1941 model (M217). But on dismantling, and measuring all of the individual gears and drive spindle, etc. it became obvious the Pump was a 'Bitsa' (*i.e 'bits of this fitted & bits of that fitted'*). Plus, over the course of what appears to have been a 'Hard Life', the internals and external state of the Pump shows signs of brutal and clumsy handling and treatment of this VIP (very important part). The internal gears & spindle *are in relatively good condition*; although they need careful 'Lapping-in' of the bearing faces & then re-assemble.

As you can see from the bottom row of photographs (the first two photos Left), I have re-ground the Base-Plate on the internal bearing face. I used fine Grinding Paste (mixed with oil & paraffin) and very laboriously 'Hand-Ground' the Base-Plate on a Machined Steel Flat-Plate. The result is quite evident.

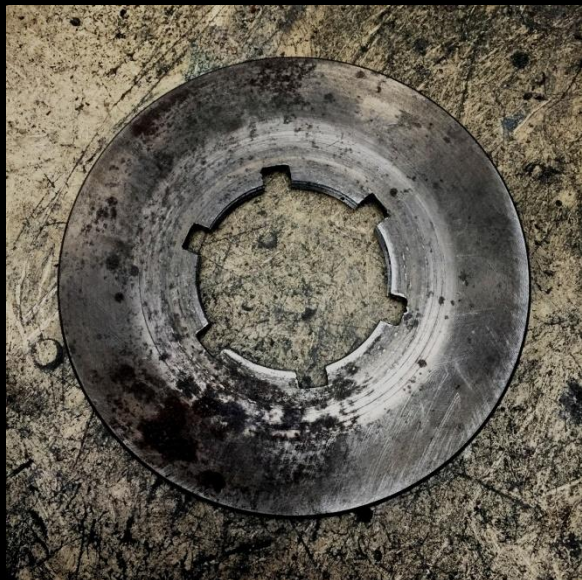
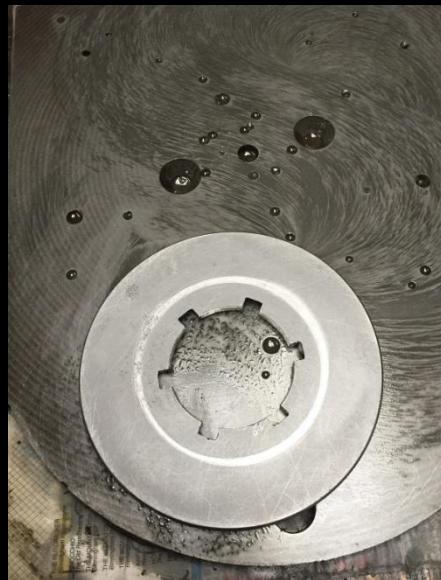
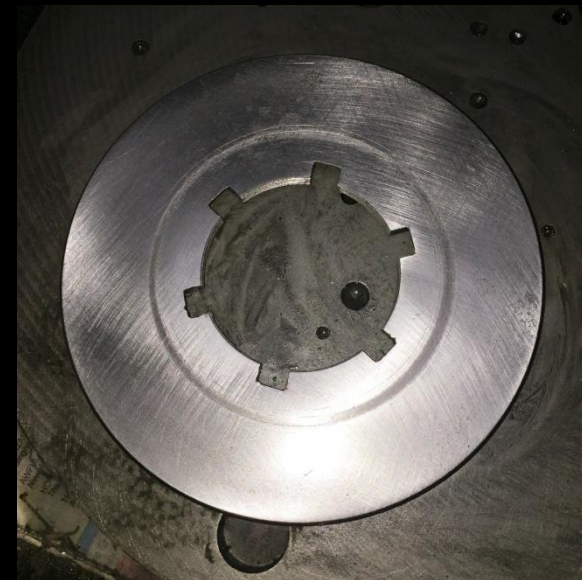
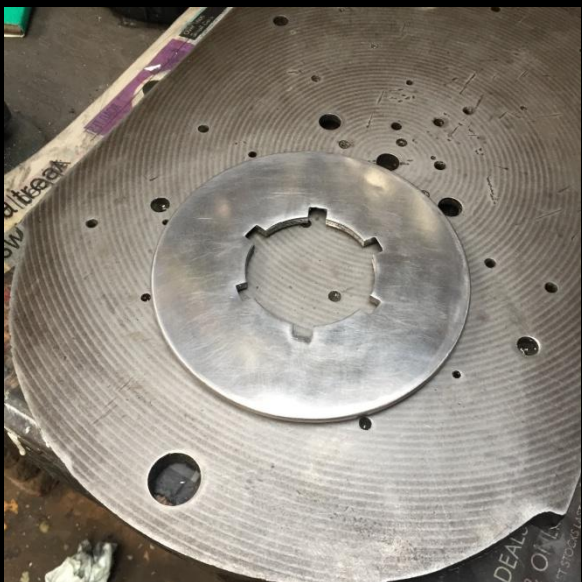
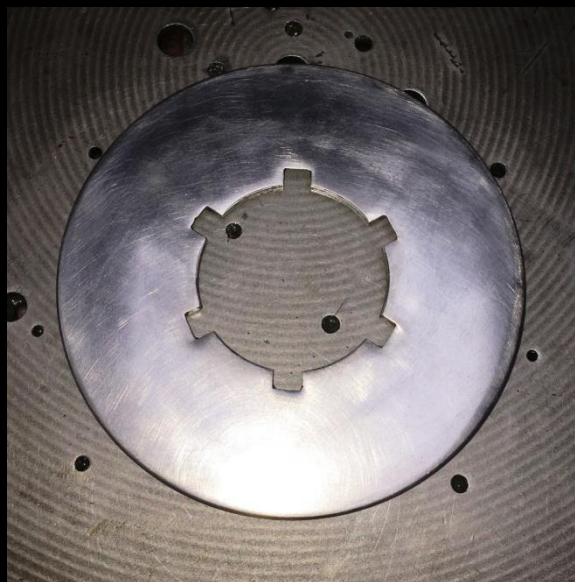
BEFORE PHOTO (below): showing deep-pitting and groove made by the Chaincase Felt Ring (Velo part No.F309) plus the usual corrosion.

DURING PHOTOS (below): showing 'KC2/25' half-done 'Lapping & Grinding' on Flat Steel Plate

AFTER PHOTOS (above): showing the finished 'Flat Surfaced' Clutch Front Plate ready for the New & very much improved Nitrile Seal (VSL part No. F309A).

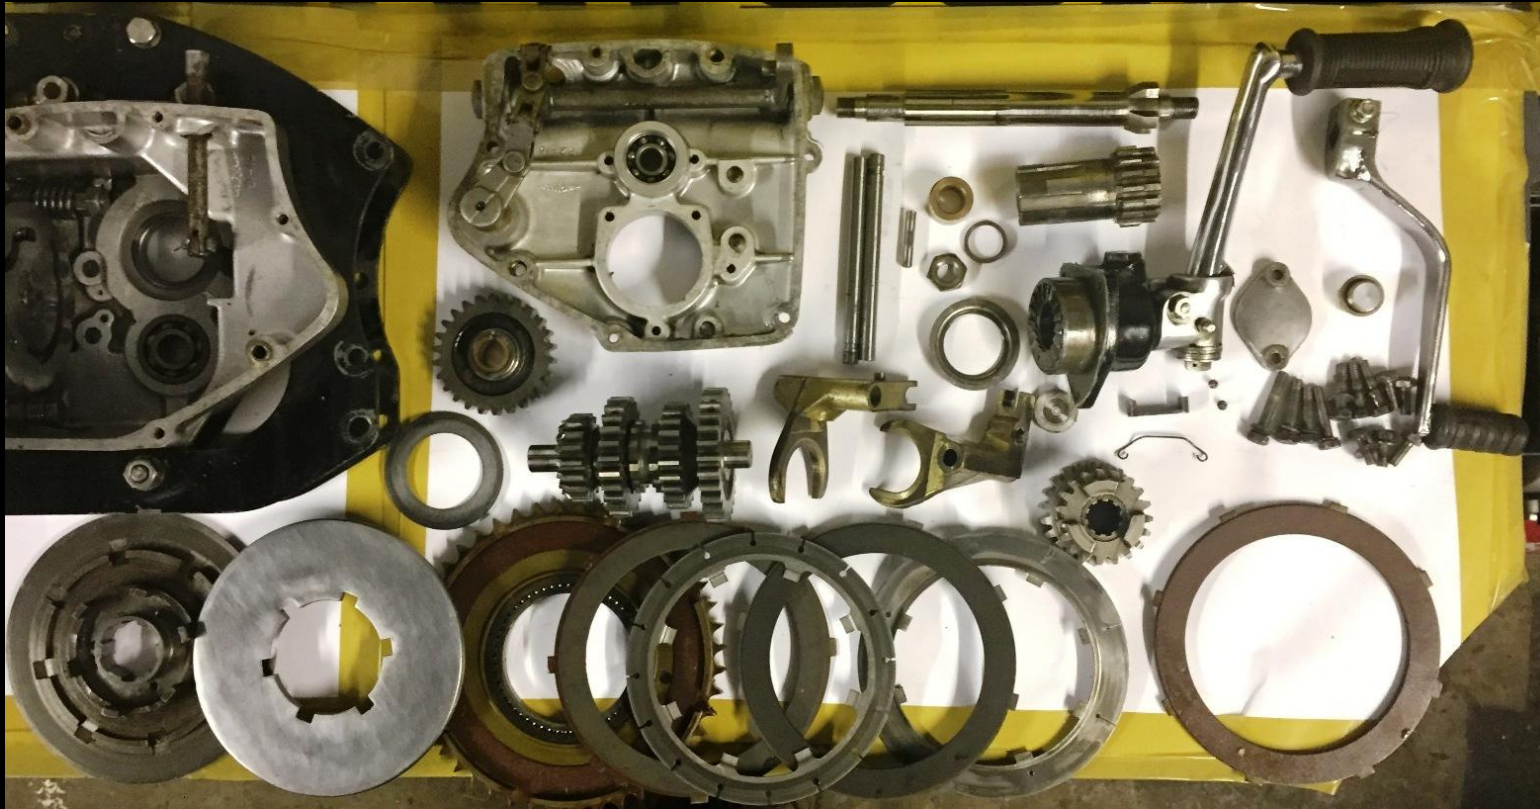
March 2019: Gearbox *dismantled* ready for inspection (with the help, guidance & expert eye of Mr Rick Essex). What did We find? Well, we discovered that '*ALL of the Internals*' ARE in really good condition. I was pleasantly surprised and positively reassured when I looked at the gear-clusters, gear-change selector-forks & change-mechanism (and bearings, etc.) as it appears that quite a lot of these internals had been replaced prior to me purchasing this MAC. To say "*I am pleased with the result*" is somewhat-of-an-understatement (after all of the *trials'n'tribulations* & extensive work already done on the engine and rest of the bike).

I managed to find some *New-Old-Stock* Bearings in one of my *Boxes of Bits* that match the outer cover bearing, making this gearbox quite an inexpensive repair.

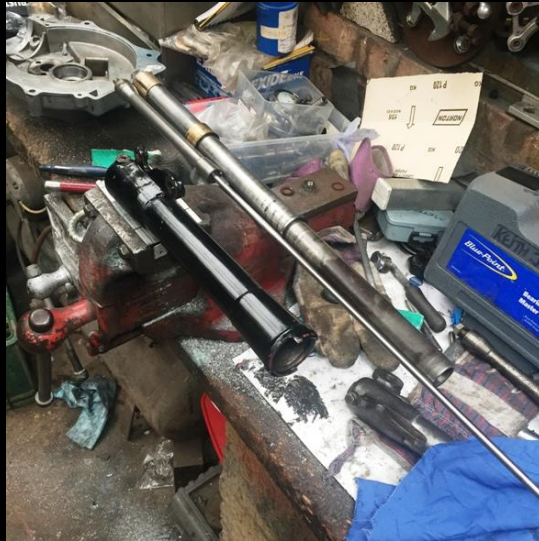
I also found a leak in the 'Bottom off-side Fork Slider' (photo right), where the bottom of the Fork 'Casting' is soldered to the Slider Tube.

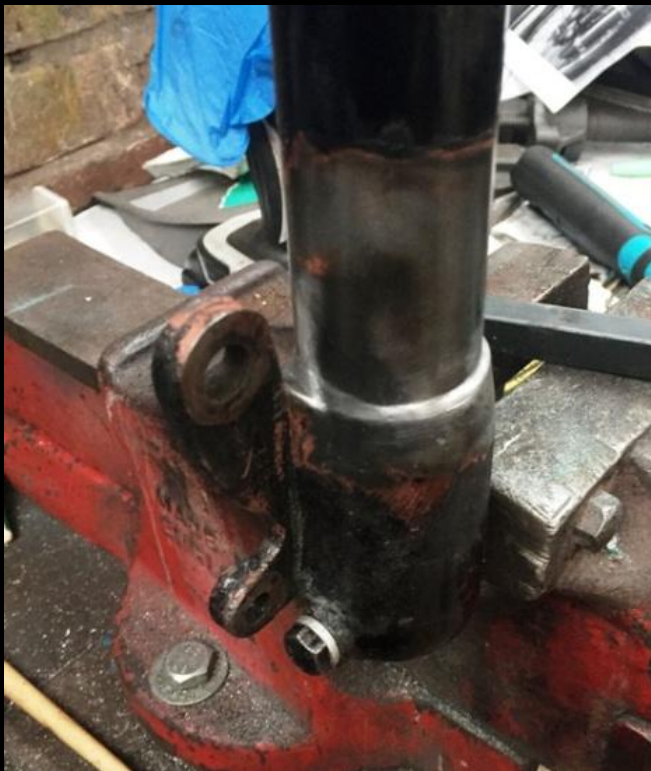
On the 3rd October, I thought that I had fixed the Oil Leak coming from the Soldered Joint on the Front Fork Slider (see photo left). BUT NO ! NOT FIXED !
