Velocette MAC 350cc

Rebuild Project Part Three

From January 2020

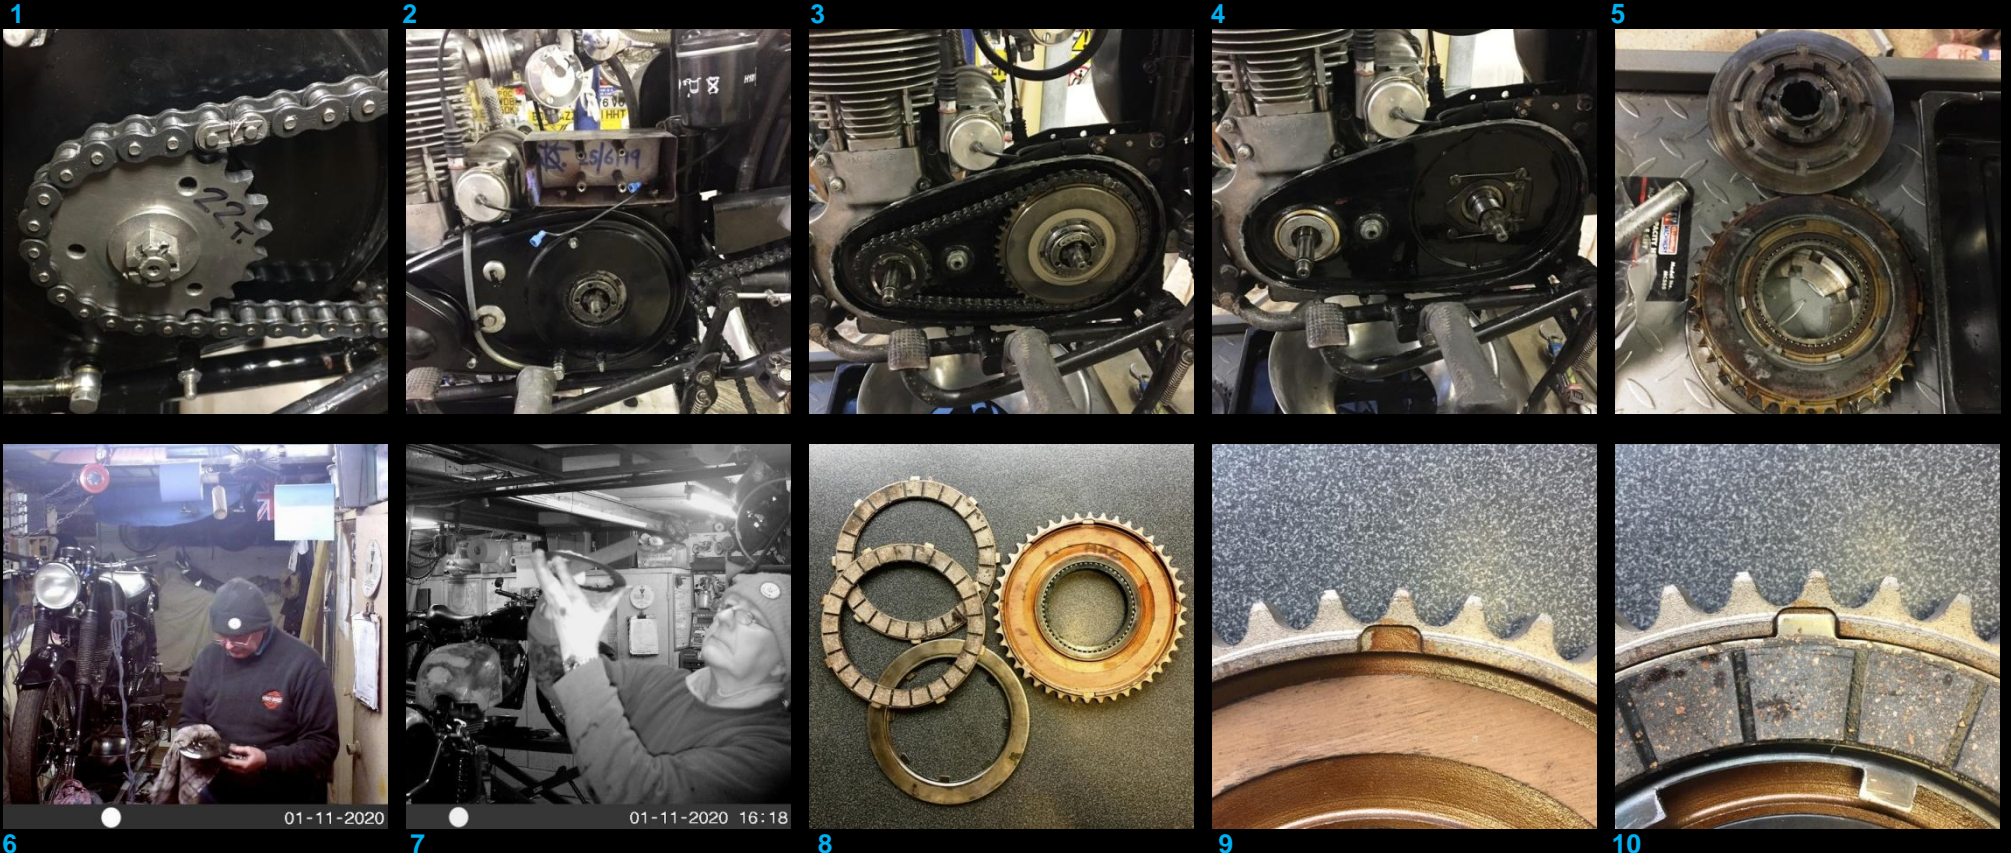
Photos 1 to 5 below show the Clutch being dismantled ready for inspection.

Once dismantled and cleaned-off, it became apparent that one of the plain metal clutch plates had been catching & rubbing on part of the centre *Hub* of the Chain-wheel, and not allowing the friction plate to rest fully 'Home' under Spring pressure. The final prognosis was; the wrong thickness of friction plates & plain steel plates had been fitted or rather a combination of mismatched parts fitted in error. And . . . to '*compound matters even further*', there was far-too-much 'Play' in the Chain-wheel Bearing which obviously added to the overall problems. I am surprised that it worked as well as it did under the circumstances.

Photos 6 & 7 (above) show me checking the outer & inner covers & plates. The other problem that was discovered was the top 'Tangs' (or Castellations) at the top of the Friction Plate showed evidence that it had also been catching somewhere (i.e. evidence of shiny metal on the tops of the tangs). Photos 8, 9 & 10 (above right) show the new Clutch Chain-wheel (including a New Bearing Assembly fitted, and two new Friction Plates. I couldn't get hold of a new plain steel plate, but managed to get a good second-hand 'serviceable' plate to replace the damaged one (I could have ordered a New Steel Plate from VOC but I am so impatient and literally – couldn't wait).

Using this reference chart, it became evident that I had inadvertently assembled the Clutch using 'mismatched' Plates.

I'm hoping that it was this combination of said mismatched clutch plates that was the likely cause of my 'Clutch Slipping' problems (Fingers Crossed . . . I certainly hope so).

16th January 2020: I decided to modify the second-hand plain steel plate that I bought the other day, by drilling the plate to replicate the one that I had just removed (using it as a 'Template' (see photos below). Followed by adding 'slots' into the plate (this mod is well documented in Fishtail & various Velo Tomes) and is intended to reduce the risk of these steel clutch plates from 'buckling or distorting' when they get hot. Well that's what I have read . . .

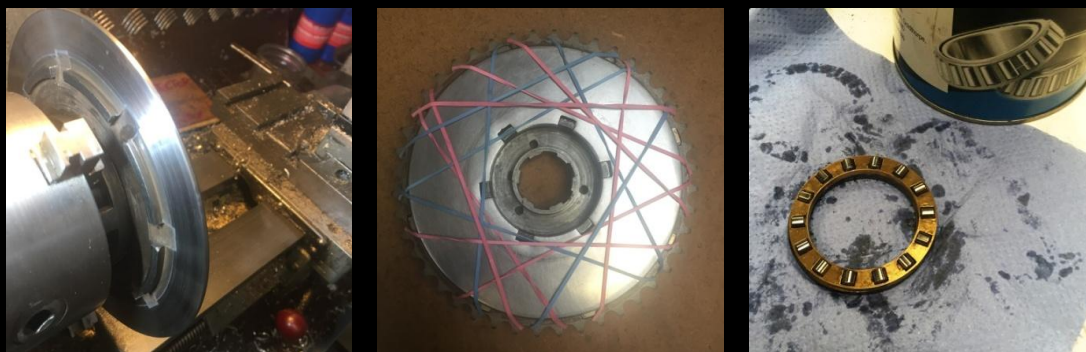
The photo below left shows the Clutch Back Plate (Velo part No. KC1 / 25) in the Jaws of my Lathe, having a quick clean-up on the outer edge of the Back Plate. Once these unwanted marks had been removed from the Back Plate I then cleaned-up the whole of the Clutch and assembled it together (holding all of the Plates together with Elastic Bands) ready for re-fitting it all back onto the Gearbox Sleeve Gear (Velo part No. B6 / 2AS). And then re-assemble the rest of the Clutch mechanism and other Primary Chaincase parts together again. Third photo below shows the 'pre-greased' new improved VOC Clutch Thrust Roller Bearing.

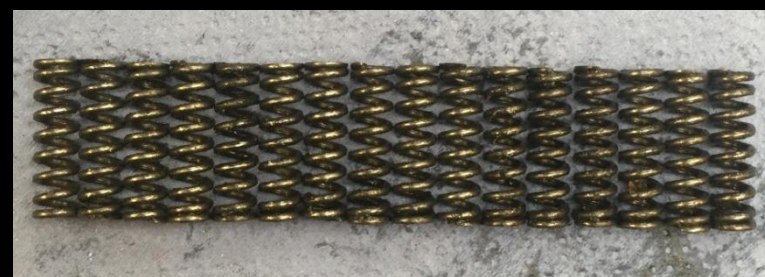
Photo below shows the 16 Clutch Springs (checked for length & straightness) and ready for reassembly.

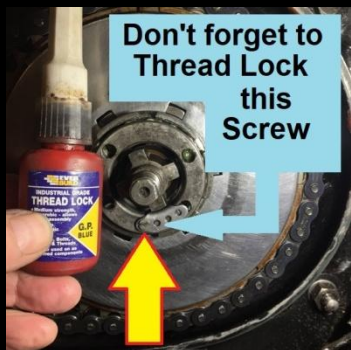
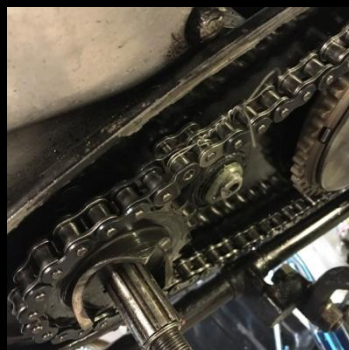
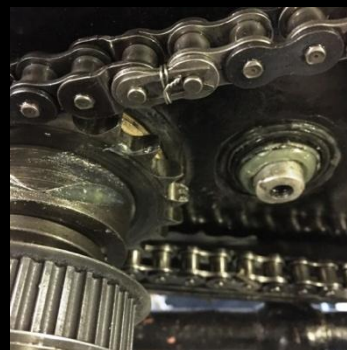
2nd Photo (left) is my method of bringing the primary chain 'together', in order to engage the chain 'Split Link' (the use of Lock Wire). And obviously (3rd photo left) I also 'Lock-Wire' the split link together.

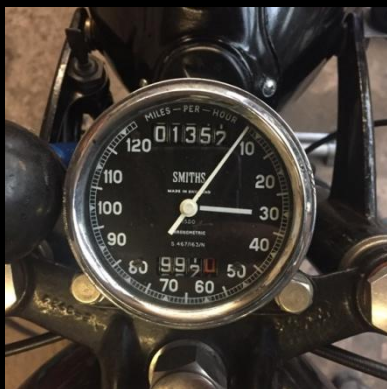
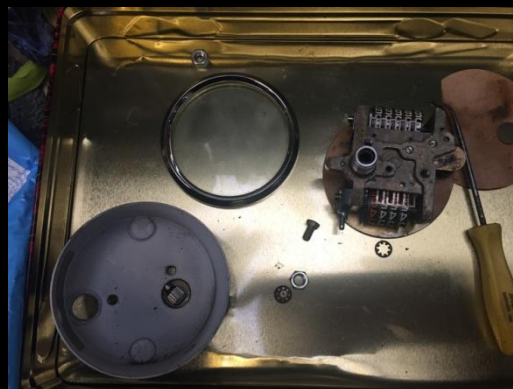
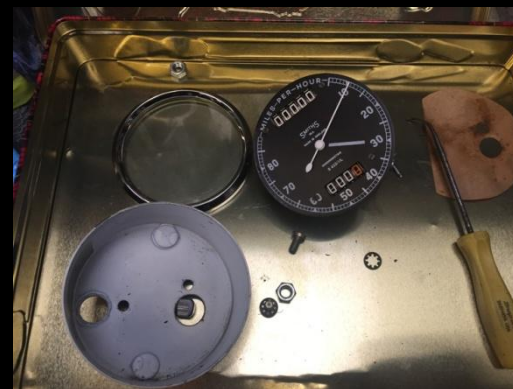
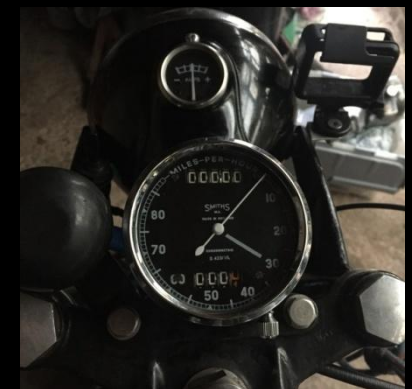
The next job that I tackled was the MAC Speedo. It stopped working last year, so I removed it and fitted my Venom Speedo as an interim measure (see the 1st photo below left); The Venom Speedo is capable of registering +120 mph (*very optimistic I know*) but at least it worked out okay. Whereas the MAC Speedo only goes up to 85 mph (*which I think is still mighty optimistic*). The GOOD NEWS is = The Speedo now works, or rather shows what speed the MAC is doing. The BAD NEWS is = the Odometer doesn’t actually work anymore. So, it is still in need of attention (*tested 2nd February 2020 . . . Bummer!*)

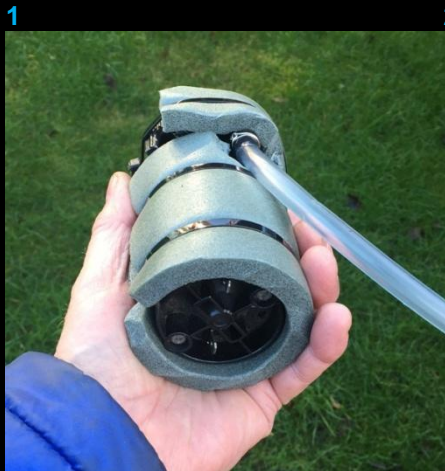
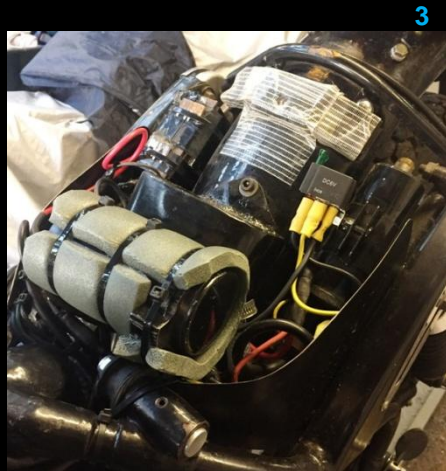
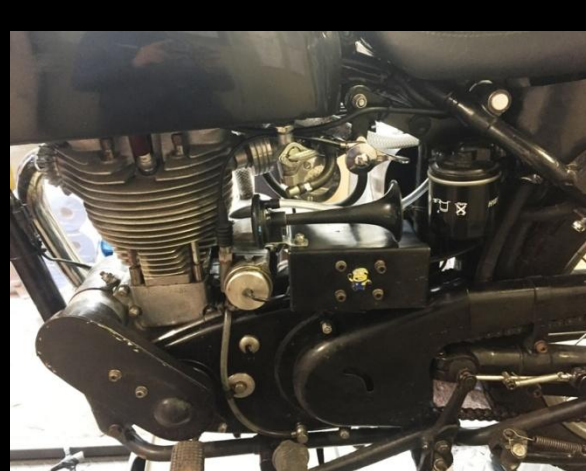
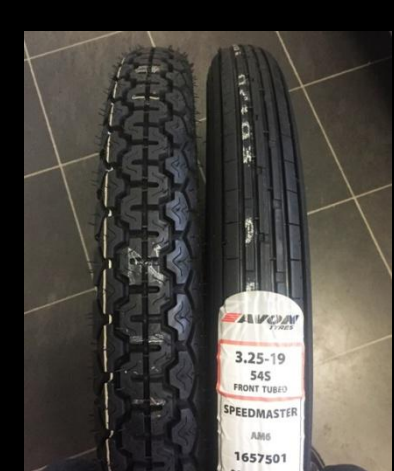
Photos 1 & 2 show the Air Horn (driven by a compressor, via a 'Fused; Relay'). Photo 3 shows the Air Horn Trumpet, & photo 4 shows my new pair of Tyres.
