HONDA CBF 1000

RESCUE and RENOVATION

Acquired 17th June 2023

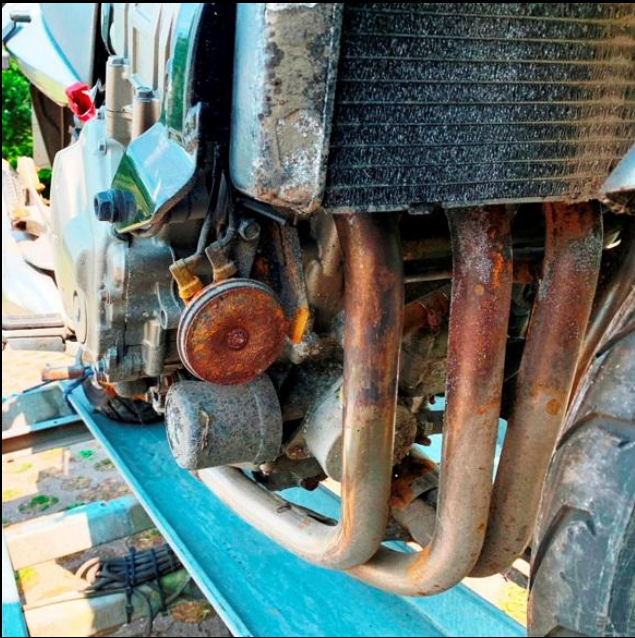
As can be seen from the photos on this page, there is quite a lot of rust on all metallic surfaces, plus a few parts seized &/or of questionable repair (plus a flat tyre).

From the condition of the radiator & hoses it is apparent there has been coolant leakage where hoses, radiator & water pump are joined. So I'm expecting to have to replace a fair few parts as work progresses. I also need to check if the radiator fan is still working too.

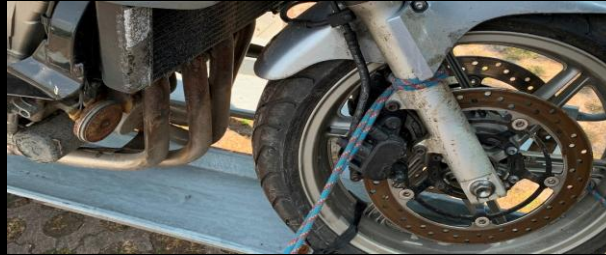
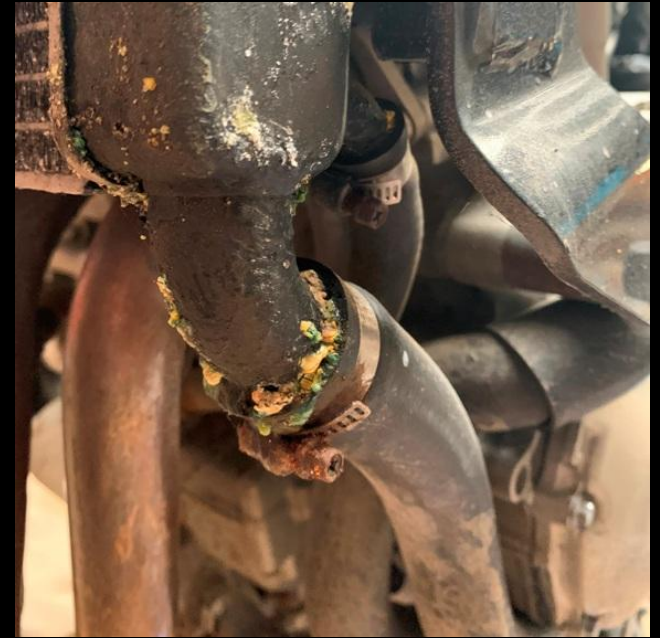
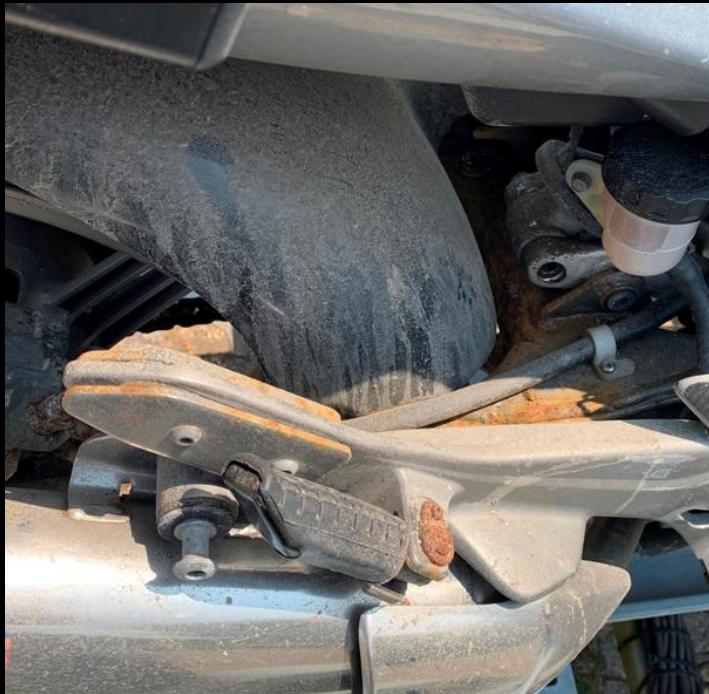
Rusty footrests & rear Swing arm (photo above).

(Photo Left): The swinging-arm is also very rusty and as CBF 1000 swing-arms are renowned for rusting 'from within' (as well as from the outside) it will need a thorough inspection to properly evaluate the condition and ascertain the extent and type of work needed to bring-it back up to MOT standards.

The rust on the swinging-arm and other corroded parts fortunately was not as serious as it first looked – being mainly surface rust I managed to remove it by ‘scrubbing-down’ with a wire brush, followed by a good ‘rubbing-down’ with various grades of carborundum paper and a thorough degrease with acetone before applying phosphoric acid, zinc primer and then a top coat of silver paint (that matches the original colour – or as near as “Damb-it” is to swearing!). The end result is tidy and a looks much better than it did before. Same process for the chain adjusters too.

- Removed all of the corrosion on the rear swing arm. Sanded-down & treated with anti-rust & Zinc primer before painting swing arm with silver top-coat.

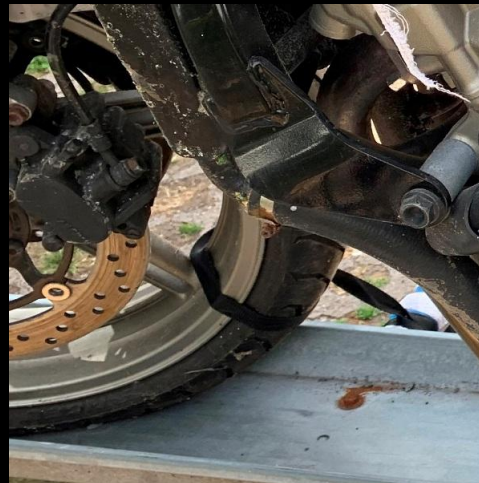
Rusty front brake callipers.

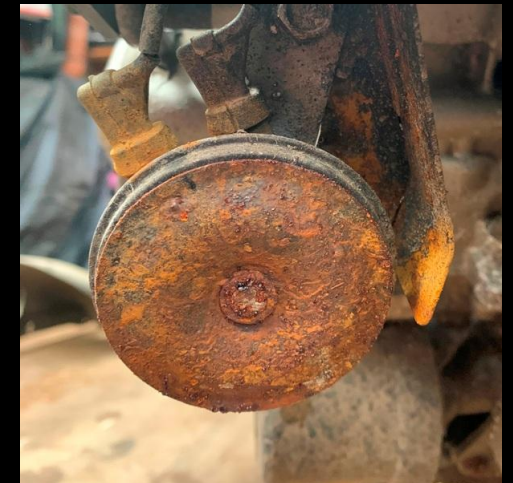
And . . . a very rusty old horn too.

Two of the easier 'Fixes' are; (1) replace the Horn; which looks well past its '*best by*' date and no amount of paint is going to do justice to that sort of corrosion.

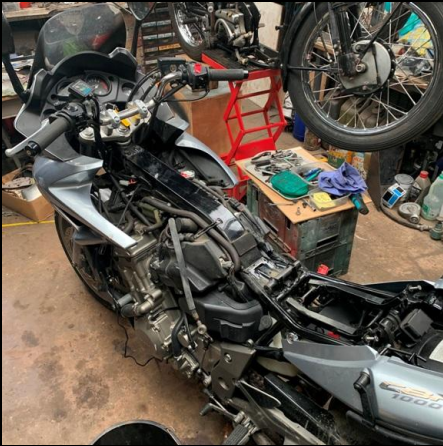
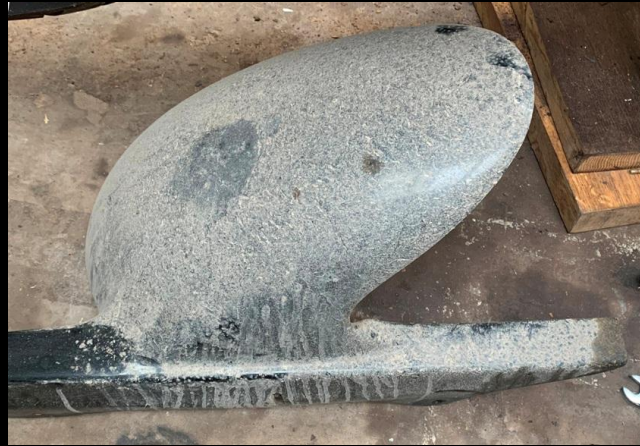
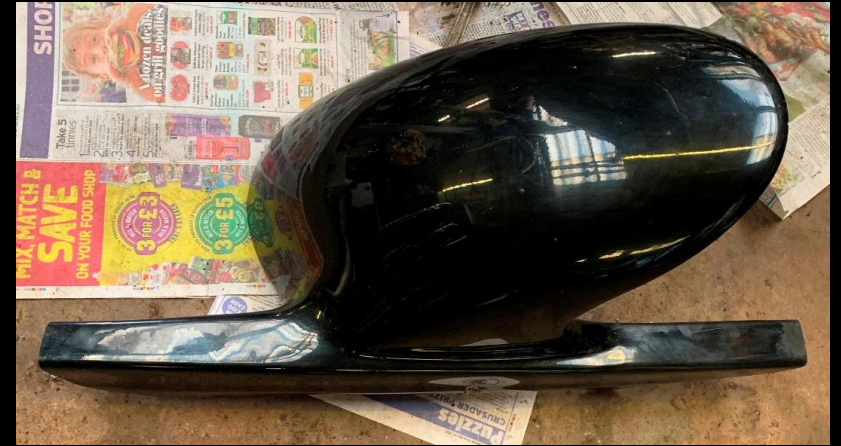
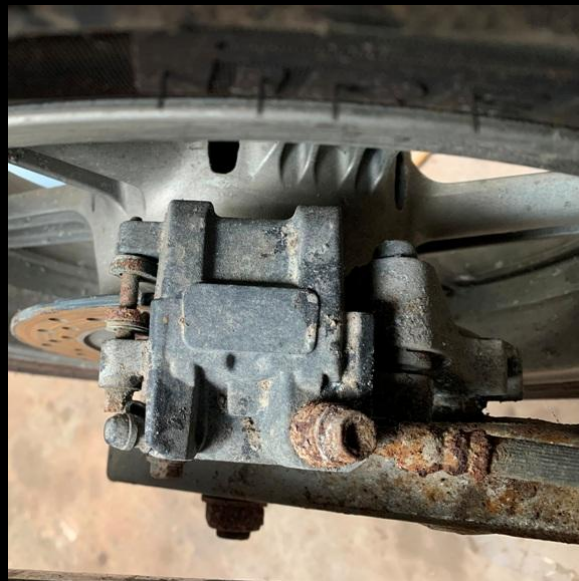
So, instead of using it for spares I think it may be viable to try and revive it '*for the road*' (where it belongs). But only further investigation will determine whether it will be worth it, or not!. Also, because this Honda has been '*laid-up*' for such a long time, I need to give it a more detailed examination as I dismantle various sections of the bike. I think it deserves a '*long-over-due*' Service, i.e ALL fluids replacing, including the brake & clutch fluids, engine oil & filter, plus air filter (and the list goes on). The rear chain & sprocket is totally knackered and in need of replacement) too.

As the CBF 1000 is such a powerful & nifty touring bike, at this stage I think it both prudent and a matter of best practice to replace the front & rear brake pads too.

And; (2) The 'flat' rear tyre which will not hold '*air*' so not sure if it's a leaky valve, a puncture or even if it needs a new tyre ? Both of which rare easily fixed.

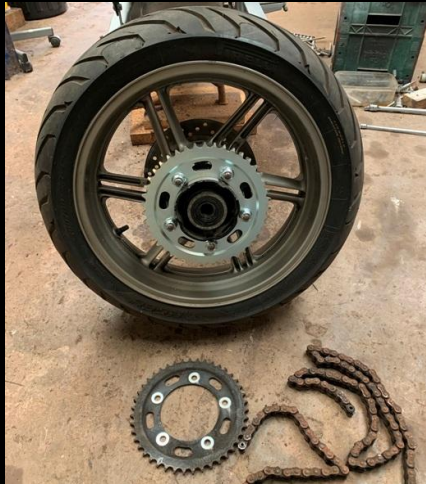
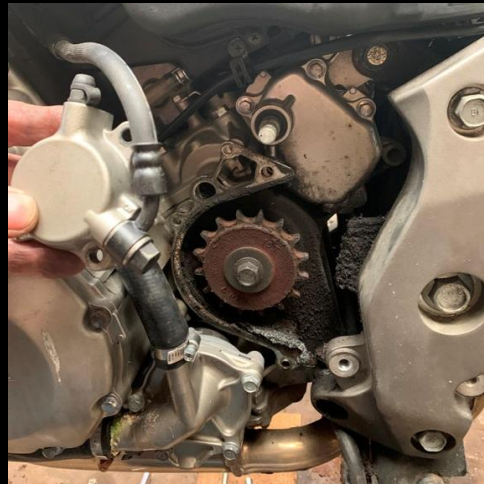
The wheel has *cleaned up* really well (photo left) and looks pretty good now, especially with the new rear sprocket and new chain fitted.

I also cleaned-up the brake disk (on the other side of the wheel) and that also looks good to go now.

The chain needs adjusting and when the rest of the components are re-fitted & adjusted, this will be the ‘Back-End’ done & dusted.

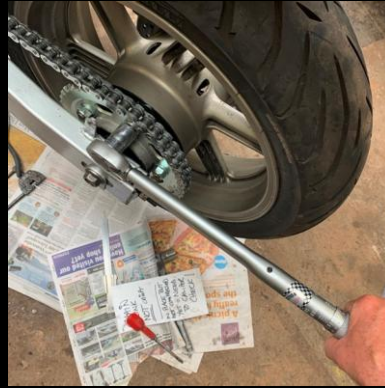
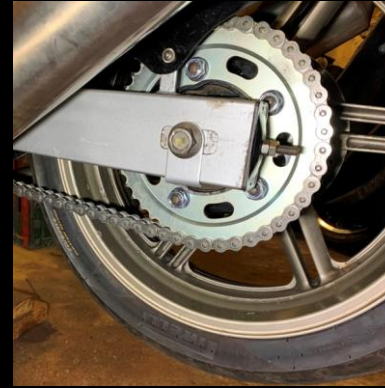
Regarding paintwork and bodywork generally, all looks good apart from a coating of some sort of sticky, dirty mess probably tree-resin (or is it tree-rosin? – whatever!!!), but once all of the bodywork / painted areas have been cleaned-off with acetone & degreaser it will be ready for a good polishing. I'm sure this bike is 'gonna-gleam & come-up-lovely'. An example of the sticky-stuff mentioned; see photo below right (Honda light).

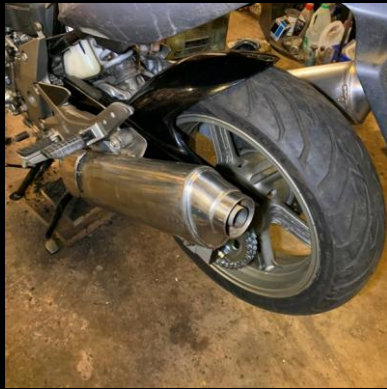
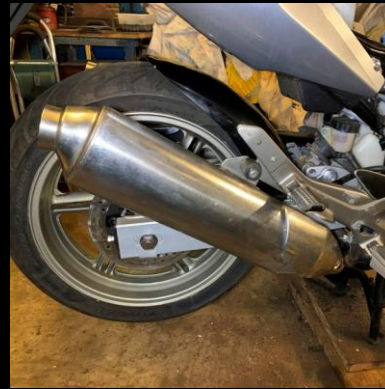
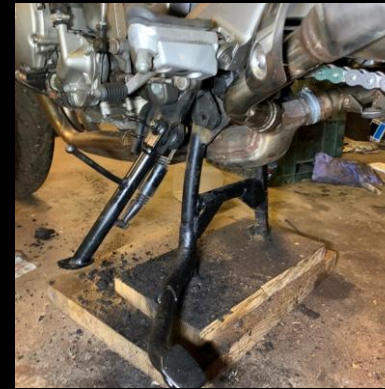
I rubbed-down, treated & painted the side-stand & central-stand and refitted the cleaned exhausts. The wheel, chain & hugger all look good now.

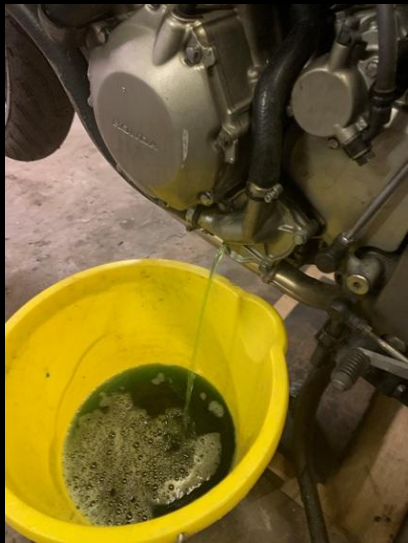
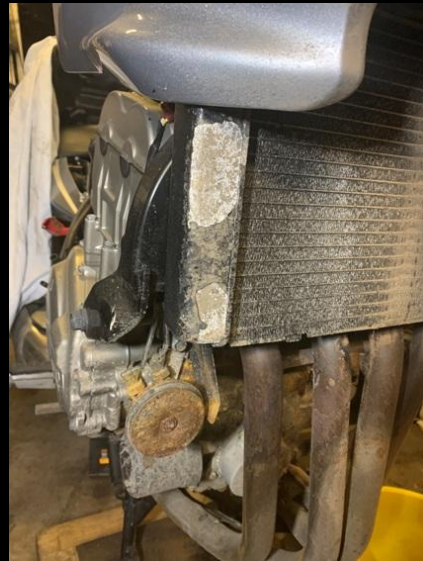
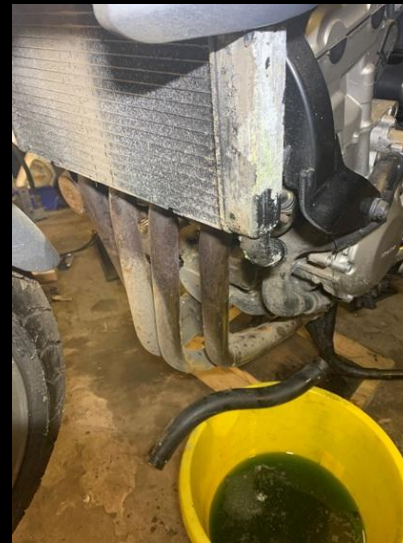
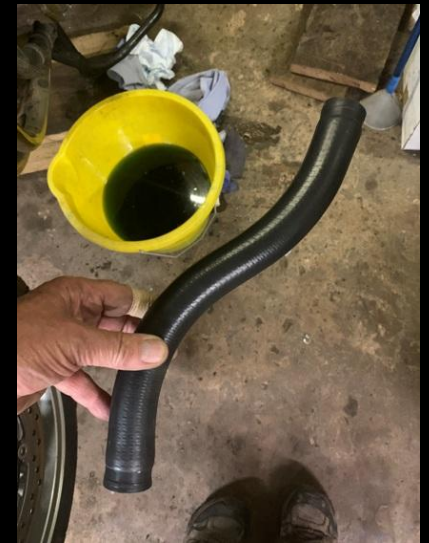
I re-started work on the CBF 5th July 2023, by draining the cooling system by removing the drain plug and proceeded to flush-out the radiator and hoses, etc with clean running water. Quite a bit of cruddy, discoloured coolant came out and when it was running 'Clear' again I refitted the drain-plug (with a new copper washer). I then proceeded to remove the hoses & re-flushed again. As can be seen (photos below) Radiator is very rusty.

The next step was to rub-down the corroded areas on the radiator and prime it with etch primer, followed by gloss black paint. The photographs on the next page show the 'Before', 'During' & 'After' stages.

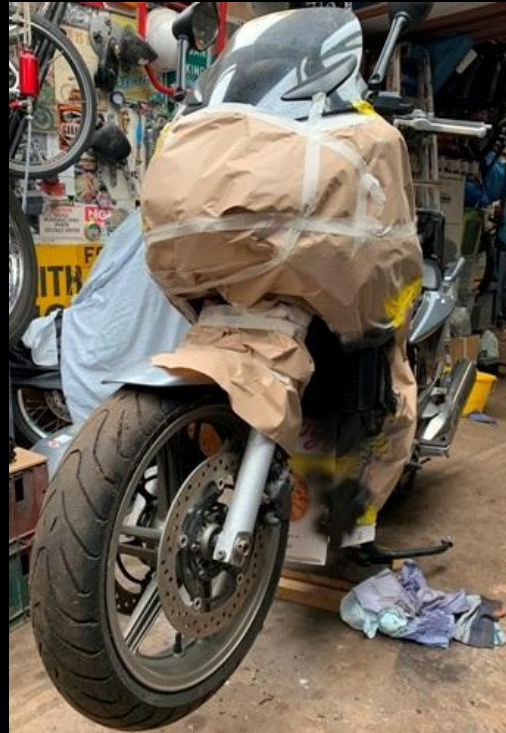
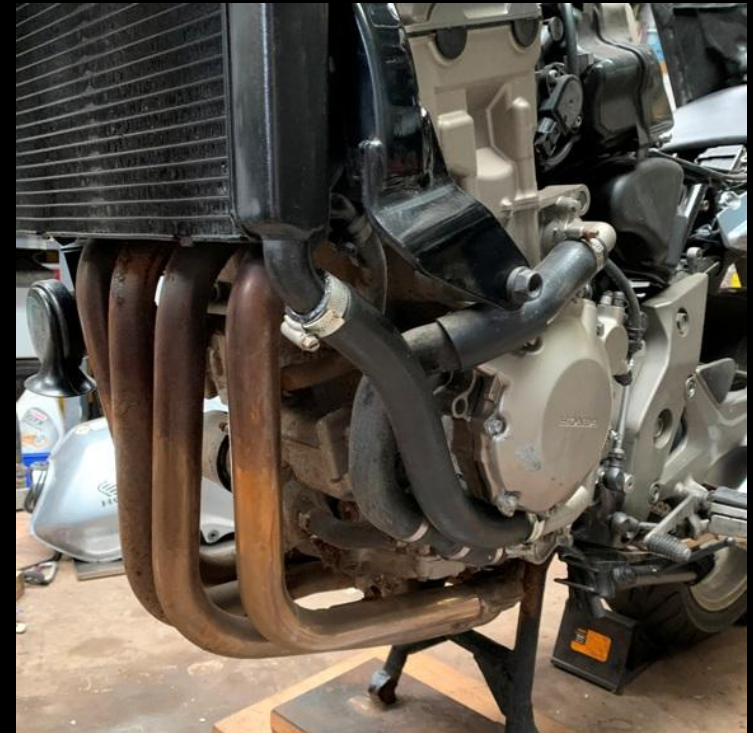
- New air filter fitted. New oil filter fitted. Engine oil drained & replaced.
- Drained engine coolant via water pump drain plug and flushed-out system.
- Removed lower radiator hose (to the water pump) and removed the corrosion from the radiator body before priming and painting (in black).
- Replaced water pump drain plug with new copper washer, then flushed-out system again, then refitted lower radiator hose with new hose clips and refilled system with new anti-freeze. Bled system & refilled the overflow bottle to recommended level.
- Painted horn bracket and replaced the old corroded horn with newer air type horn.
- Refitted petrol tank (and added new fuel), fitted new battery (ready for start-up).
- Checked-out lights, horn, indicators, ignition & oil lights and brake lights, etc.

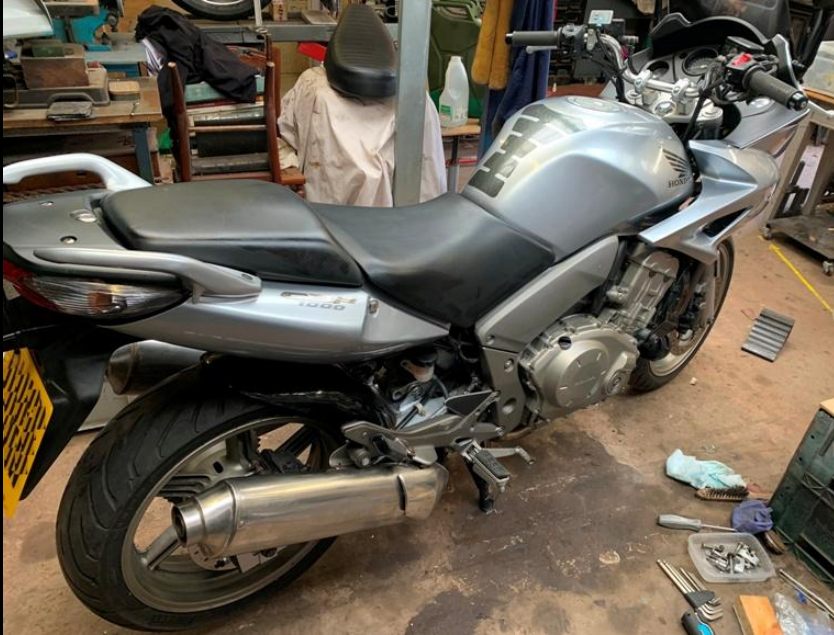
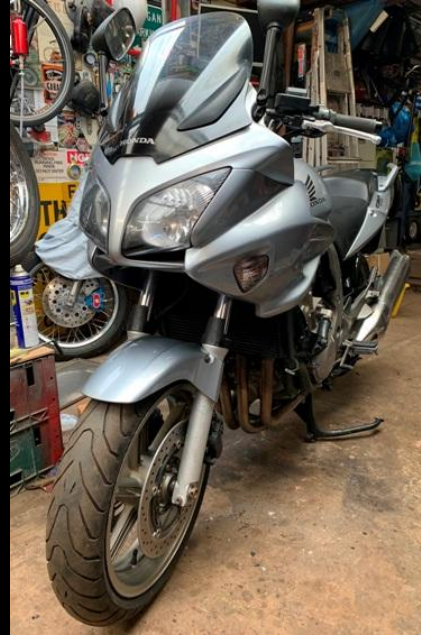
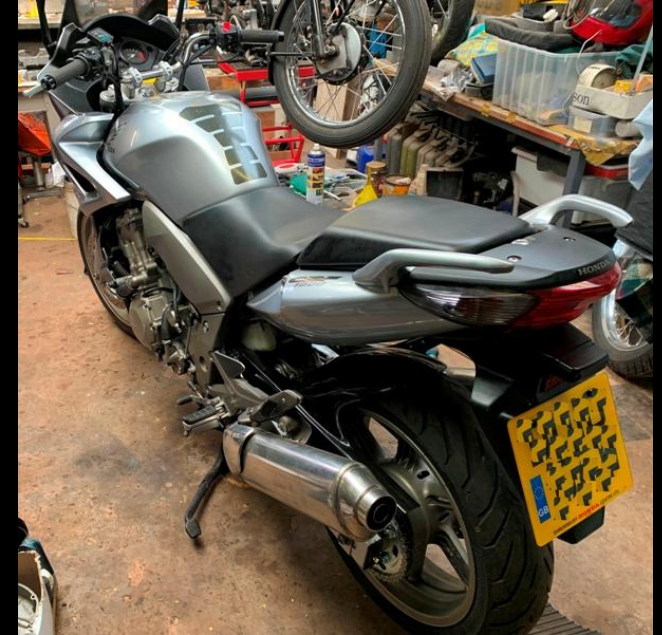
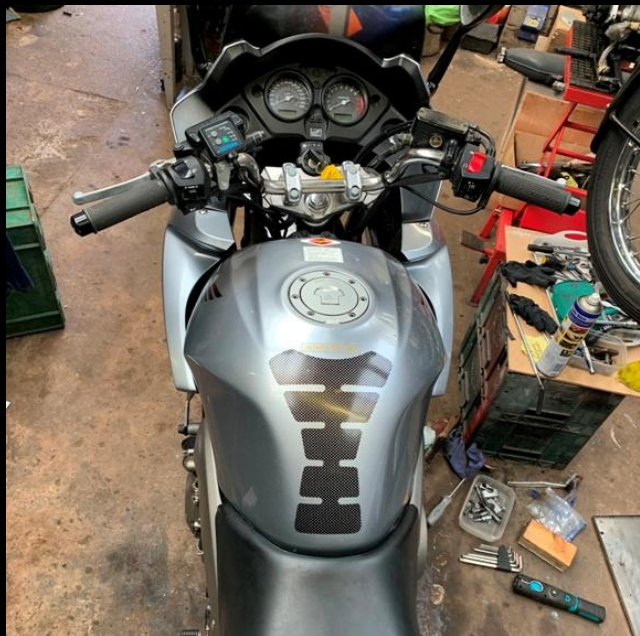
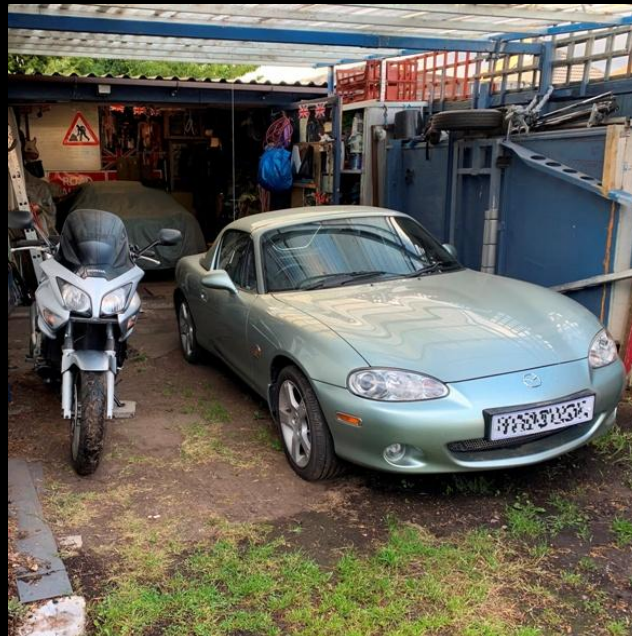
As can be seen from these photos here-on, the Honda CBF 1000 is now finished and all of the necessary work completed ready for MOT testing.

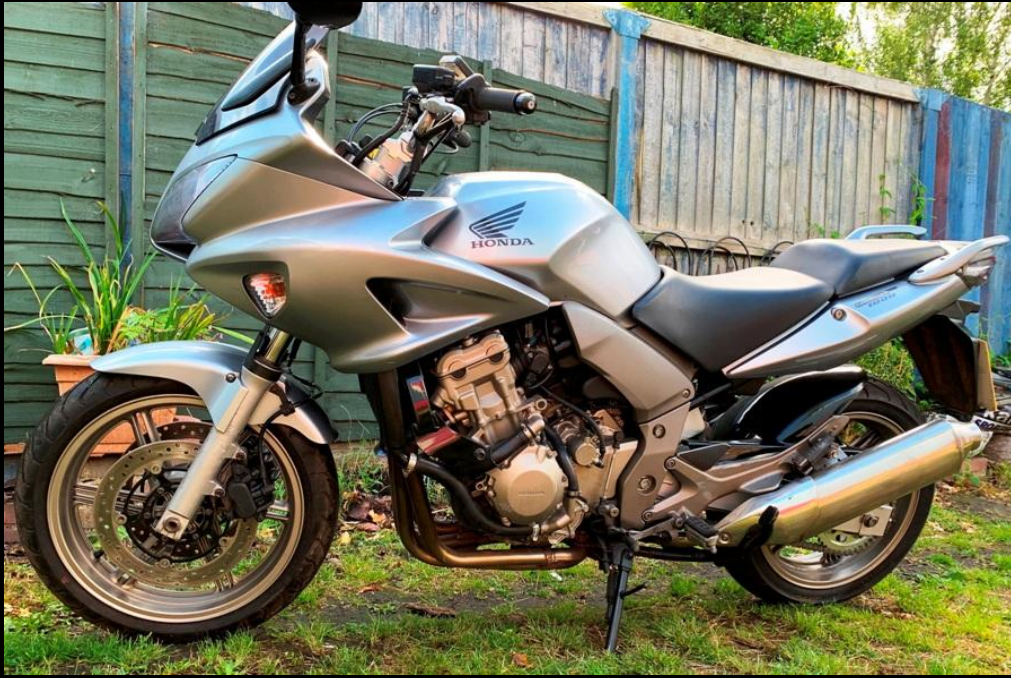
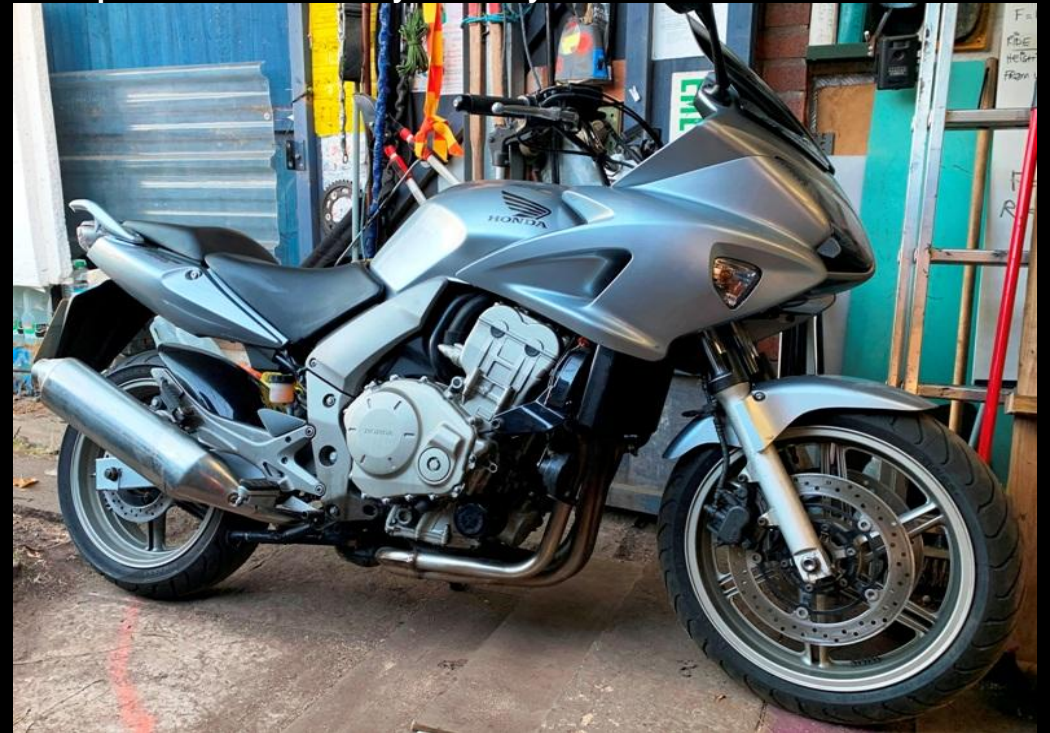
The final two photographs on the next page represent the 'Finished Article'.

The beauty of Mr Honda's CBF 1000 was captured from both sides (below).
