2002 MX5 Mk.2.5 ARIZONA SE

MOT Welding Repairs

& Suspension Upgrade

This blog highlights the MOT work carried out on my Mazda MX5 Arizona Mark 2.5 special edition. Welding & suspension upgrade 2022.

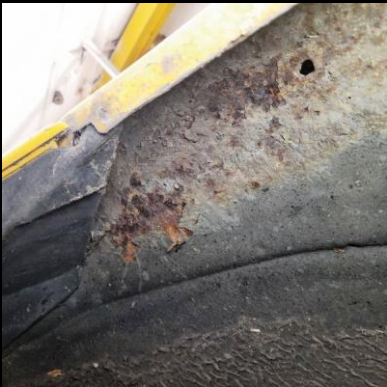
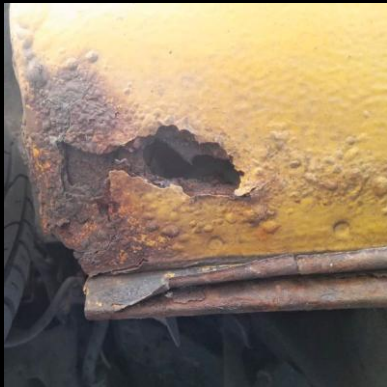
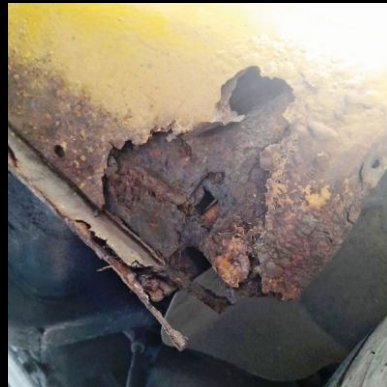
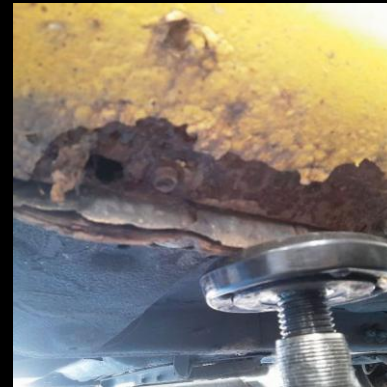
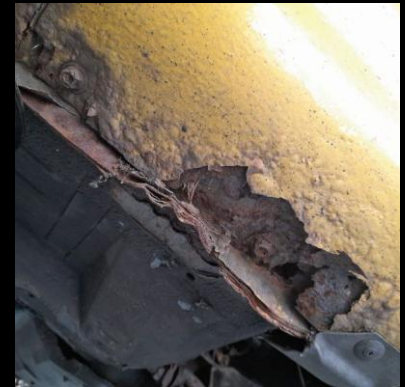
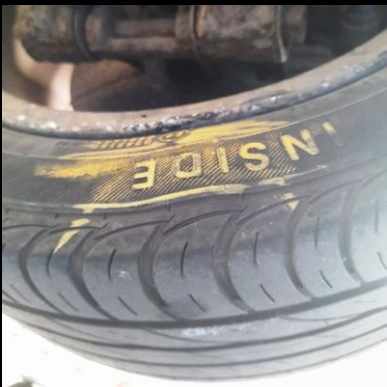
OMG ! These are the original pre-MOT photographs that I received on my phone from the Mazda dealership (below):

More Holes than Swiss Cheese. Rust, rust & even more rust . . . not to mention needing a new Tyre as well.

Now THAT was a SHOCK to this old body system of mine. I certainly didn't expect the under-body section to be THIS BAD ! WOW! I was gutted. From NORMAL view, standing by the car (at street level) none of this ROT was visible or evident. So WHAT A SURPRISE (and not in a good way)!

I find there is nothing more MOTIVATING to do a job yourself than getting a MASSIVE QUOTE FOR REPAIRS, so I decided to carry out the repair work myself. Fortunately for me I still have all of my welding equipment and tools from when I ran my own garage repair business. Plus; bucket-loads of experience & skills, not to mention plenty of TIME (very little money, but loads of time on my hands) to rectify this problem and turn-around this rusty mess back into a road worthy car once more.

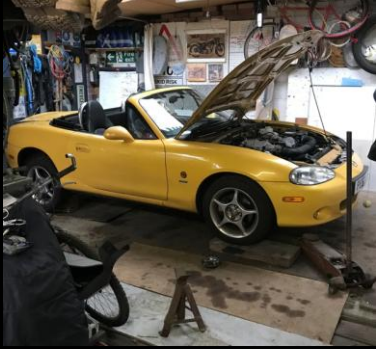
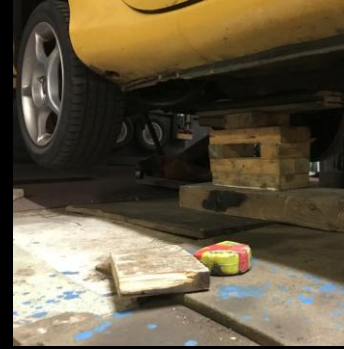
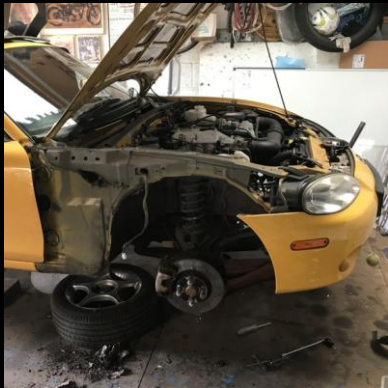
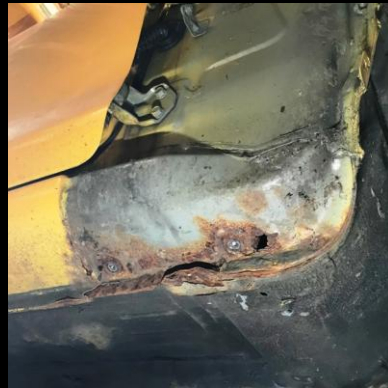
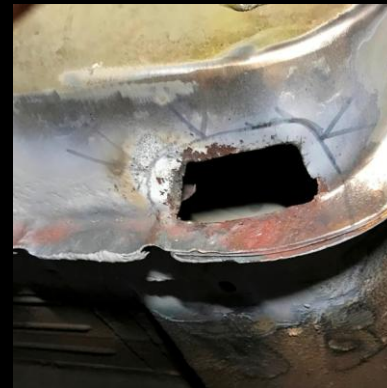
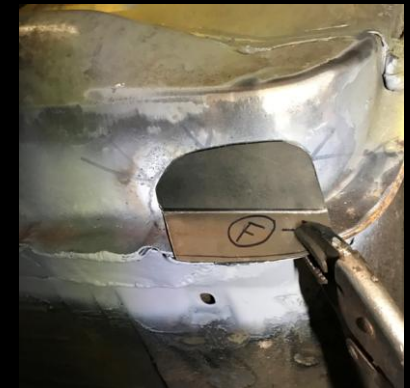
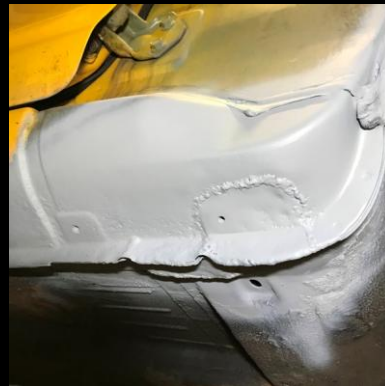
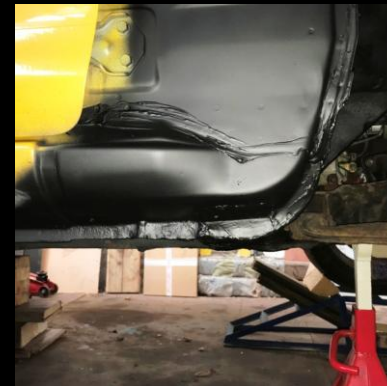
The following pages below show a series of photographs plotting my progress addressing the welding repairs & bodywork needed to get my once beautiful MX5 back up to MOT Standards & looking as good as a 20 year old car can look. After 'jacking the car up' on axle stands (& extra blocks of wood for added safety) I then started work on the front off-side corner by removing the wing for better access to the O/S rusty sill, jacking point and to repair the bottom of the wing.

Once welding was finished all of the welded joints was coated with phosphoric acid solution. After this had dried, all of the *phosphated* areas was cleaned & sprayed with zinc primer & 'Tiger Sealed' (squeezed into all of the welded joints & seams) before covering the whole lot with 'Stone Chip' under-seal spray (for good measure). When ALL of the welding is completed (on all four corners) the intention is to Lanoguard® or Wax-Oil all inner sills & box sections, etc.

The next stage was to 'open-up' the 'Sill drainage holes' that had been crunched-closed over many years of improper 'jacking-up' use & misuse (NOT by me I might add). This is one of the reasons why the sills are in such bad condition. The drainage holes being *closed* meant that any ingress of water &/or road detritus could not 'drain out' as intended by Mazda. I 'enlarged' these drainage holes using a tapered Drift-Punch, making each hole bigger than originally designed, thereby alleviating future problems (providing I instigate & maintain a regular cleaning-out programme for these newly enlarged drainage holes).

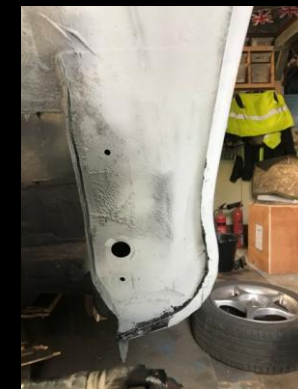
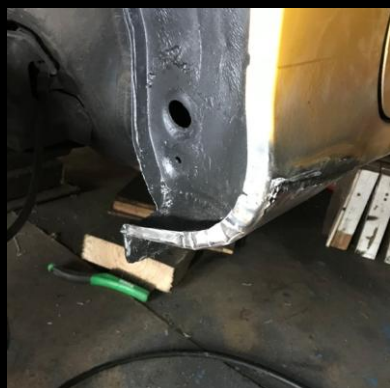
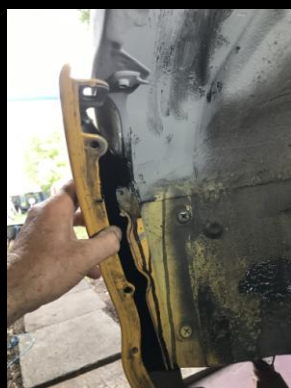
First photo left shows the corrosion inside the boot around the two drain-hole rubber bungs.

These 'bungs' can be removed to drain-off any excess water that may find its way into the boot. If water is allowed to collect there the result is often corrosion around these holes.

The photos below (next page) show the final *fabricated* o/s outer sill (cut-out of 20 gauge mild steel sheet), shaped to fit the original curved bodywork. The '*dotted-line*' area is then cut & folded to make a right angle edged-seam to join the new bit to the wheel arch quarter-panel. Then ALL seams heavily Tiger Sealed.

Once fully welded; all seams Tiger Sealed

The next photos (right) show the rusty metal being cut-out & the end photo shows two new drain-plug plates inserted ready for welding. Once sealed with Tiger Seal, two new bungs will be fitted.

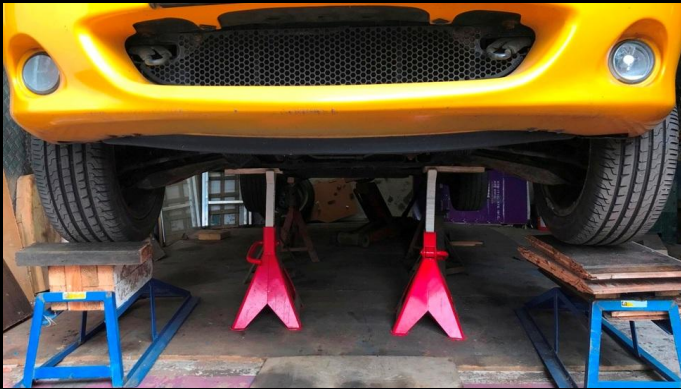
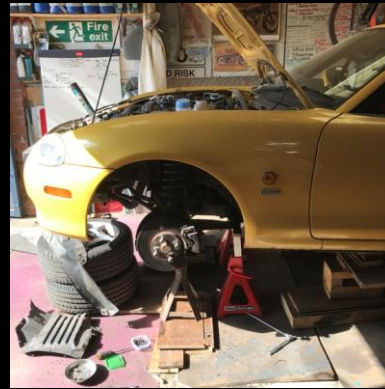
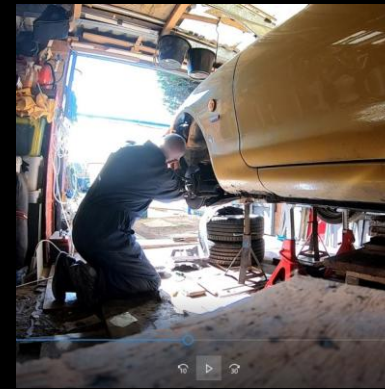
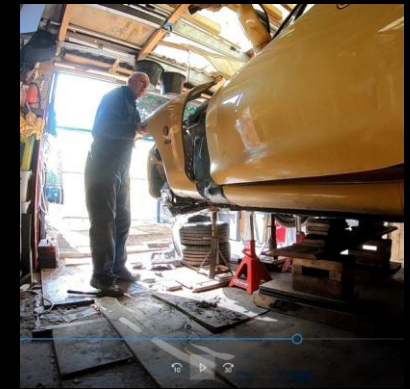
Now for the nearside repairs. As you can see from the photos below my 'Arizona 2.5 special edition' is ready for a 'duplication' of the off-side-repairs. More pix.

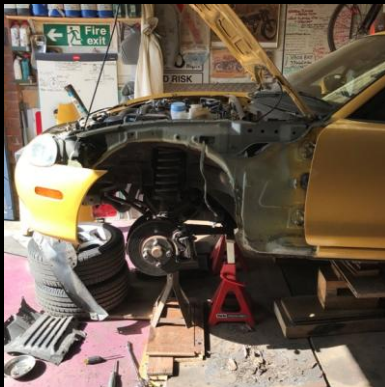
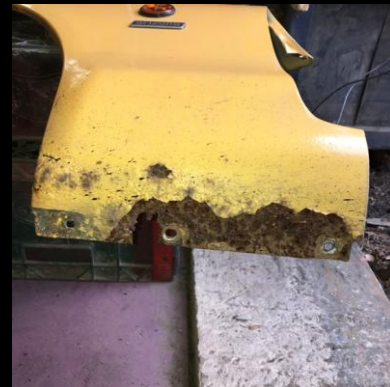
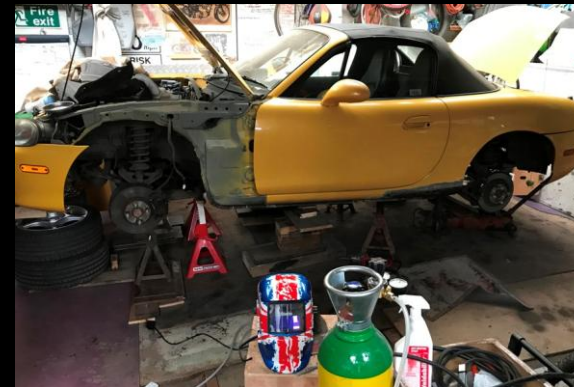
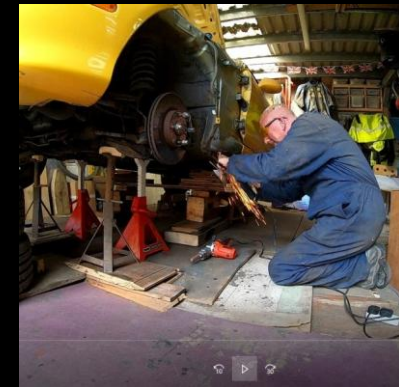
The near side front wing being removed (you can see it's just as bad as the other side). Followed by working on the inner & outer sills & jacking points.

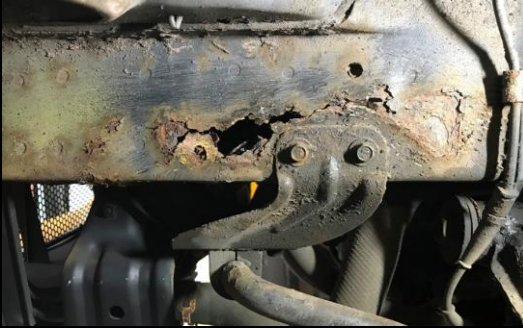
Just as I was thinking "I've nearly completed all of the welding on all four corners" (apart from welding the bottom of the near-side front wing) I discovered the front chassis rail was also badly corroded. This didn't appear to be in need of immediate attention until I probed more deeply but because the corrosion is within 30 centimeters of main structural parts (i.e. suspension roll bar mounting, wishbone and shock absorber mountings) it is obvious that this should constitute an MOT 'Fail', so it was a no-brainer to tackle this chassis rail now whilst the car is still 'in the air' on axle stands, so I decided to tackle & weld this section too.

This section is quite an important structural part of the car supporting the front suspension & steering. The bad news is: to get at it properly I have to remove the Radiator, Power Steering pipework, various other fittings, wiring & hoses in the engine bay just to get access to the inner chassis member. I made a new chassis rail out of 14 guage steel plate (captive nuts welded in place to support the anti-roll bar bracket and other fittings) exactly where Mazda designed & intended.

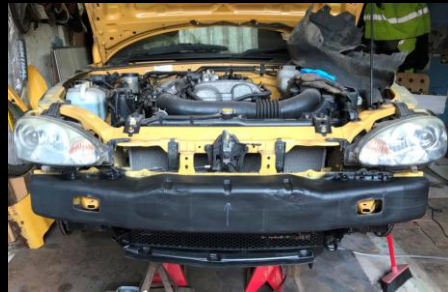
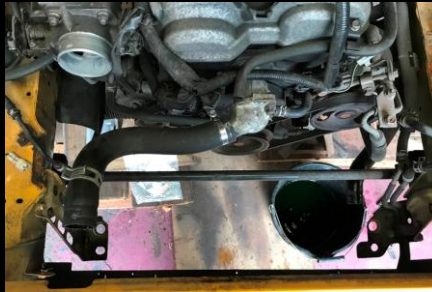
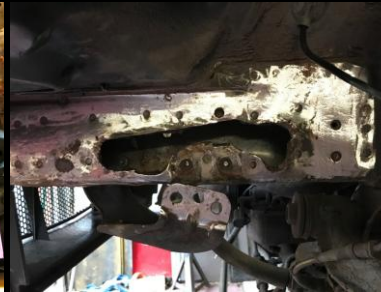
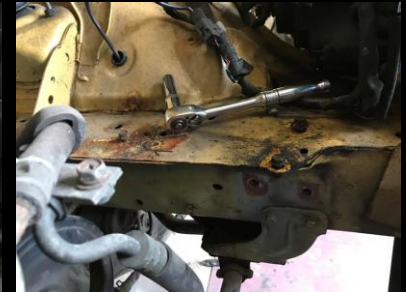
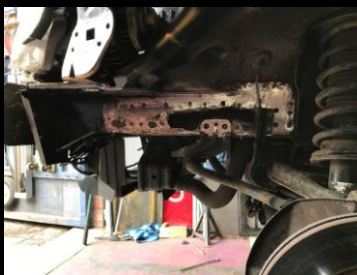
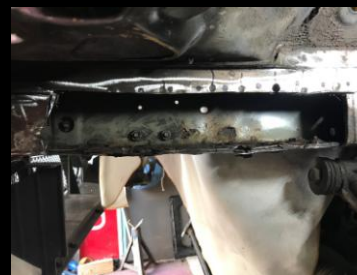
Now the inner & outer rear sills & jacking-points are welded up fully, the next step was to start on the front near-side chassis rail. The front bumper was removed to gain access to the rotten chassis rail. The first challenge encountered was the plastic fittings that broke-off 'one by one' as I tried to release the bumper. This thing is fighting back all of the way! I made new metal captive nuts to replace the broken plastic fittings and as mentioned above, I had to drain-off the coolant and remove the radiator, plus unbolt the power steering unit and induction air-filter housing, pipe work & wiring. To remove the anti roll bar bracket I had to unbolt the two bolts on each side of the bracket (which sheered off) and drill-out two spot-welds that further secure the anti-roll-bar bracket to the chassis rail.

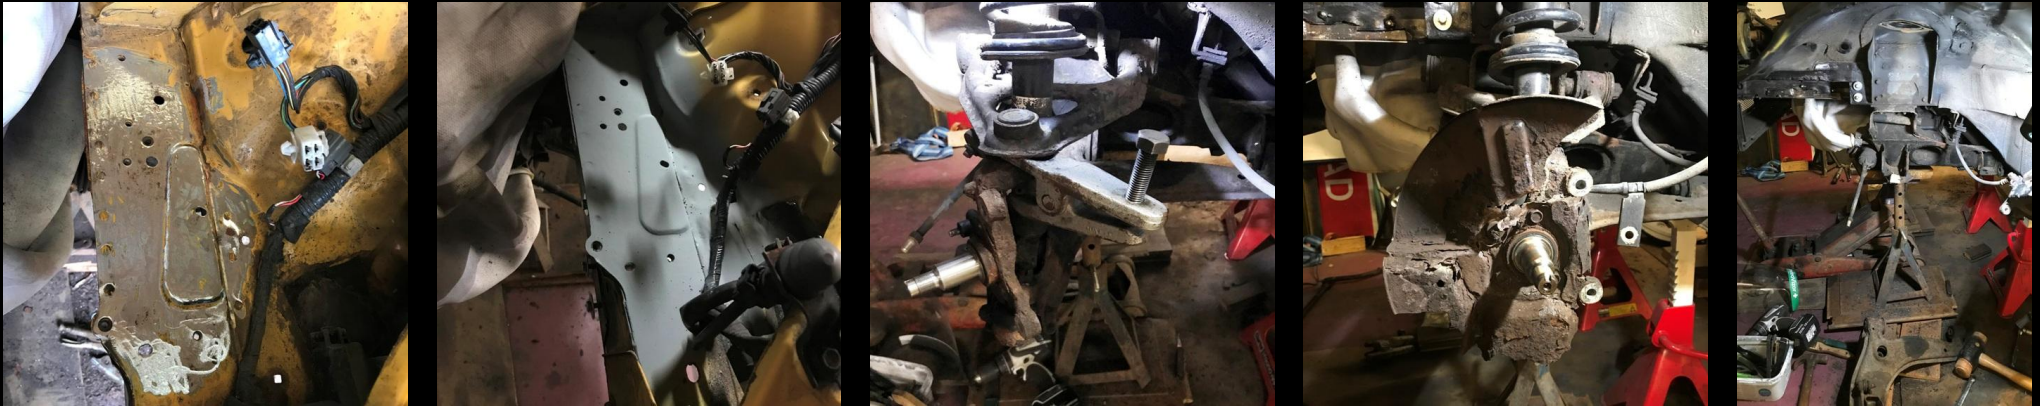
I then had to remove the front near side suspension & steering assemblies completely to gain better access to be able to weld the front chassis rail on properly. Removing all of this was necessary anyway, to replace all of the worn out suspension parts and replace them with the MX5Parts Ltd items that was 'in-waiting'. It was necessary for these parts to be removed in order to weld the new chassis rail onto the main baulkhead (where the chassis rail meets the highly reinforced Mounting Brackets and inner wing supports (that the top of the shockabsorber is bolted to) and mounted to (and forms) the inner wing-flitch-plate.

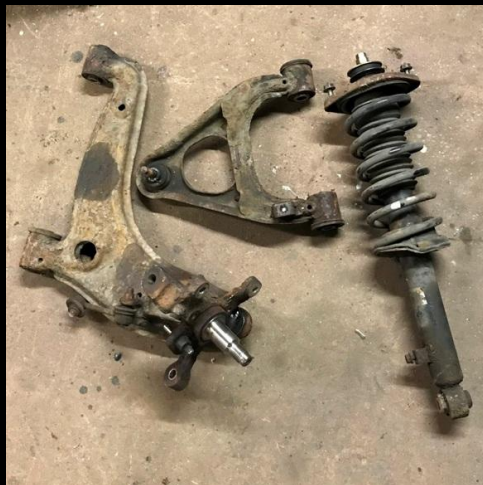
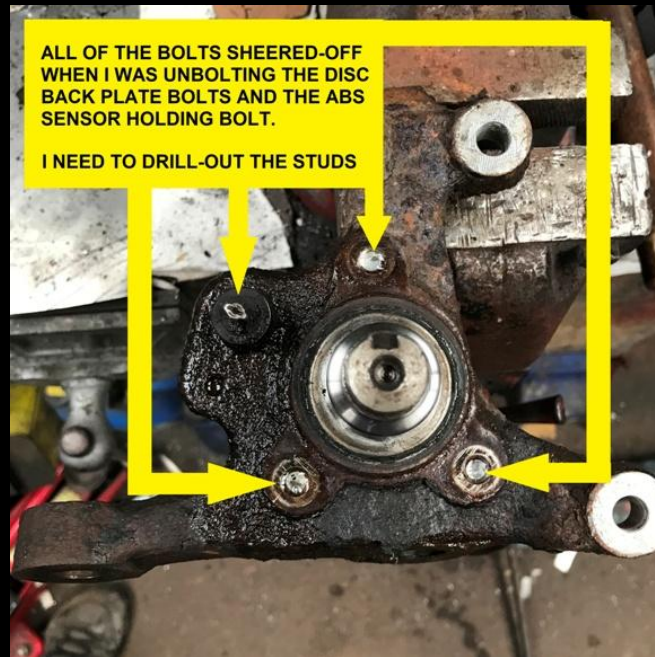
Photo below:
The front near-side top & bottom wishbones and suspension leg removed ready for reconditioning and upgrade.

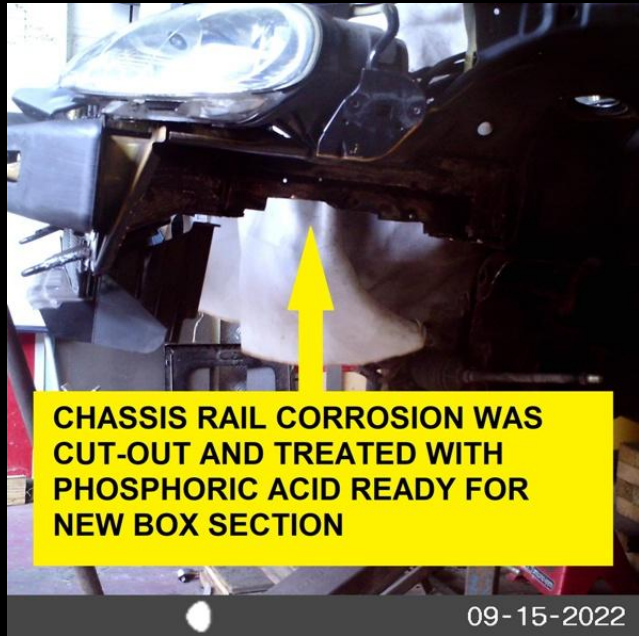
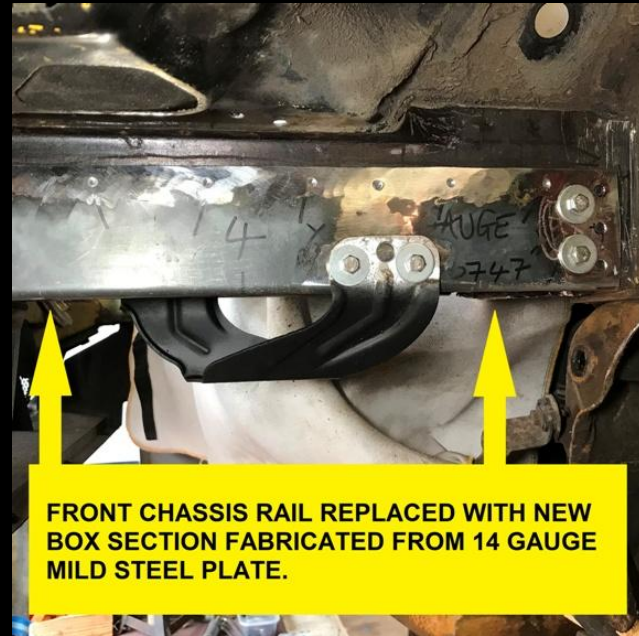
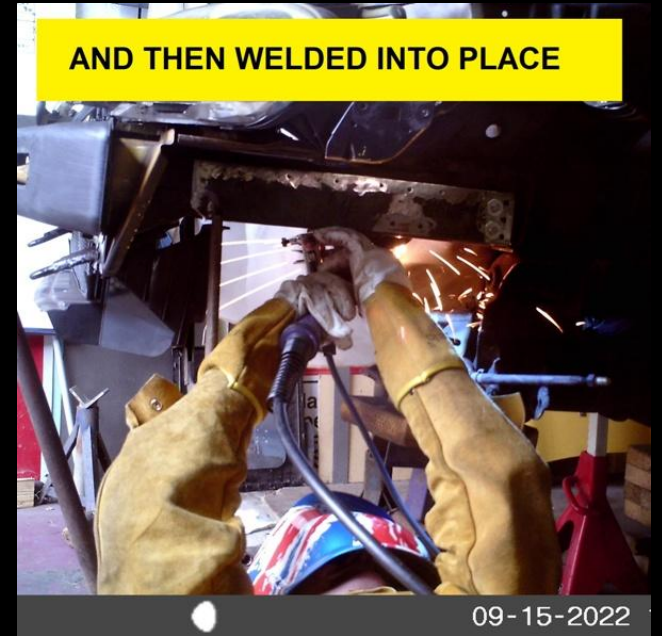
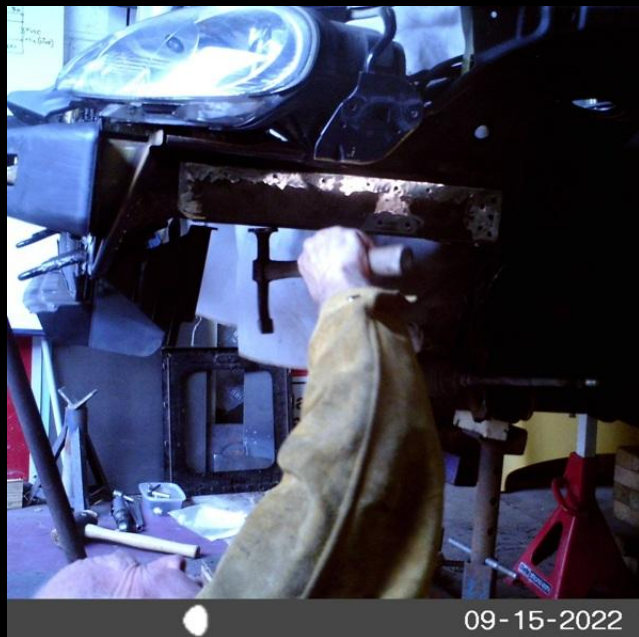
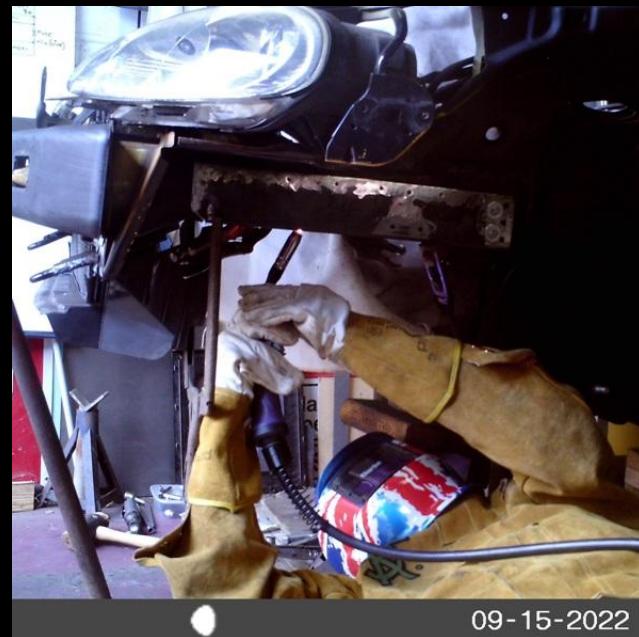
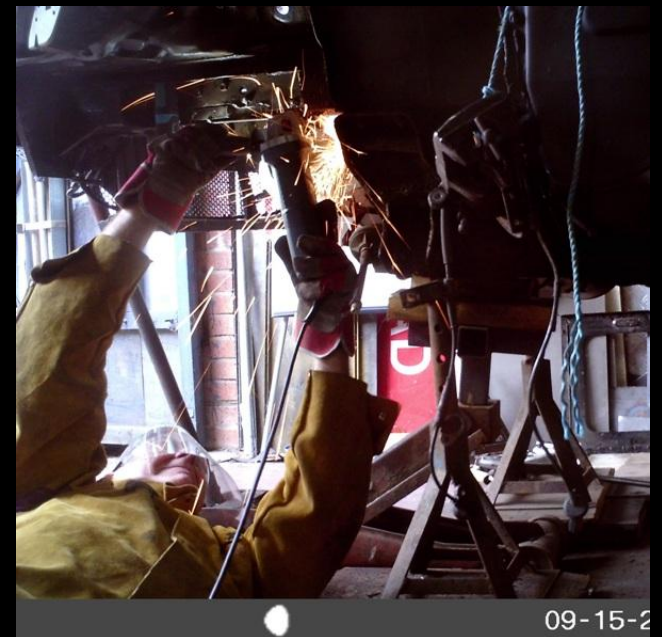
15th September 2022 work continues: I'm glad I managed to tackle this chassis rail now as it definitely turned-out to be a lot worse than it first looked.

The front near side chassis rail is now fully welded & finished-off with zinc primer etc. & ready for re-assembly after *Tiger Sealing* all around the seams.

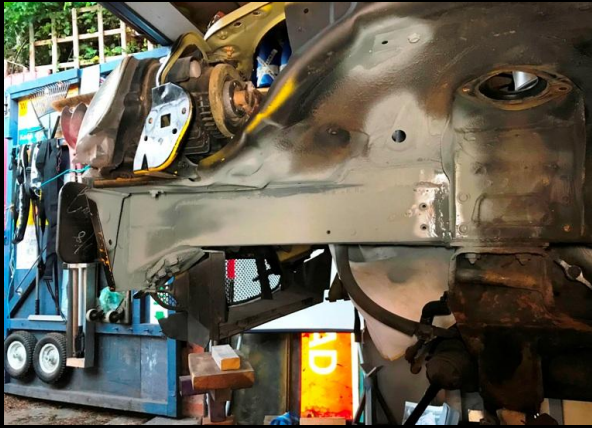
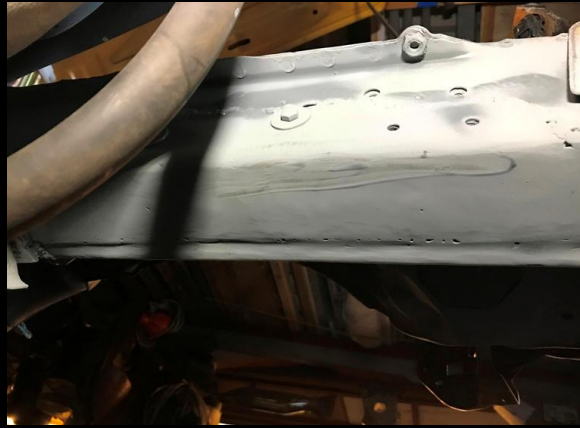
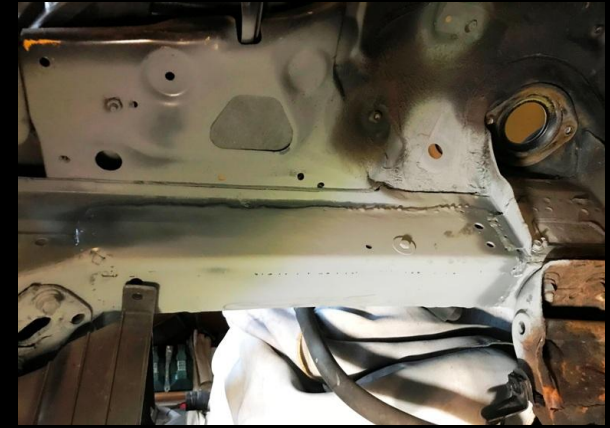
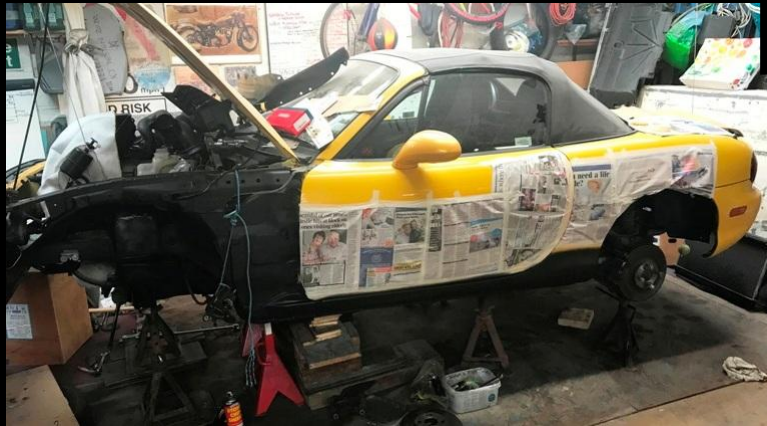
3 extra tack-welds added as well as the original 'central' plug weld.

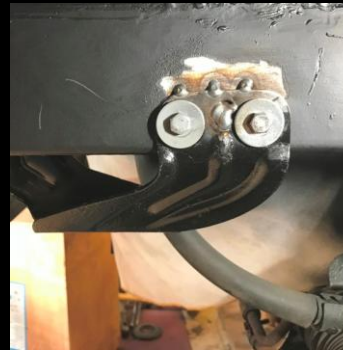
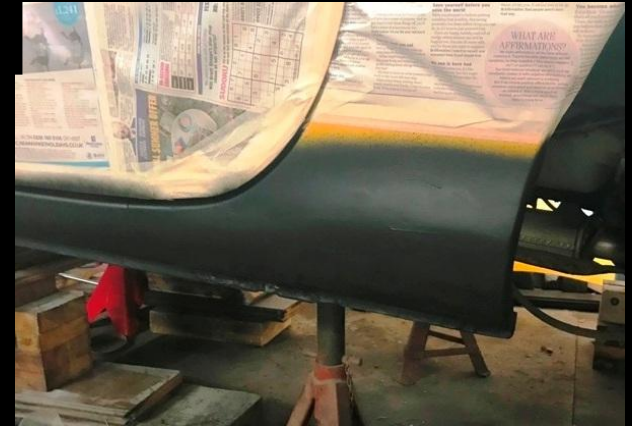
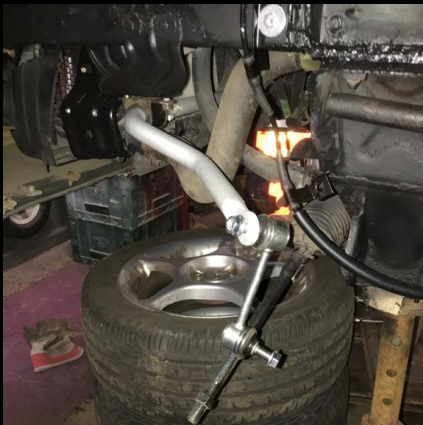
Photos above right show the sill & lower quarter panel sprayed with black body Shutz under-seal (which is 'paintable' to accept topcoat paint).

Photo Left: the reconditioned front anti-roll bar fitted with a new tie-bar link. The Americans call these *sway bar links* (but here in the UK they are also known as drop-links).

Next two photos (right) show the near side upper wishbone (rusty & then treated in red anti-rust primer) ready for a top coat of black gloss paint prior to bush fitting.

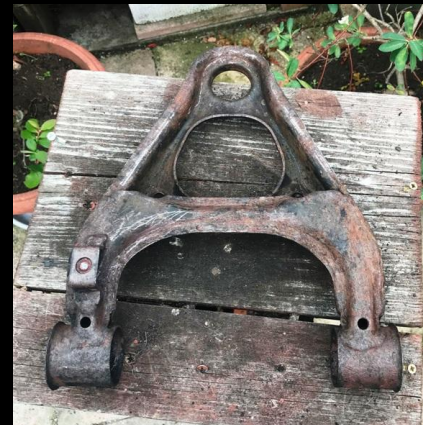
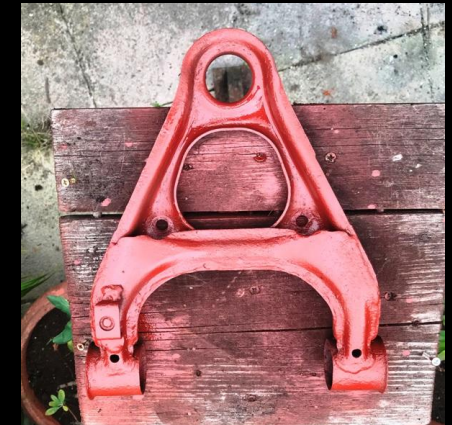
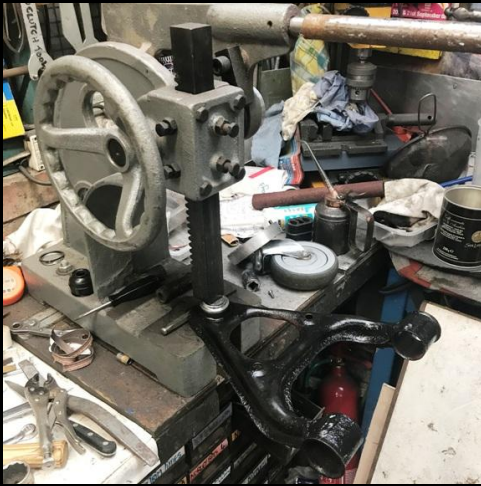
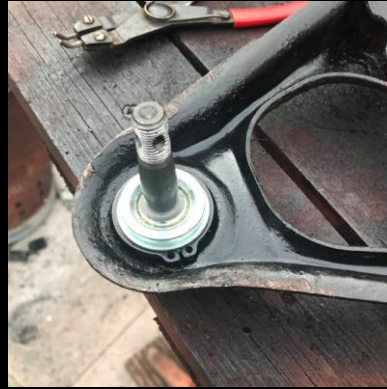
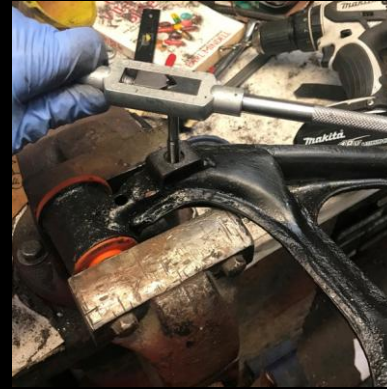
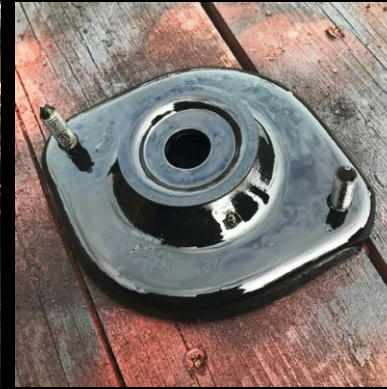
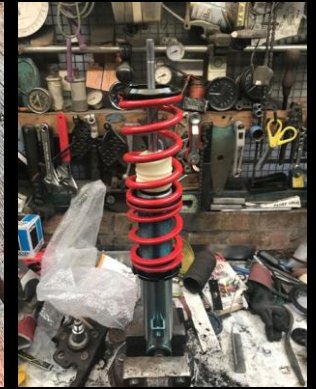
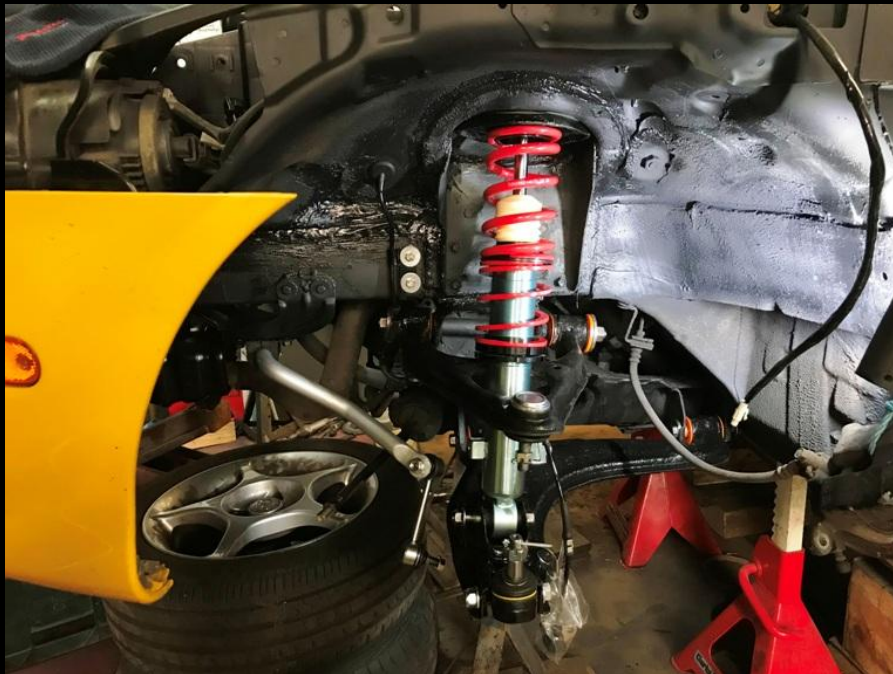
First photo below shows the new upper ball joint being 'Pressed-into-place' using my two ton arbour press. Even though this ball joint is an extreme 'interference fit' in the upper wishbone there is also a new retaining 'Circlip' fitted (for added security) just to make sure this vital suspension component stays in place. The 3rd photo along (below) shows the lower wishbone (after the 'broken stud' was drilled-out) being re-tapped. This re-threaded captive nut holds the new ABS wheel speed sensor cable bracket in place. Photo No.4 is a picture of the top suspension bracket that fits on top of the shock absorber (painted gloss black), ready to be bolted onto the new coil-over Vmaxx shock absorber. The end photo below right; shows the shockabsorber being assembled on the bench.

The new Polybushes ® were also 'Pushed' into place (into the top & bottom wishbones) using my two ton arbour press. These jobs (or any jobs for that matter) are always easier with the right *tools & equipment* at hand.

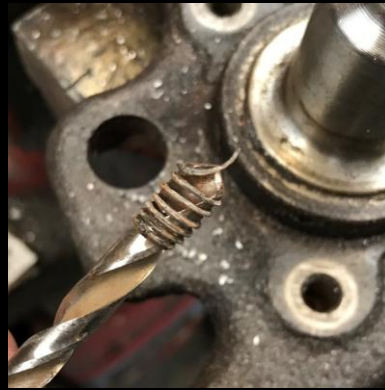
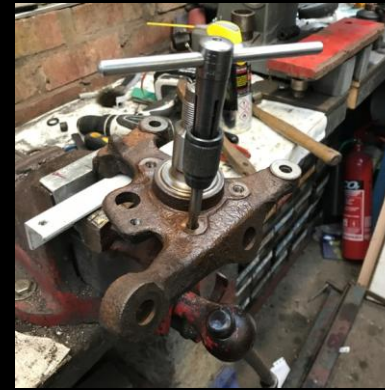
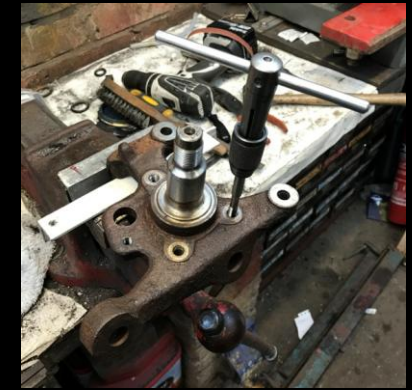
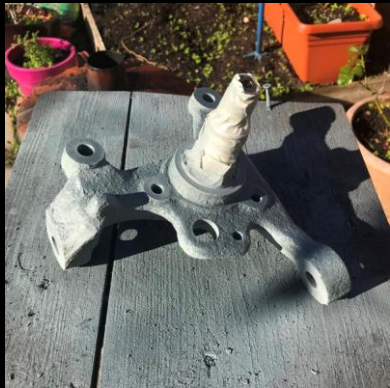
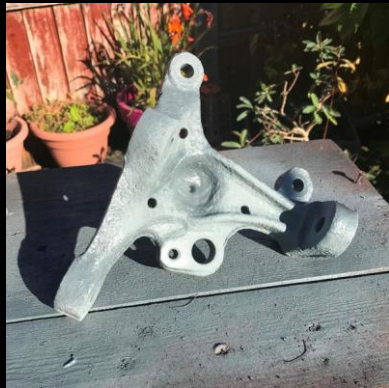
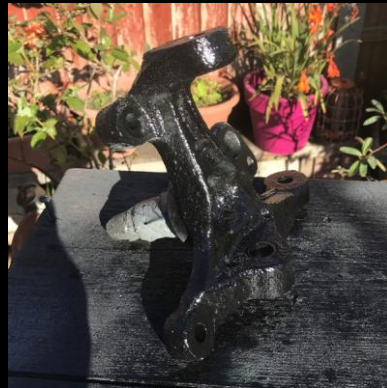
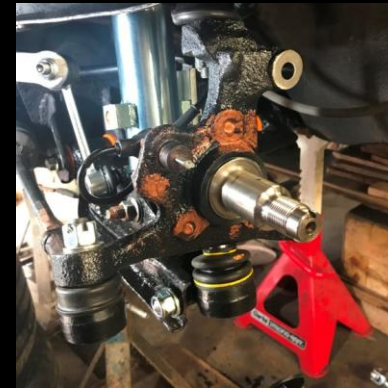
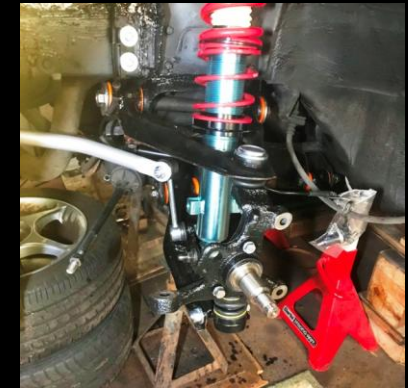
I had to drill-out the four m8 broken bolts (sheered off during disassembly). The 'trick' is to drill as near 'dead-centre' as possible with a small pilot-hole followed by using a 6.5 mm drill which should just 'break' the crest of the thread.

When you get this process right it should look just like this (first photo on the right). If you are very careful and aim for precision, the remains of the thread comes out with the drill (like the photo).

All that is needed then is to clean-up the thread with an 8mm Tap (like the two end photos - far right).

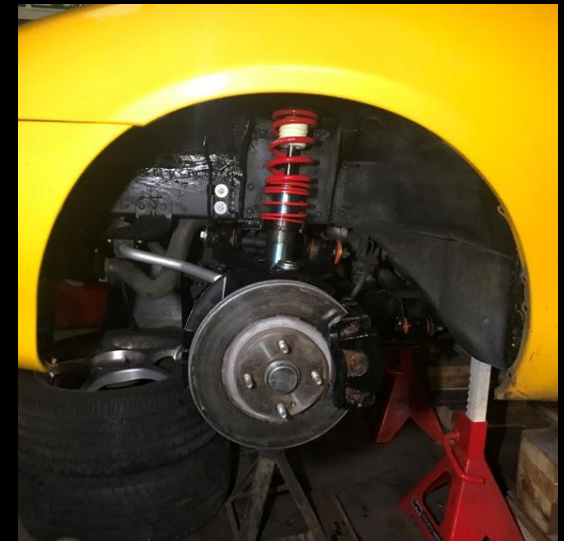
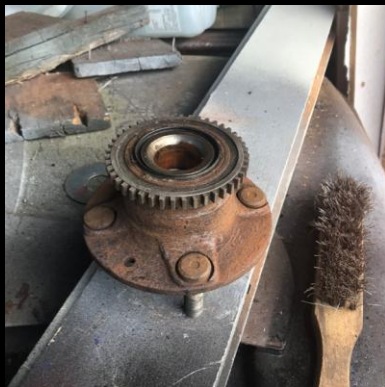
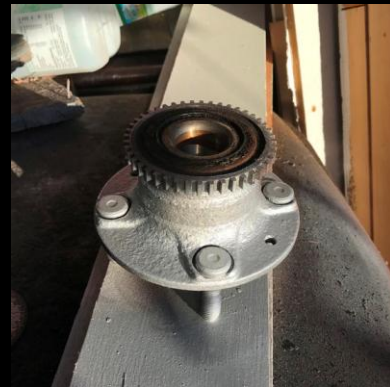
Photo No.1 (left) Shows the front axle wheel bearing housing, wire brushed ready for painting. Photo No.2 (left) shows after being cleaned-up & painted, ready to be refitted on to the stub axle.

Photo (right) shows all of the suspension, shock absorbers, wishbone bushes, ball joints etc. including the disk brake & calliper have now been refitted.

The wing is only loosely fitted at this stage as the rotten-part of the bottom of 'the wing' still needs welding-up. But the rest of the suspension work and brakes have now been completed (on this side at least). RESULT ✓

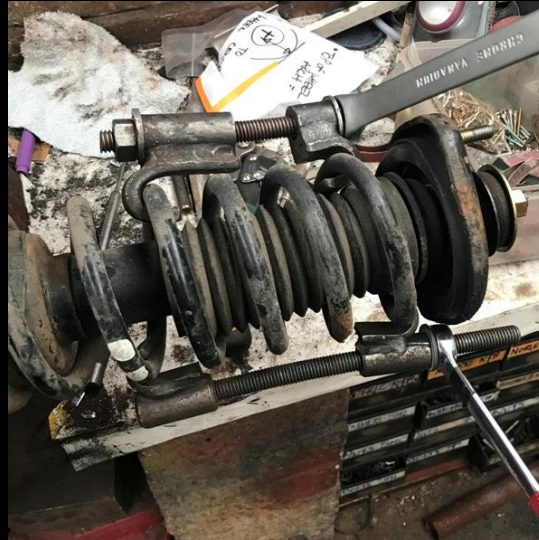
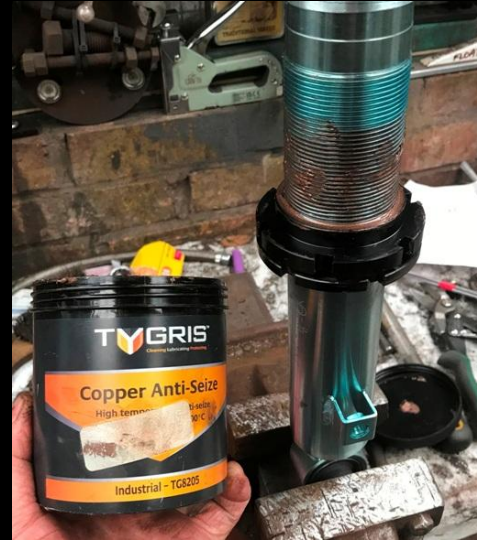
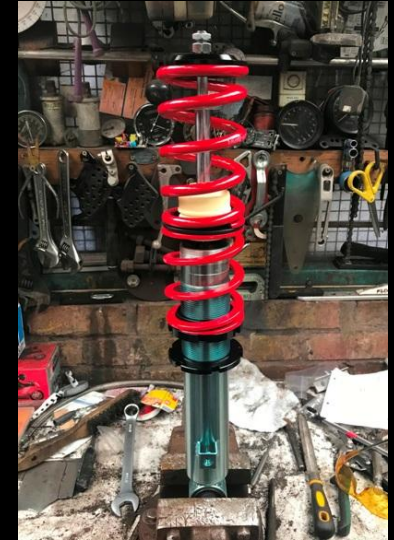
The first photo below (left) shows the new disk calliper 'Slider Bolts' fitted to the refurbished disk brake brackets

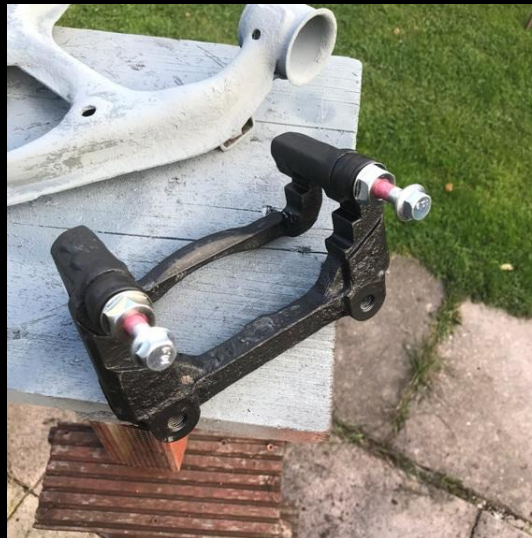
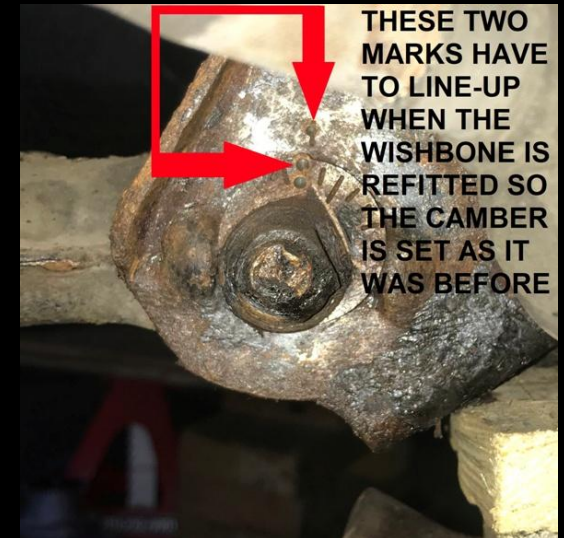
The photo above (far right) shows the lower wishbone camber adjuster 'Cam', marked ready for re-setting the wishbone back to its original 'camber' setting.

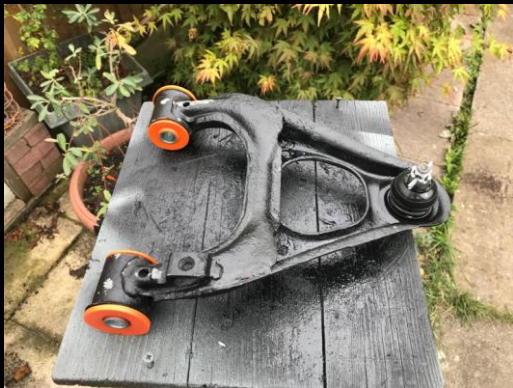
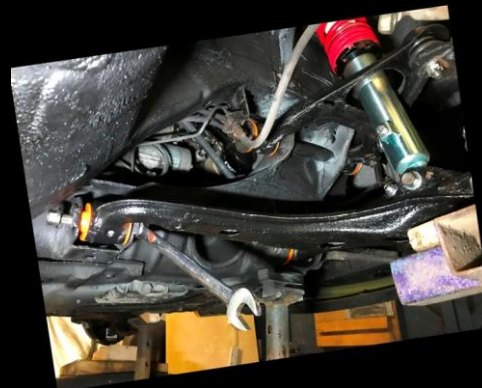
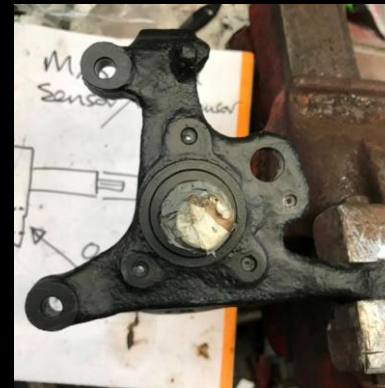
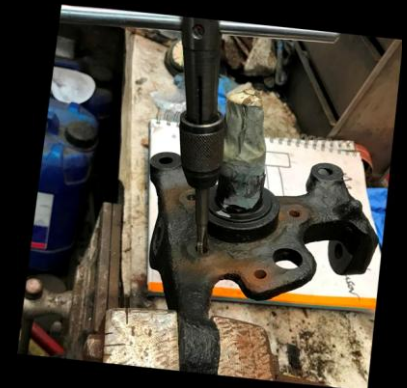
The off-side top wishbone now reconditioned (below left) with new ball joint & polybushes fitted. Next photo shows both wishbones in place before tightening.

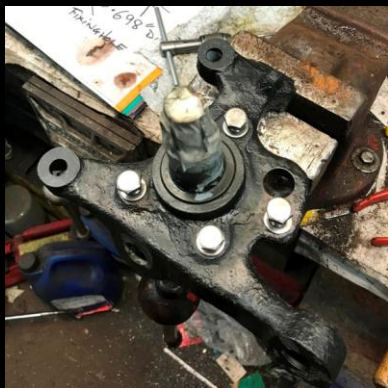
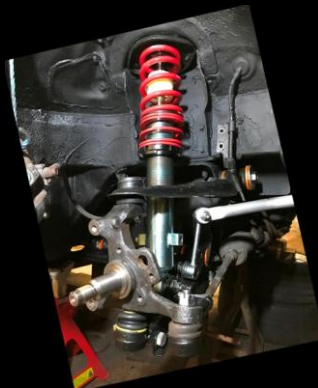
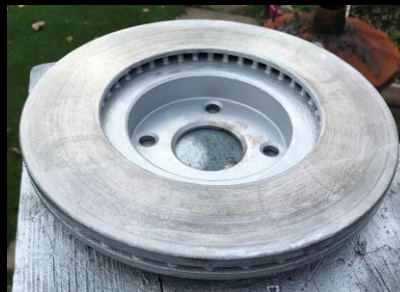
Just like the near-side stub axle, I had to drill-out the broken bolts & re-thread to 8mm before re-assembly. M8 stainless steel bolts used as replacement bolts.

I removed all of the rust from the brake disk (left) and rubbed it down before painting it silver (just like I did with the other side).

I obviously removed all paint overspray from the actual 'brake pad contact area' before assembling the disk back onto the stub axle. I fitted my new calliper sliders to the painted calliper housing and then fitted the new abs speed sensor & new brake back plate.

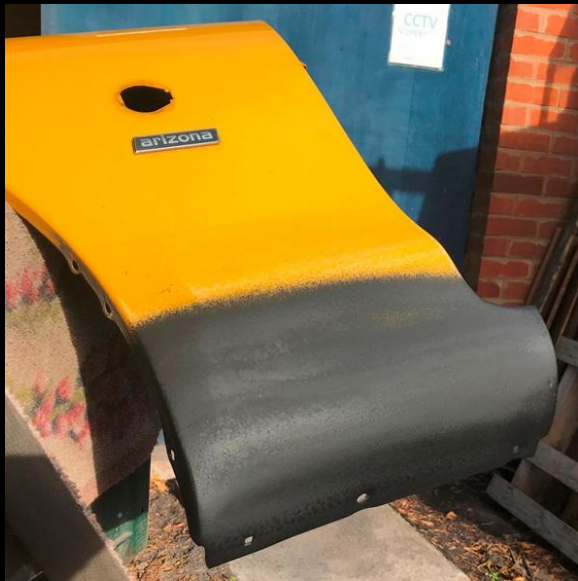
Photos (left & below) show the stone chip under-seal guard also applied to the inner part of the n/s front wing as well as the bottom section of the outside part of the wing. The wing was then reunited once more with the car to finish off the front . . . all that is needed now is to refit the front wheels.

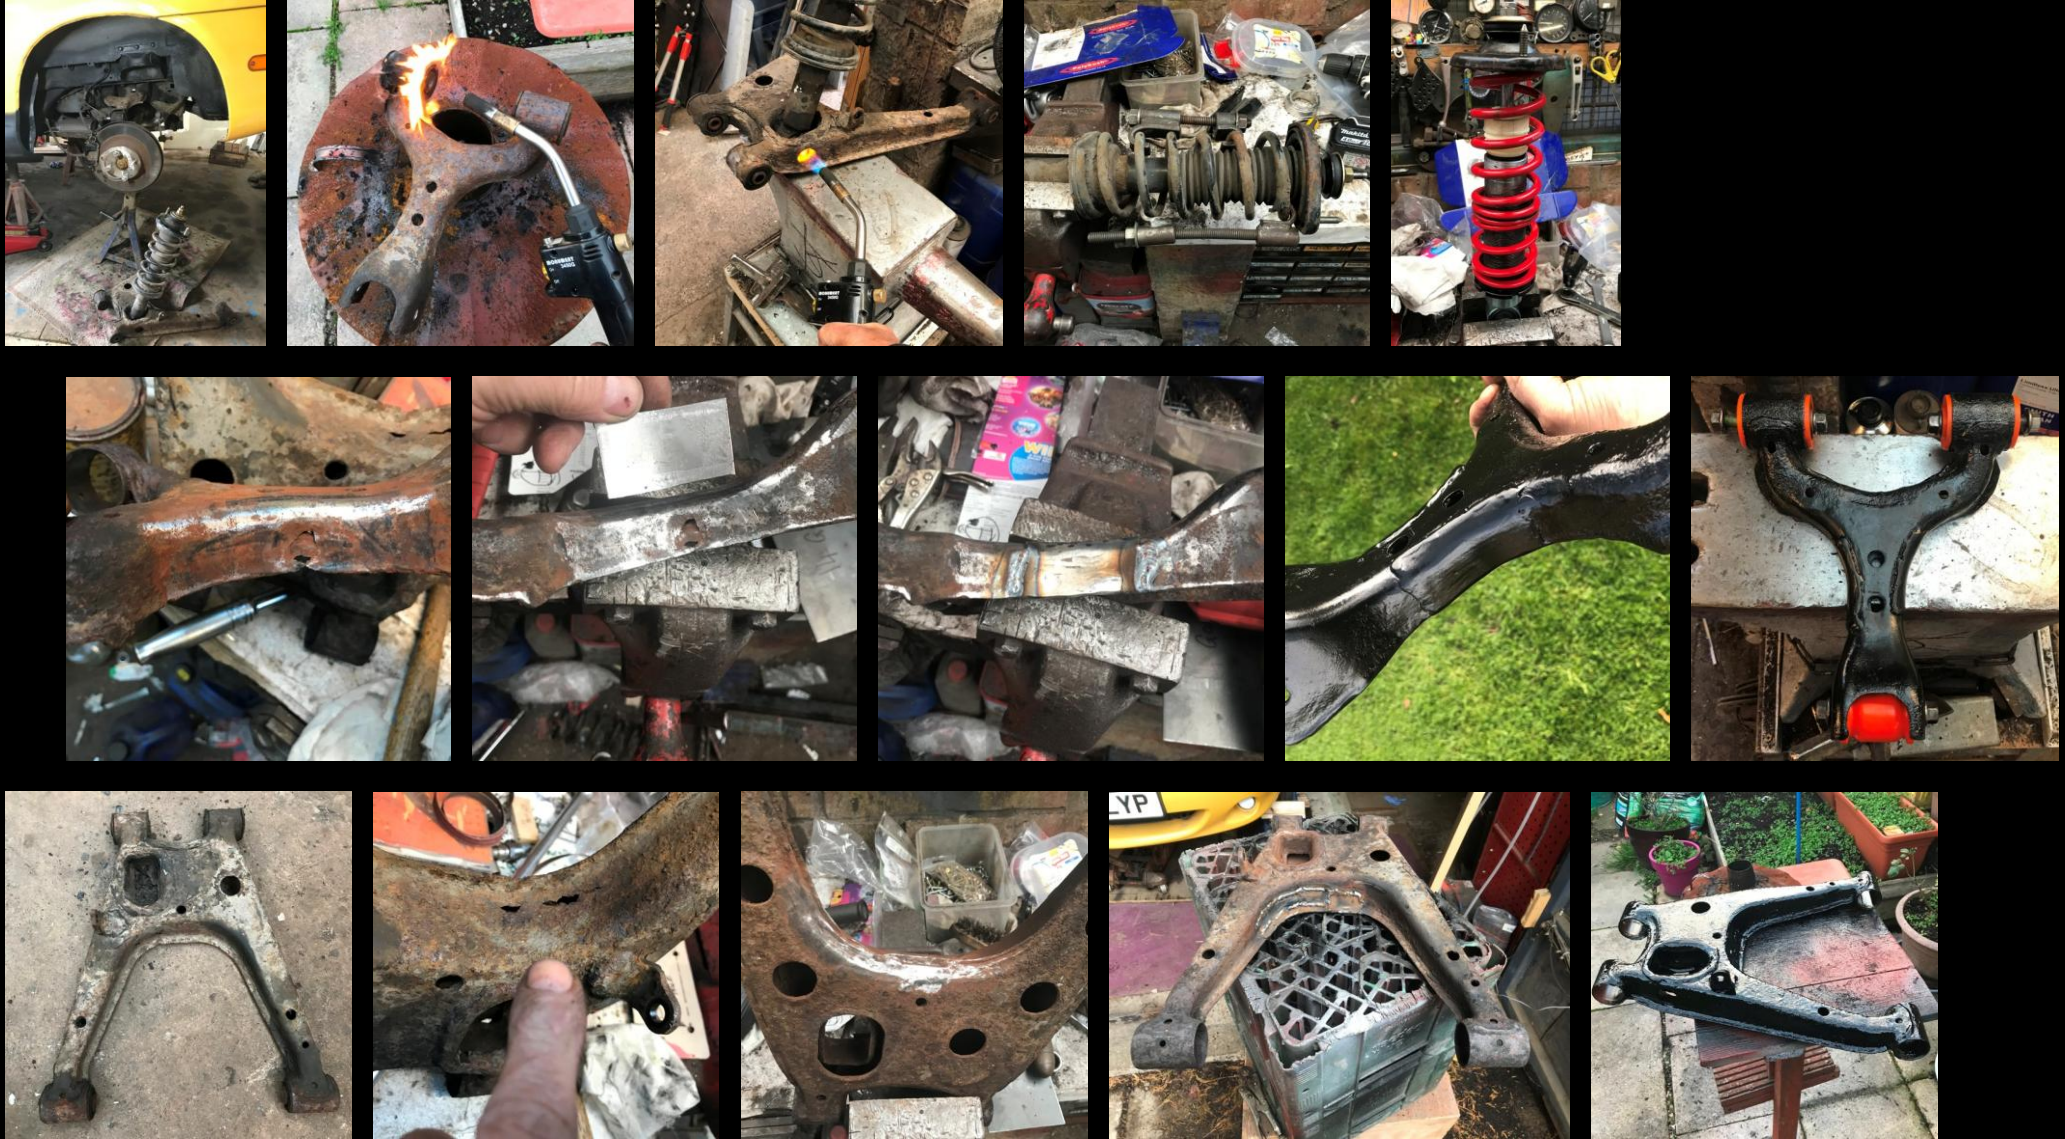
Near Side Rear Suspension Reconditioning Work begins . . . The near-side rear shockabsorber 'Bolt' was totally siezed in the wishbone and needed heating-up to eased it out, as a sheared bolt or broken 'captive' nut at this stage would add even more expense to an already increasing repair bill. It was easier to remove the shockabsorber & wishbone together as one unit and tackle the job 'OFF' the car (seen here on the anvil). OEM Shocker & spring in Vice for the change-over.

The near side rear suspension 'came apart' without too much hassle, but when dismantled . . . I found that both top & bottom wishbones had been attacked by the dreaded rustworm. Fortunately, after a bit of grinding-back to good metal I managed to MIG weld some strengthening strips to both wishbones. So with a lick'of'paint and new Polybushes fitted (see photo on next page) all that is required now is to re-assemble and finish-off this side before starting on the 'Home-Run' . . . or rather . . . to begin to recondition the off-side rear suspension – to complete this epic SAGA of a repair.
