2002 MX5 Mk.2.5 ARIZONA SE

MOT Welding Repairs

& Suspension Upgrade

This blog highlights the MOT work carried out on my Mazda MX5 Arizona Mark 2.5 special edition. Welding & suspension upgrade 2022.

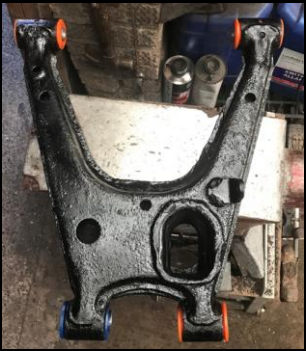
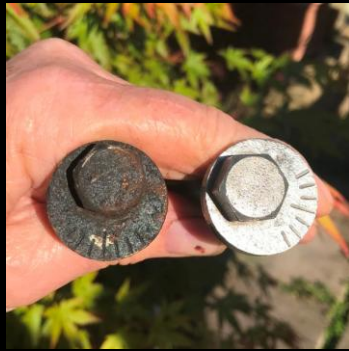
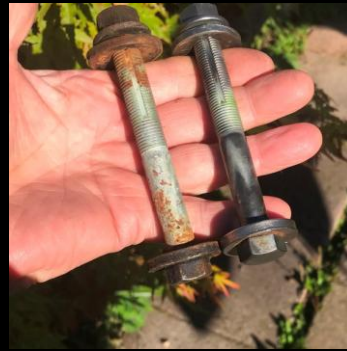
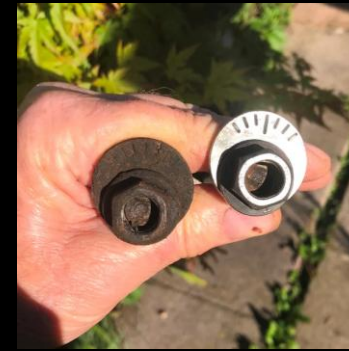
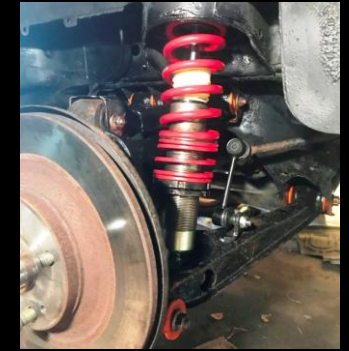
Photos below show the rear wishbone bushes fitted and the Camber 'cam adjusting bolts' (before & after photos), after 'rotary wire brush' polishing the bolts & cams. And finally (below far right) the VMAXX shocks & wishbones re-fitted to the car once more. The rear off-side suspension work can now begin.

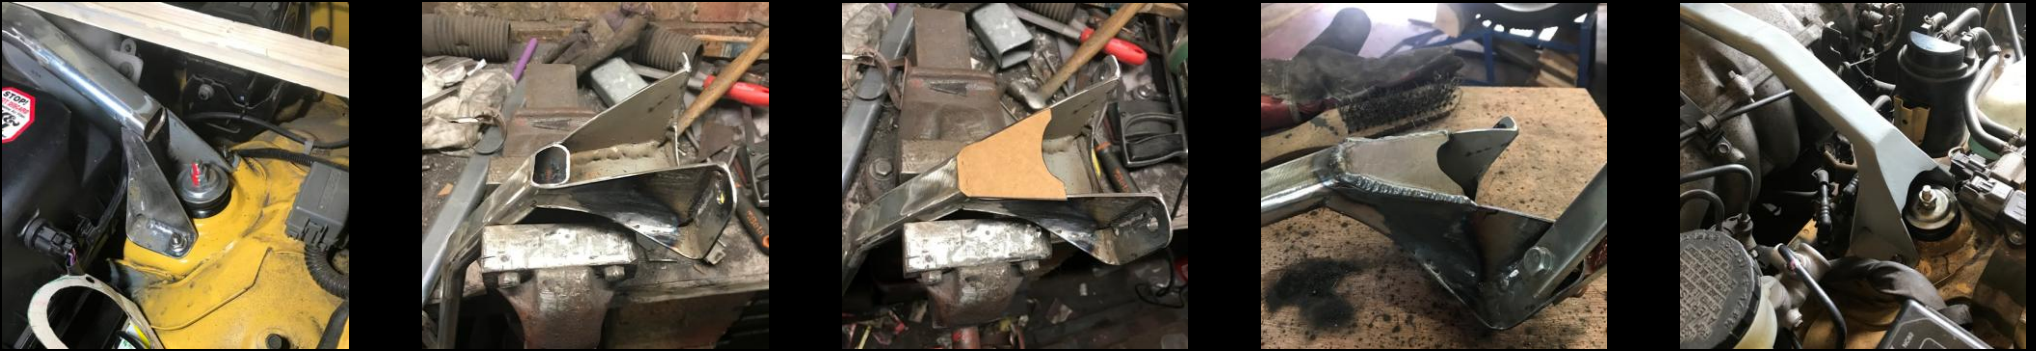
Oh! I may have forgotten to mention *one extra little job* that I decided to give myself. See photos below of the little extra fabrication / welding project completed.

I read the other day that my MX5 Mk. 2.5 Arizona model should have a top-suspension mounted Front Strut Brace fitted. These front strut braces are only fitted to the Sports Editions (like mine). My other MX5 has a front strut brace fitted but the Arizona's is missing??? So I decided to take this opportunity to make my own version of a front strut brace to fit my Arizona too. The materials used for this extra little project was made out of 90 percent recycled steel (14 gauge oval m/s tubing) that I've had in the garage for ages (waiting for just this sort of project) and to be repurposed into something 'most useful'.

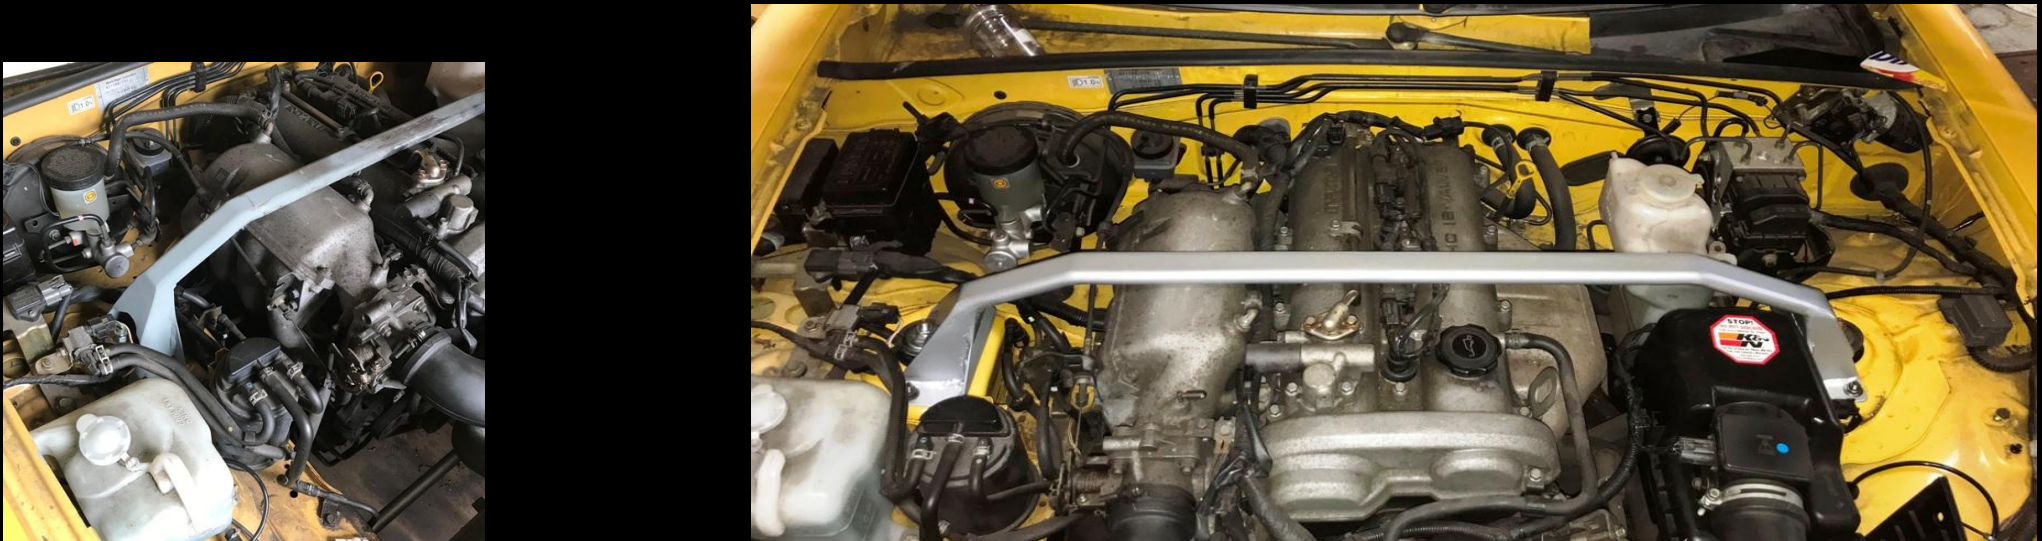
The two 'Bases' that join the strut cross-bar to the bodywork are MIG welded together, finished-off and then painted silver, hopefully to compliment the rest of the under-bonnet layout. The finished Strut is then bolted to the top of each suspension mount. Each 'mounting base' is also made out of 14 gauge mild steel plate that I've cut, folded, fabricated and then MIG welded-up to form a strong mounting pillar completing the new support cross-bar 'suspension Strut Brace'.

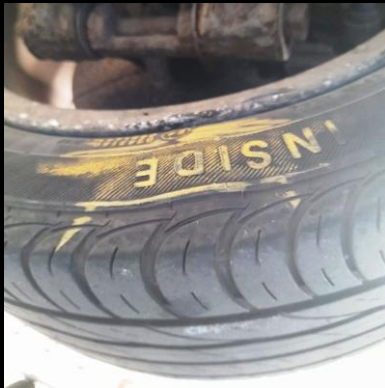
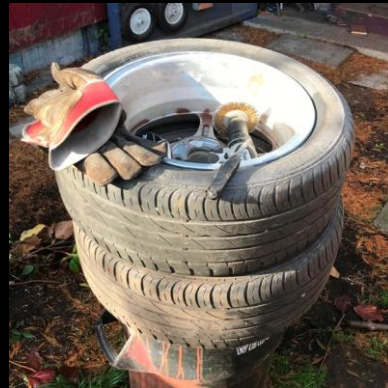
The rear tyre that was an obvious 'immediated MOT fail' because of the large 'bulge' on the inside tyre-wall (see first photo below left). Again this was out of sight. I'm convinced this damage was caused when I unavoidably struck a very large Road Pot Hole at speed a few months ago. Our bloody Roads are crap!

The middle photo shows both of the rear wheels stacked together for the inside part of the wheels to be cleaned-up and prepared ready for new tyres. Both of these old rear tyres still have a reasonable amount of tread left on each tyre, but obviously the damaged one definitely needs replacing. I've never been a fan of just fitting one new tyre on the same axle set and leaving the other old tyre on the other side of the car. I believe tyres should be changed in pairs on the same Axle. I am also opposed to fitting part-worn tyres on any of my cars, as the history of such second-hand tyres is unknown. There is also the issue of the 'age of said tyres'. Tyres should be changed every seven years anyway – irrespective of visual condition as the materials used for tyre manufacture deteriorates and degrades over time. That's why tyres have a date stamp code on them.

Third photo (below right) shows my new Avon 190/50R/15 ZV7 tyres that I decided to buy. These two new tyres now match the front tyres which are also Avons.

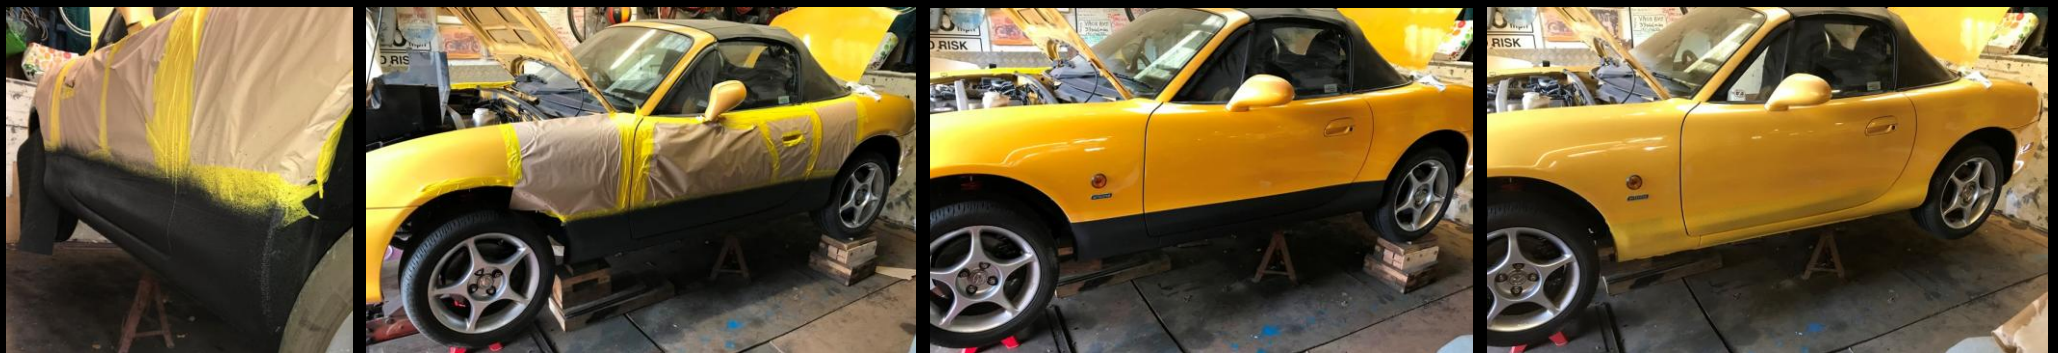
After part-masking the the car, I applied Body Shutz to the lower wings, sills & bottom of the doors. The end photo (above right) shows the Shutz 'painted over' with the correct paint-code 'Base Coat'. No Glitter added yet, that will have to wait until the car is MOT'ed again. It's starting to look more like its old self again.

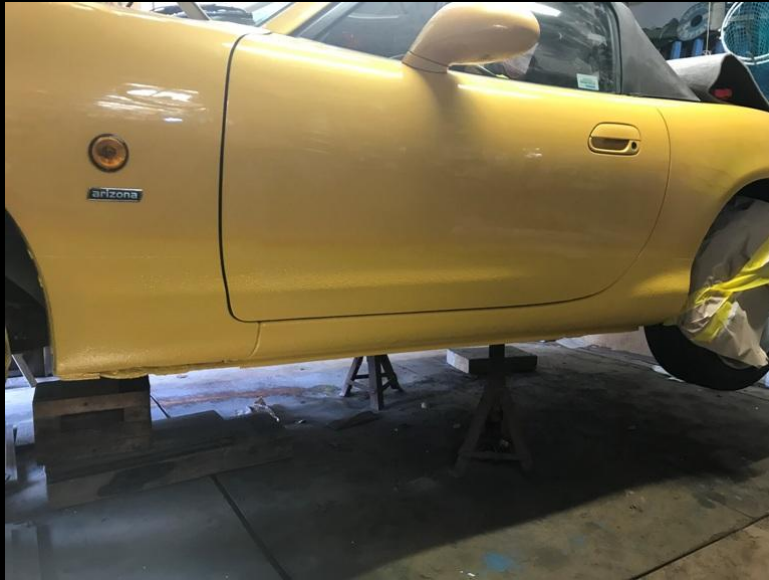
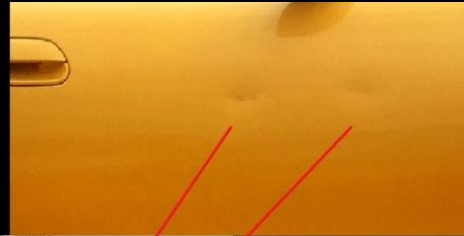
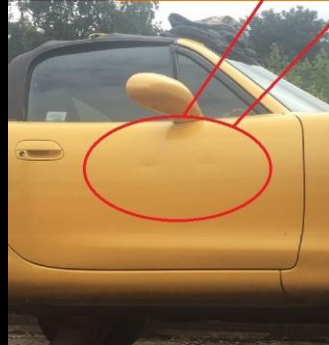
As you can see from the photos below . . . I managed to put some more yellow 'Base Coat' colour over the 'Primed' areas of my Arizona. The bottom of the doors & sills have also received several more coats of yellow base coat over the black body shutz (see the 1st photo left). The original coverage was not as good as I expected so it needed more paint to get it to look right. However, It's looking pretty good now. FULL COVERAGE achieved (but still only in base coat – in other words; No shiny glittery paint added to the car yet). All of these new painted areas have been done using *Rattle Cans* only. Purely as a quick-fix paint job.

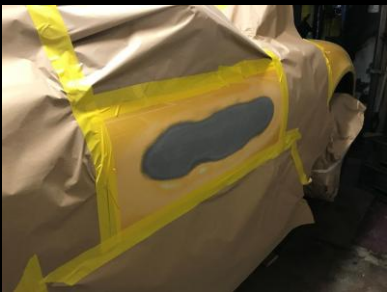
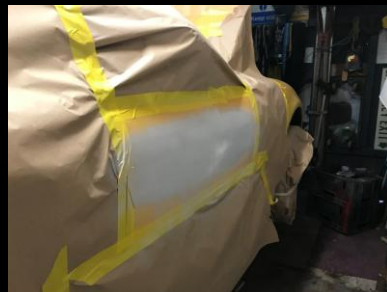
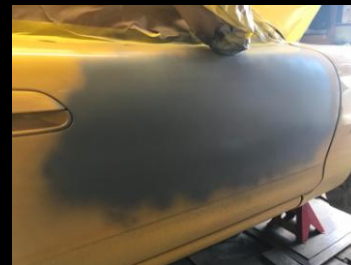
And . . . finally, after having two small annoying dents in the drivers-side-door (for several years now) I decided it was time to 'get rid of them'. See close-up photo (above centre), but only because I already have body filler, primer & paint, etc. to finish-off the cosmetic work (following welding repairs) so I thought . . . "I might as well tackle these 'two annoying dents' at the same time". The photos below: show the driver's side-door repair. After a bit of panel-beating, followed by the application of a small amount of body filler, then sanding-down & multi-priming. I added the yellow base coat to the o/s door and other primed areas on the front wing & rear wheel arches just to neaten everything-up and make it a bit more presentable ready for the MOT.

I really wasn't expecting to do this driver's side door repair (when I first started to work on my MX5) . . .

. . . but at least its done now.

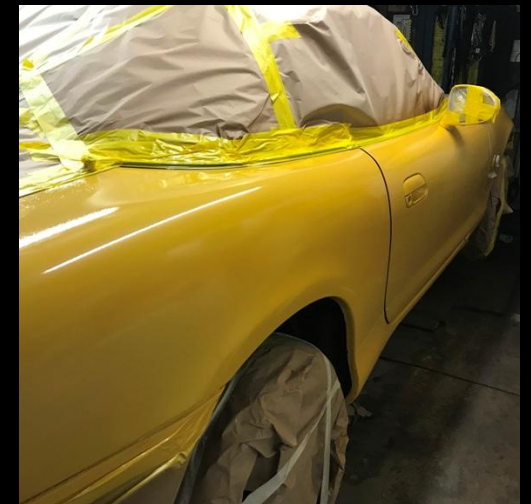
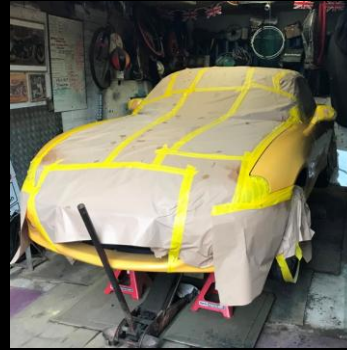
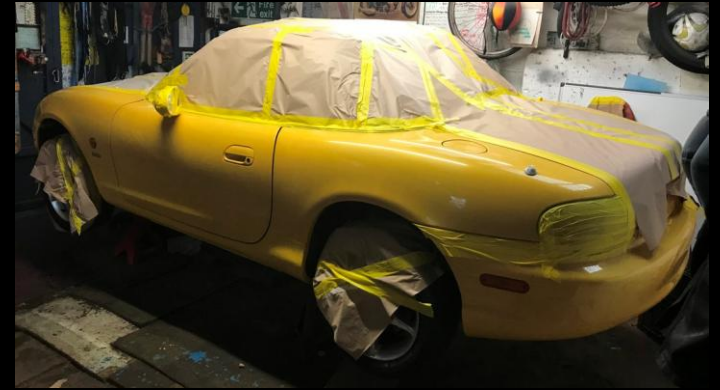
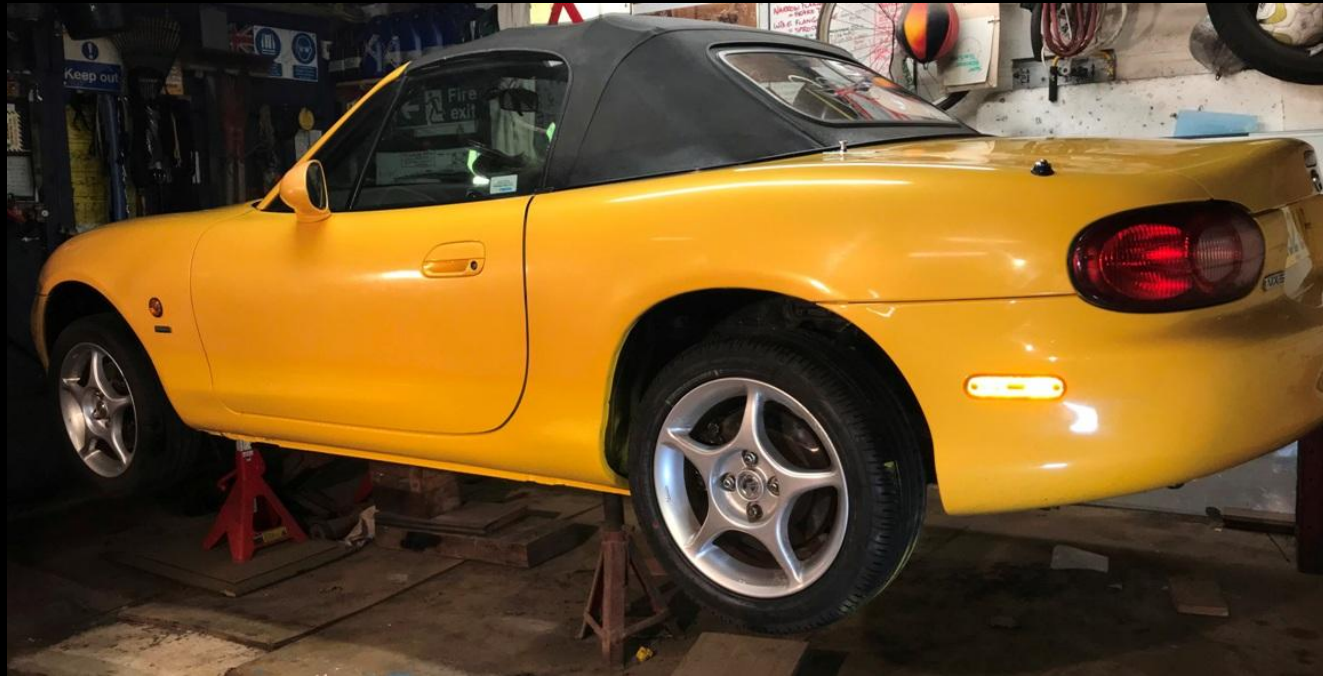
I must admit the finish is not brilliant but not bad for 'Rattle Can' spraying (or rather 8 rattle cans to be precise, which includes the primer used). And . . . Like I have already stated several times now, my intention is to do the proper paint job / re-spray later when the car is MOT'ed and back on the road again and when the weather improves.

I am quite impressed with the results produced using just *Rattle Cans* and whilst it's certainly not showroom condition, it'll pass muster (just).

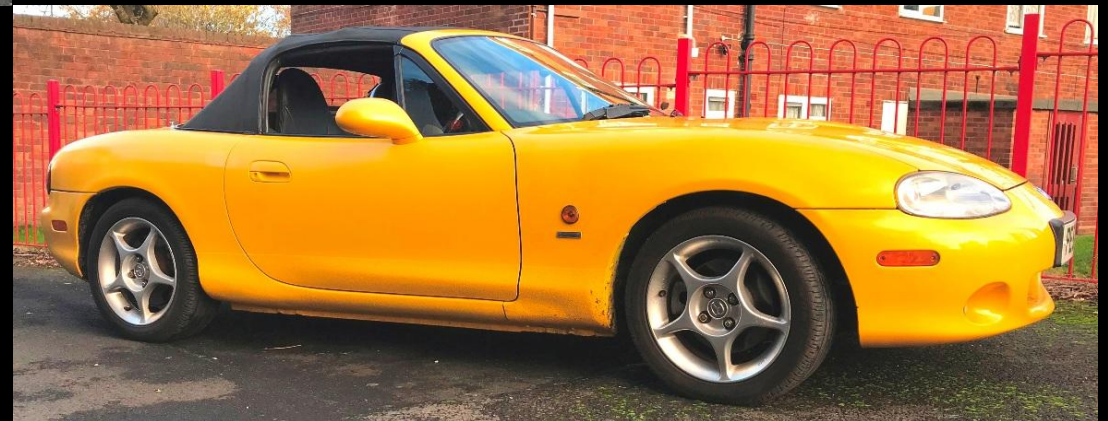
Finally . . . My Arizona (photo below) has successfully passed its MOT Test and is once more back on the road again (all legal like), i.e. it is Road Taxed, fully Insured and is now MOT'ed once more.

On the positive side: The suspension & steering upgrade has certainly made a positive difference (from the standard 'set up') because the steering is so much more responsive than before. It '*Holds the Road*' better and feels tighter than with the OE parts. I am very pleased with the steering upgrade (ten out of ten) as it has definitely sharpened-up everything steering wise.

On the negative side: The new Vmaxx coil-over shock absorbers feel quite hard, or rather . . . the '*Ride*' now is much '*Harder*' than with the original (OE) shock absorbers.
