Land Rover Defender

TD5 - 110

County Station Wagon

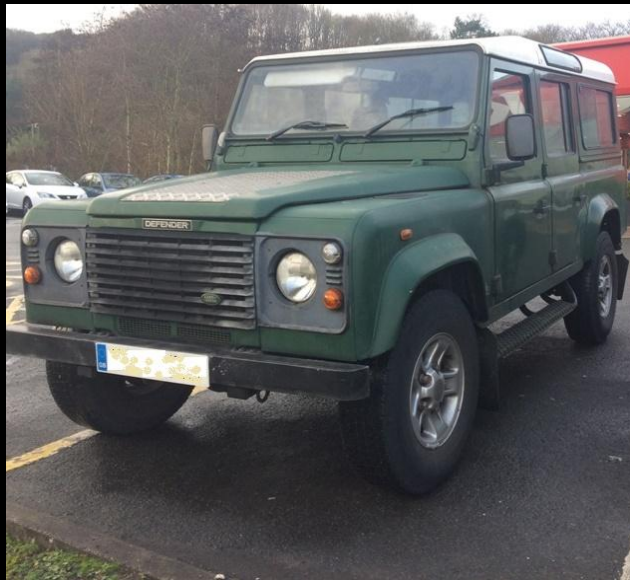
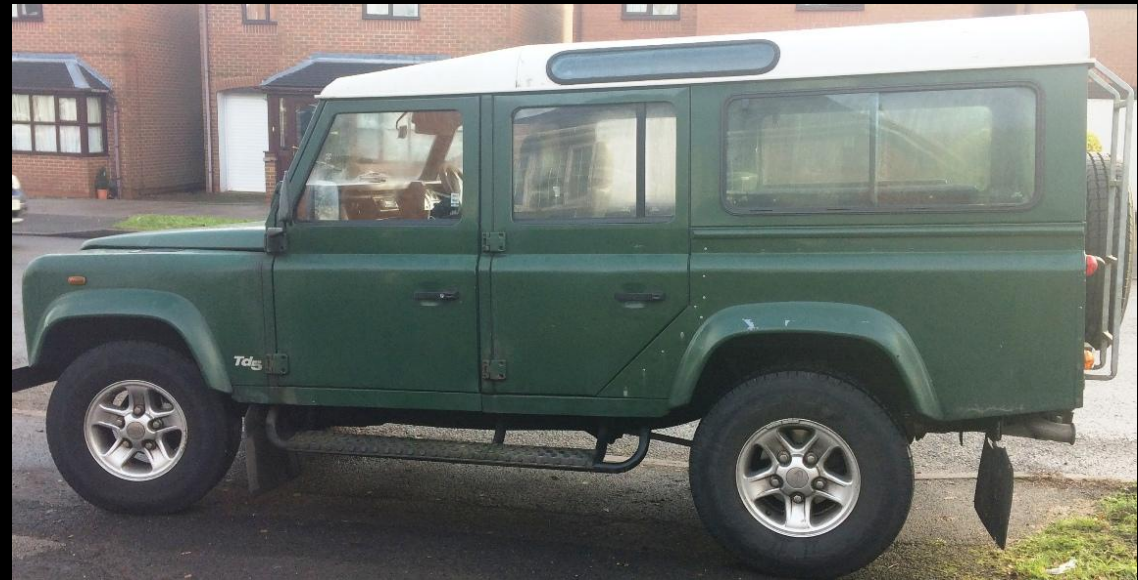
Yes, it's tatty (at the moment), and it leaks water into the cab when it rains (mainly through the poor seals around the Glass Sun Roof and through the Door Seals too), especially because neither the bonnet nor the doors fit or close properly. Paintwork is well-weathered and totally Matt-Flat (no shiny paint on this one). So . . . it's in need of loads of TLC and a fair-bit of cosmetic surgery here & there. But, it appears to go well, handles & brakes okay and was an enjoyable 'drive' home (based upon our initial test drive and 25 mile return journey back home). It feels & drives just like a 'Proper' Land Rover Defender should do. We both 'love it' and cannot wait to get started on the *refurb-work*, and start *enjoying* this Landy.

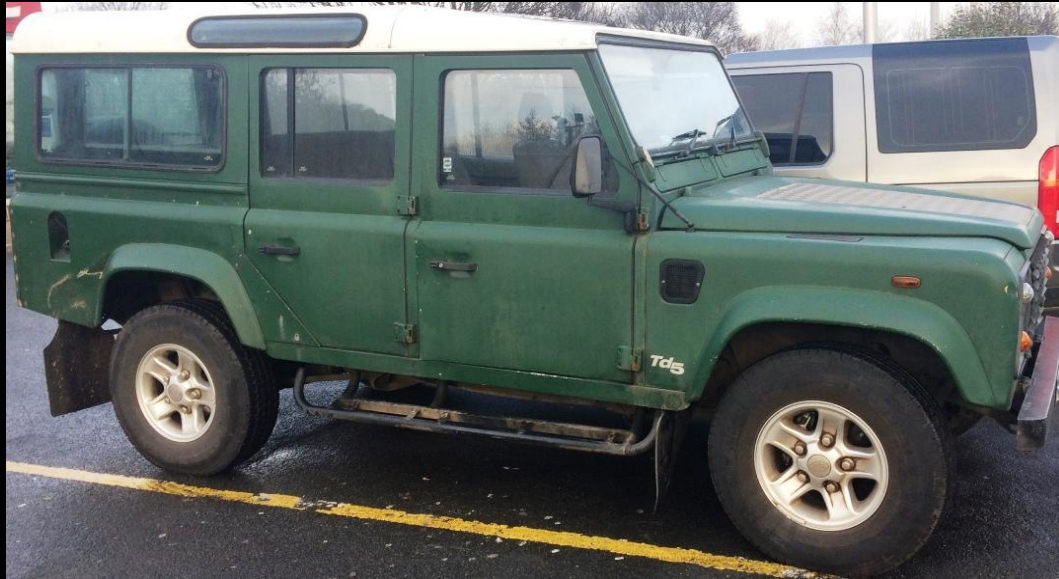
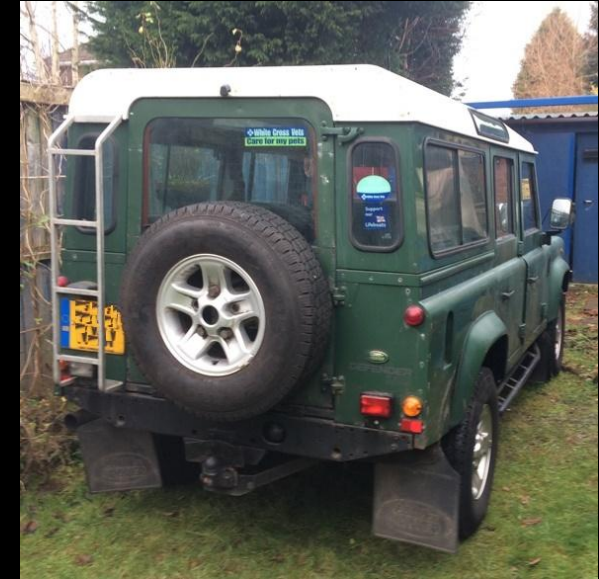
First Job on our *works-agenda* was to fix both Front Doors. Neither of them fit properly as the Door Hinges are both knackered (worn & broken hinge pins). Neither Front Doors would lock easily (it was possible to lock them, but with great difficulty). So our first priority was to make this 'Landy' as *secure* as possible. We tried getting new hinge pins, but ended-up buying new hinges instead. As you can imagine on an eighteen year old vehicle (that's seen its fair share of hard graft and outdoor living) most fittings & *nuts'n'bolts* was well and truly rusted & stuck-fast. After plenty of encouragement (i.e. a Big hammer and lots of WD40 & heat) we managed to extract & re-fit the new hinges into place. Job Done!

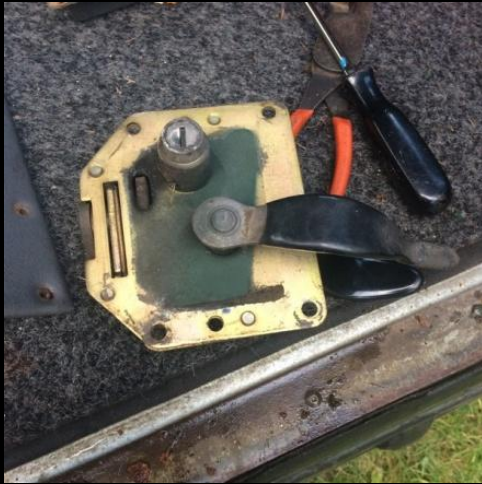
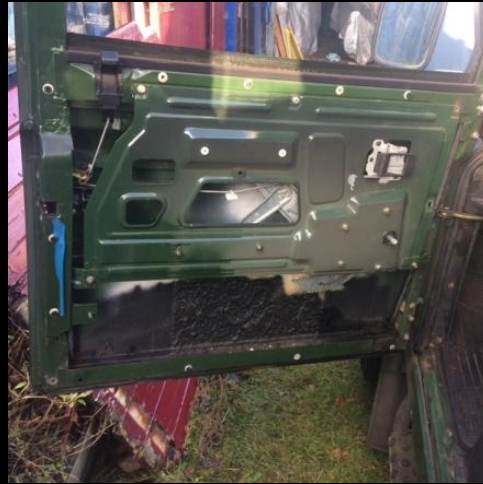
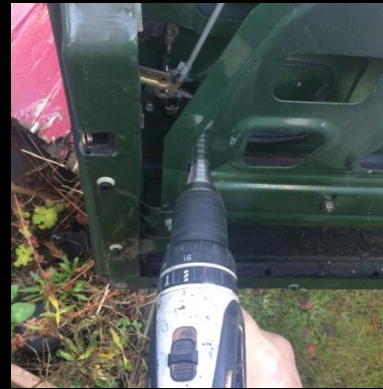
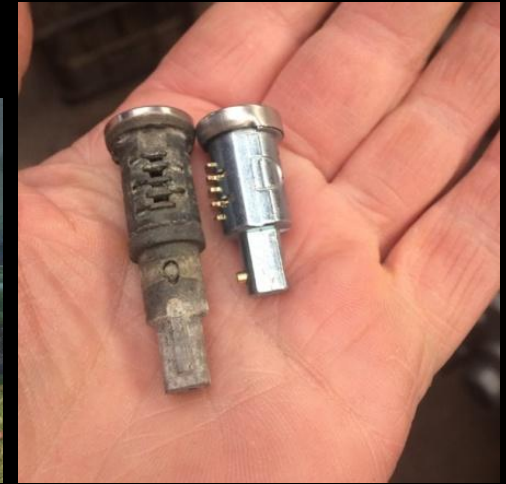
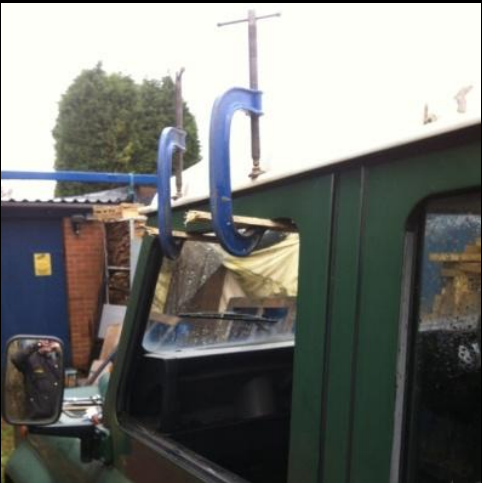
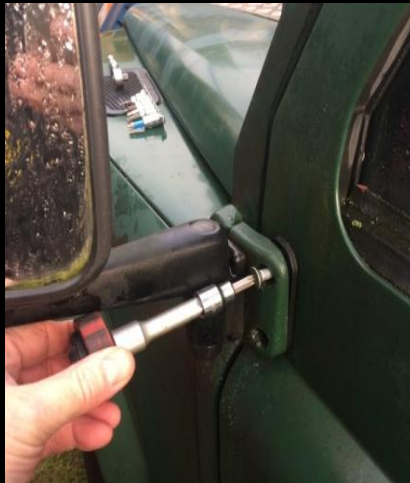
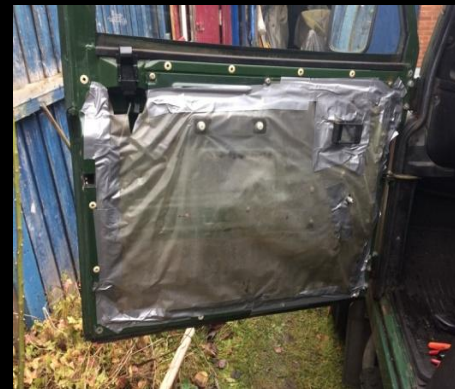
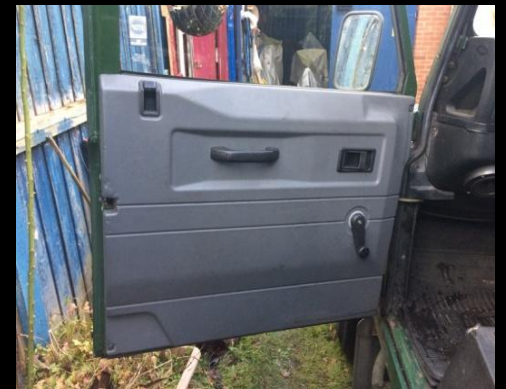
"It really does look a lot worse than it actually is" (this is my MANTRA at the moment, and if I keep repeating it, over & over again, I might even start to believe it soon). I'm sure the weight of the Spare Wheel (which is fitted to the outside of the rear door) has compounded matters and has contributed to these serious fractures and cracks (a combination of rust-corrosion, plus continuous movement fatigue and door flexing = Fractures). The Answer was to repair and strengthen-up the door & the Spare Wheel Carrier by adding *steel fabrication* to the vulnerable and damaged top & bottom fractured areas (and Wheel Carrier Bracket).

The rear door Lock & Barrel (1st photo below left) was removed together with the nearside door Lock Barrel (using same procedure as the driver's door). The Passenger side door was then *re-aligned* with 'G-Clamps & wooden strips, like we did on the other side. And, the whole lot tightened up and all the *door trim* was refitted.

The Spare Wheel Carrier was removed & repaired, plus a new rubber seal fitted. Galvanised Steel plate was used to reinforce the existing door cross-members, thereby effectively reinforcing the old rusty and tired door (giving us a at least a couple more years of 'use' before replacing it).

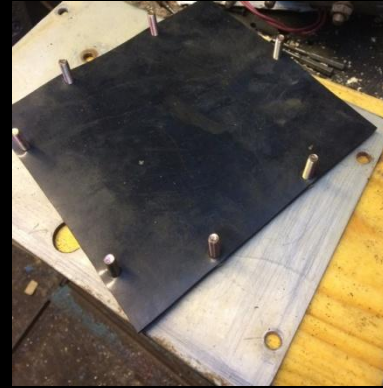
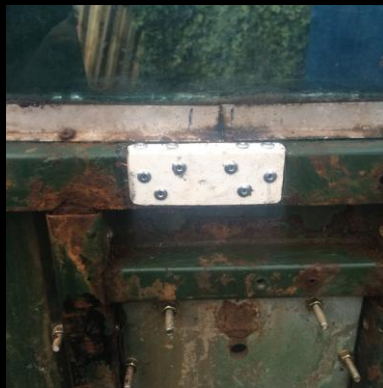
Because the rear door had developed serious fractures and splits virtually 'centre-line' to the door, it was decided to remove the rear window Wiper Motor Unit & Wiper Blade (and leave it 'Off' altogether). And to reinforce the top & bottom damaged areas of the door with 2mm & 3mm steel plate (pop-riveted & bolted together) and to make and fit a complete new 'Steel Panel' (instead of & in-place-of the original Defender 'Cardboard Door Panel' cover). The finished *result* is a very strong rear door (but at the loss of a rear wiper motor & wiper blade system).

The photographs above show some of the fabricated steel gussets & plates bolted & pop-riveted into place to reinforce the rear door. The photos (next page / below left) shows a sheet of steel being used - measured-out, cut and folded (with the pop-rivet holes pre-drilled) and ready to fit on to the bottom of the rear door. Just by adding this bottom steel fabricated piece makes such a difference to the door. It is already a lot stronger than before and I'm quite pleased with the outcome. Apparently later model rear doors are *Pressed-out* in one piece, rather than *Welded* together.

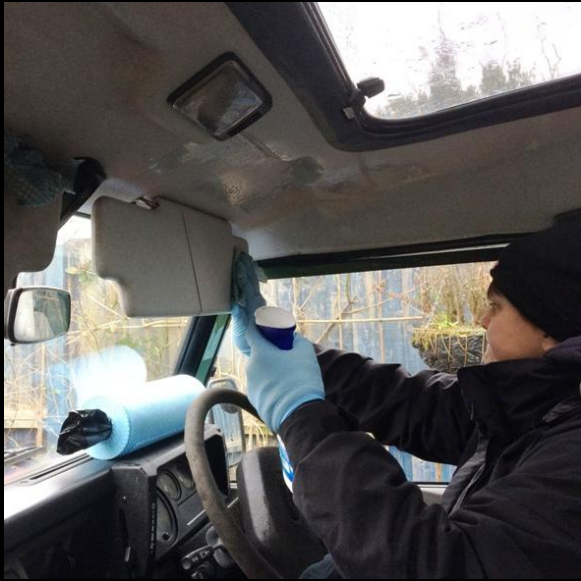
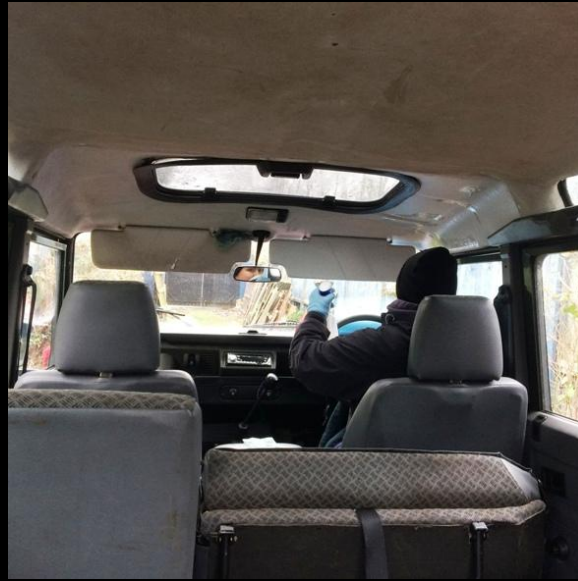
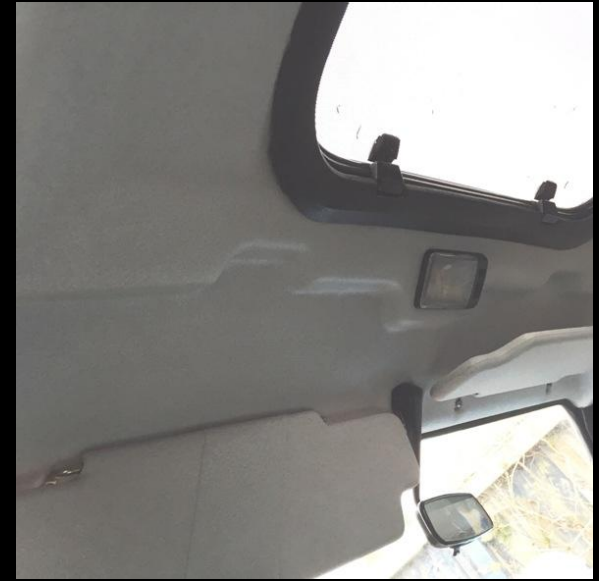
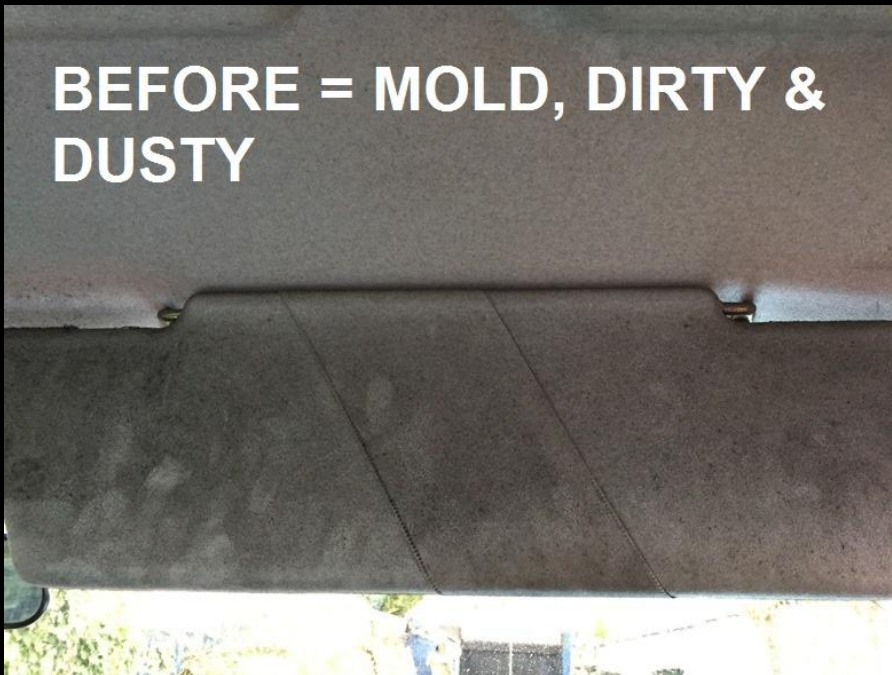
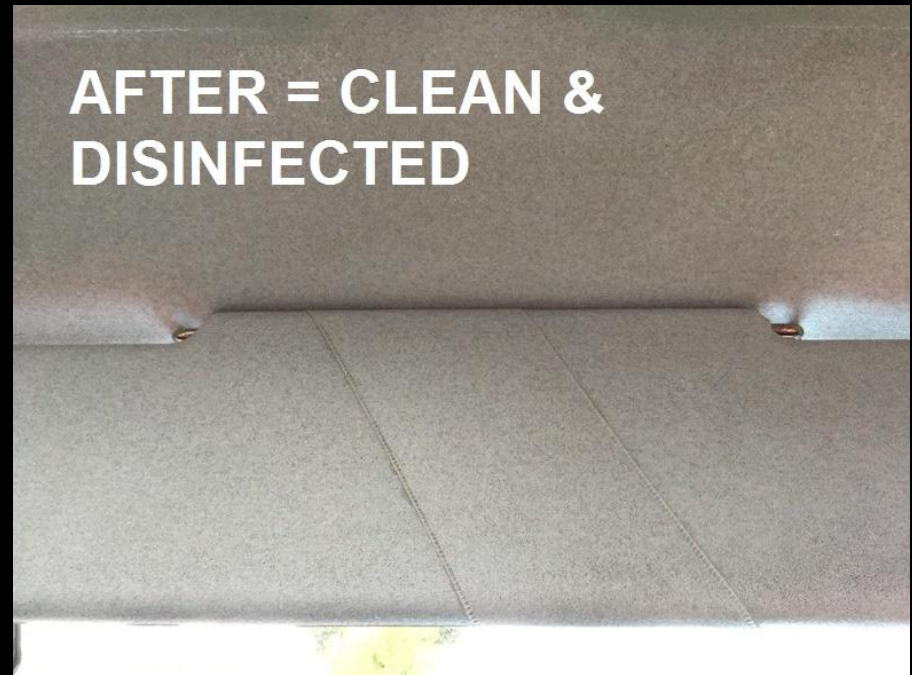
Whilst I was working on the rear door, Debz was making a difference inside the car by cleaning and disinfecting the interior (the middle photo below illustrates what a difference this has made). You can see where the Roof-lining (at the rear of the 'Glass Sun-Roof Hatchway) looks really dowdy against the 'Clean' section that has just been 'sorted'. This just goes to show the power of good-old-fashioned elbow-grease & hard graft.

The above photos show the *Before & After* images. What a transformation from "*Dirty to Clean*". Or, as I like to say; "*It's been Detol-ised*".

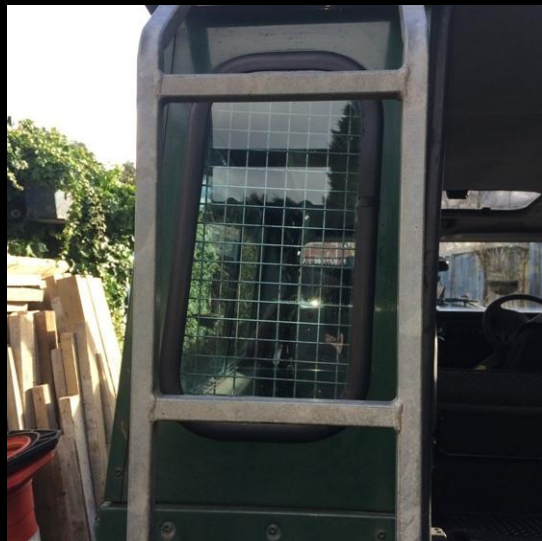
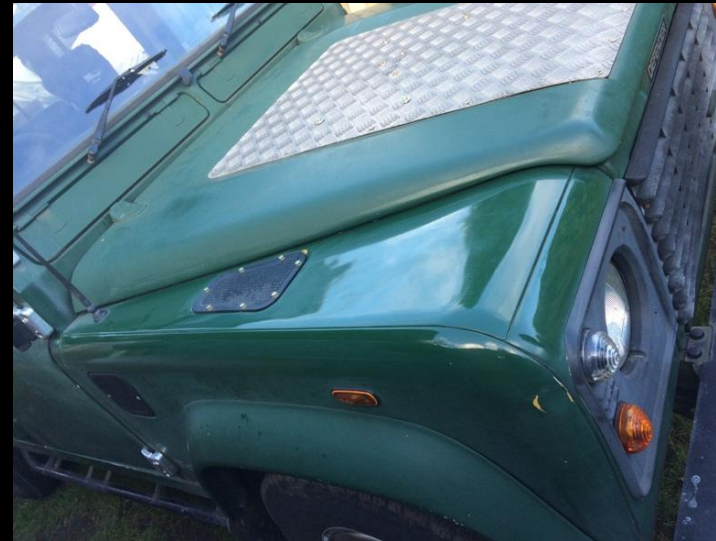
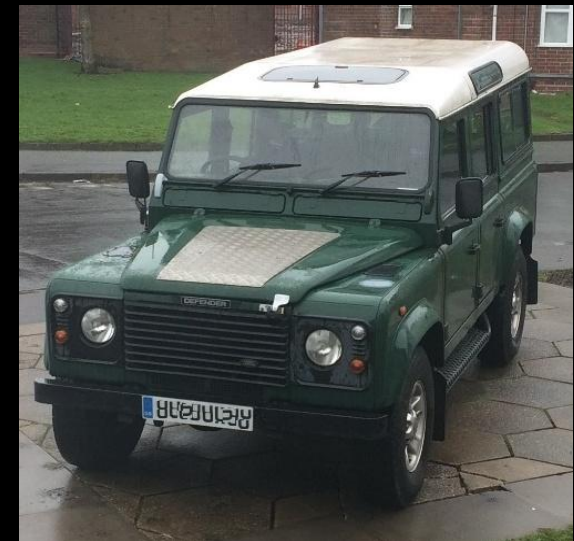
Another successfully security job completed. And . . . a 'Comparison' between the unpolished Matt Paint versus polished Shiny Paint = RESULT.

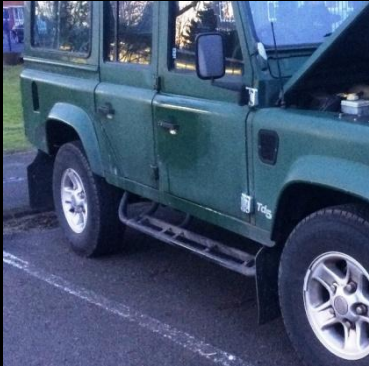
The Side Steps (on both sides) were in need of serious repair. They wobbled and creaked whenever any weight was put on them. Following closer inspection it was discovered the mounting brackets (where they bolt onto the chassis) had fractured & split due to corrosion. Plus, the nuts & bolts (that hold these Steps to the Chassis) was totally rusted & seized solid. So the next stage was remove them for structural repairs (i.e. fabricate & weld new brackets and support plates onto these old & rusty *Side Steps*) before we can re-fit them back onto the vehicle.

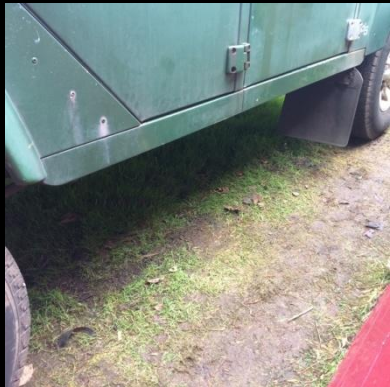
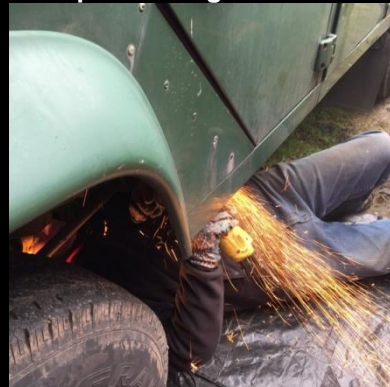
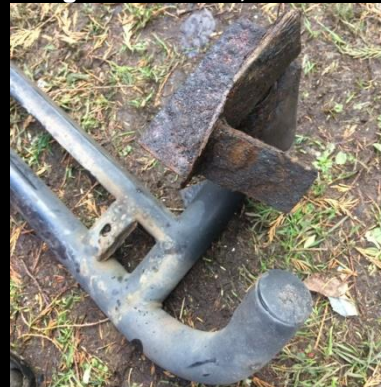
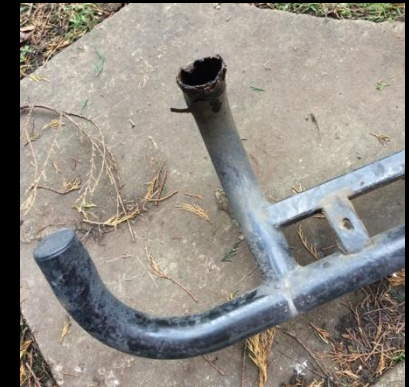
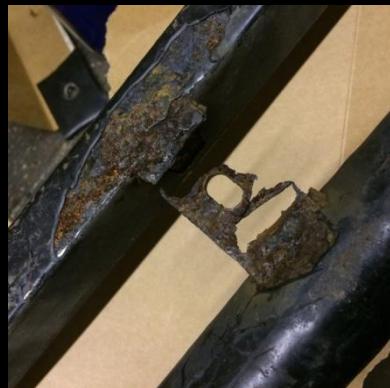
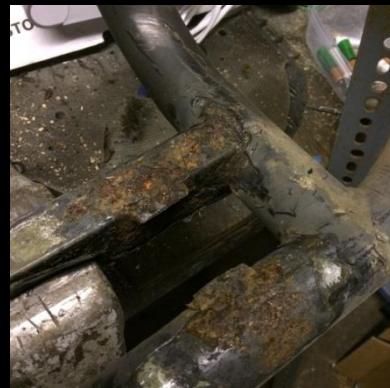
Due to the extreme corrosion of the Step mounting brackets and seized fixing nuts & bolts, we had to use a Disc-Grinder to cut them off.
