Velocette MAC 350cc

The Re-Rebuild of KJ's MAC (Part Four)

From May 2023 onwards

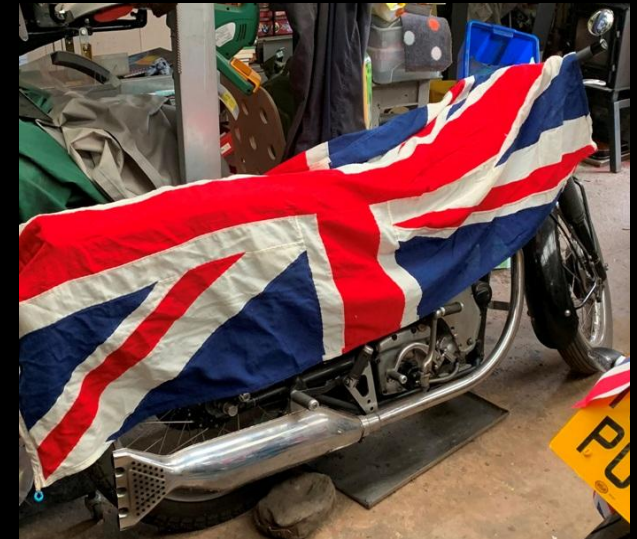
I removed the timing cover to discover that the oil loss was due to a broken 'Cam Shaft Spindle Nut', the one that goes through the timing gears steady plate. This 'cracked nut' allowed the Cam Shaft Spindle to move itself inwards away from the timing case (enough for the Oil Quill to disengage from the Oil Feed Hole). As the oil quill was no longer firmly seated into the Timing Cover oil feed hole this caused a loss in vital oil pressure & flow. In other words, the oil was allowed to flow freely without restriction, causing said loss in pressure & delivery to the engine's vitals. Unfortunately, I'm not sure how many miles I did before this situation was discovered. Obviously, oil was still reaching the big-end and mains but at a much reduced amount & pressure. Not enough oil starvation to seize the engine, but enough to potentially cause damage to the bearings. I immediately replaced the damaged *Nut* and I rebuilt the timing-side. I put the MAC back on the road again (but at the time I did not fully appreciate the long-term damage this may have already caused). I carried-on using the MAC.

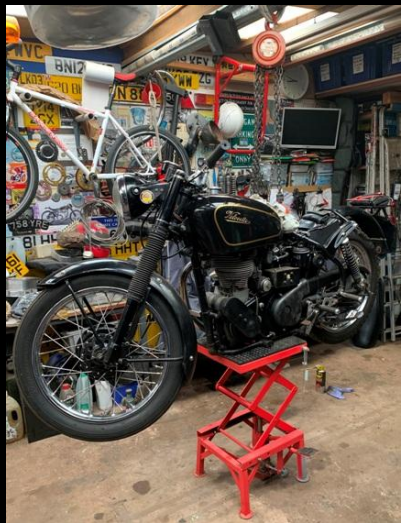
I'm pretty sure the earlier problem (lack of oil pressure) had contributed my latest engine 'rumble'. But before taking the engine out of the frame I decided to check the crank 'end-float' (with DTI) which should have no pre-load / side-to-side movement (i.e. set at Zero).

I was able to move the crankshaft backwards and forwards by twelve and a half thou" (0.0125").

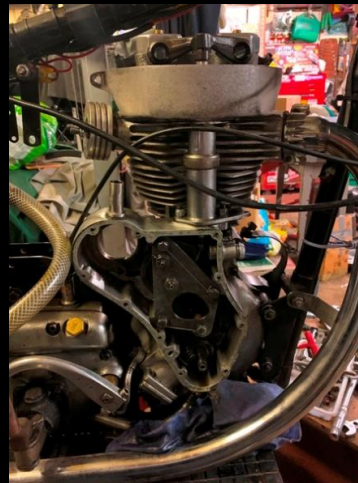
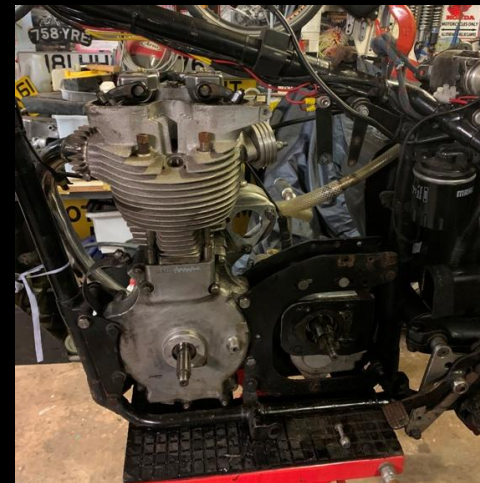
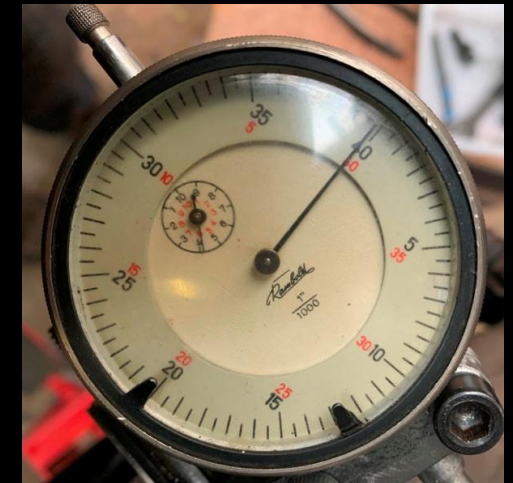
Upon dismantling the engine I discovered that both of the parallel roller main bearings had signs of wear, so I'm guessing that the Big End Bearings & B/E Crank Pin may also show signs of damage too. To add to the problems the timing-side main bearing had 'spun' on the main-shaft so that requires attention too. **On Thursday 18th May 2023** I took my MAC 'Crank' into Alpha Bearings of Netherton, Dudley. Chris (who runs Alpha B) said he could sort-out the Crank and fit a new timing side main shaft "No problem at all, but it wasn't going to be a cheap or a quick repair". But he couldn't give me a definite quote for this work until the whole lot had been stripped and inspected. At this stage I did not know that Alpha B was moving premises (which would present even further delays . . . but that is a whole other story).

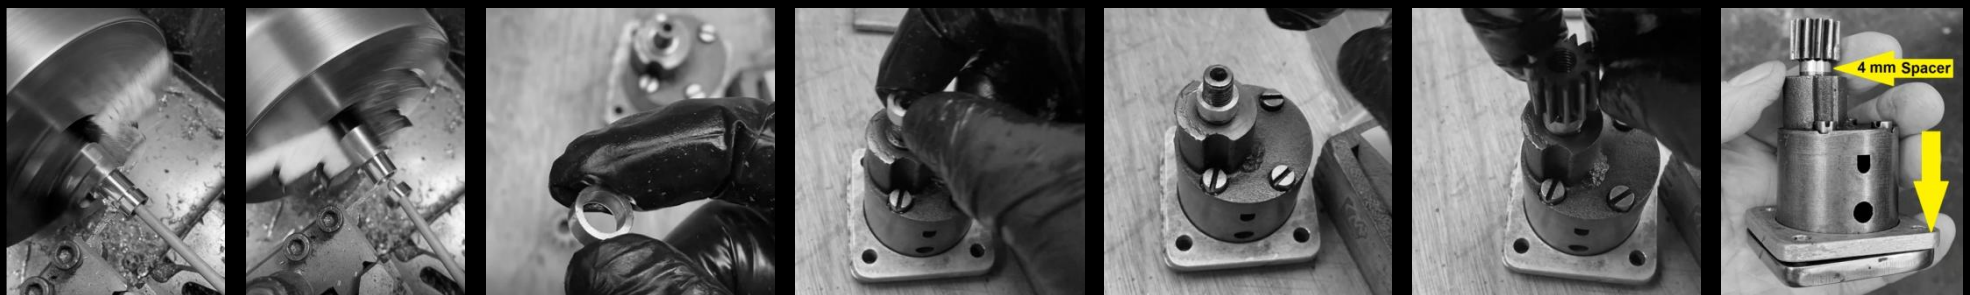
First two photos above show the new 4mm spacer for the Oil Pump. I've already done this oil pump modification to the Venom oil pump. The reason for this 'mod' is to raise the pump driven gear (upwards) to allow more contact area with the *driving* worm-gear. The last photo (above far right) shows the newly-made 4mm spacer in place (top yellow arrow) and the original 'riser-base-plate' I made ages ago, because the MAC oil pump is shorter than the Venom oil pump. This plate allows the oil-ways to line-up with the holes in the crankcase pump body.

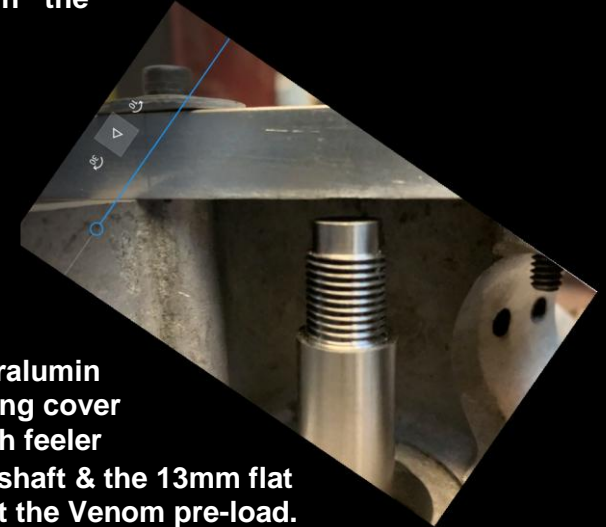
The photo on the right shows 'My Method' for checking the crankcase to crankshaft end float (which on the MAC 350cc engine should be set at 'Zero' end float). Look at the 'Gap'.

I made an 'end plate' out of 13mm duralumin that is drilled to fit onto the outer timing cover 'face'. The gap is then measured with feeler gauges between the end of the crankshaft & the 13mm flat plate. I also used this method to sort the Venom pre-load. (Hence, the writing on the Plate: Venom Crank Tool).

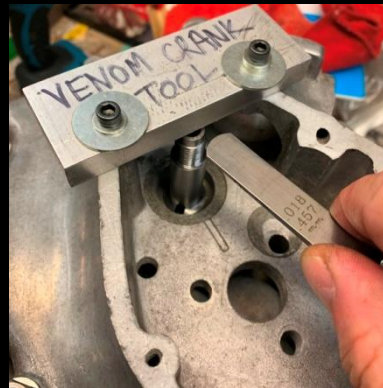
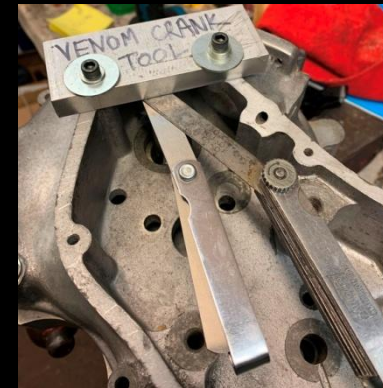
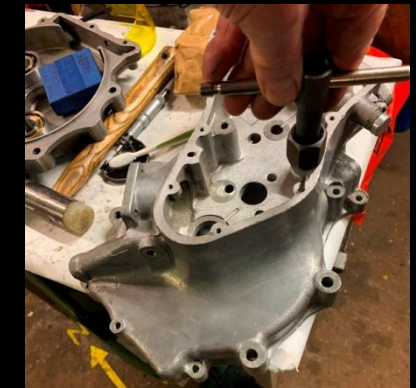
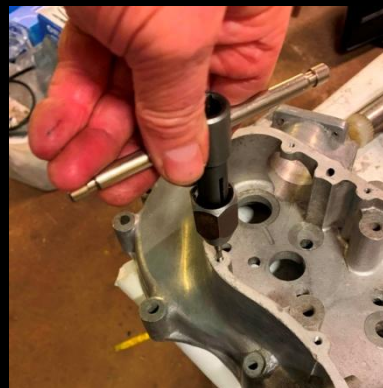
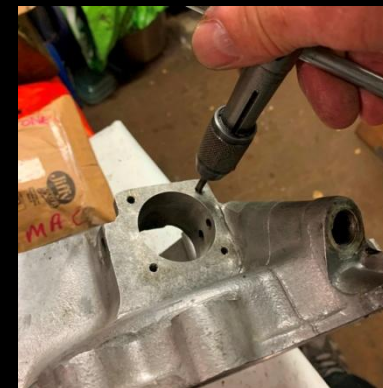
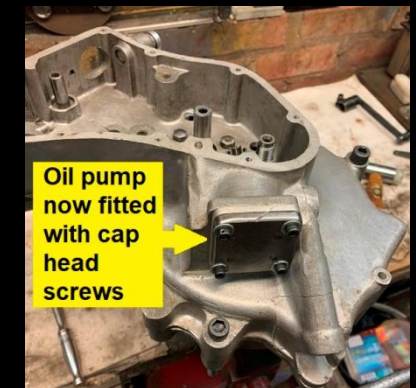
First 2 photos (right centre) show the gap being checked with feeler gauges to find the starting position (i.e. the gap between the end of the crankshaft and the 13mm alloy plate). The trick is then to lift the crankcase up & down to find the *remaining* actual 'gap' (again using feeler gauges) which amounts to the size of the shims needed.

The remaining photos on this page show me 'chasing' the threads in the crankcase ensuring all of the threads are clean & ready for the rest of the re-build. Last photo shows the much better *Venom* oil pump fitted with spacer.

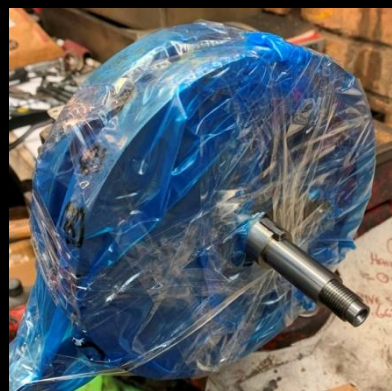
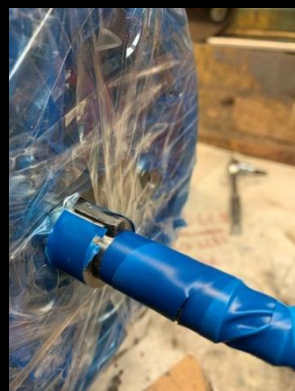
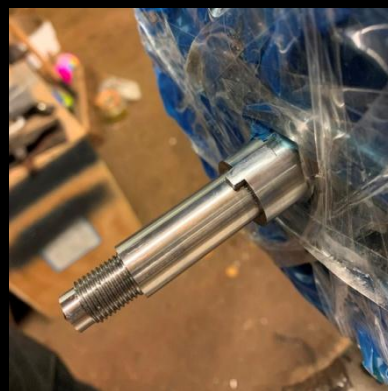
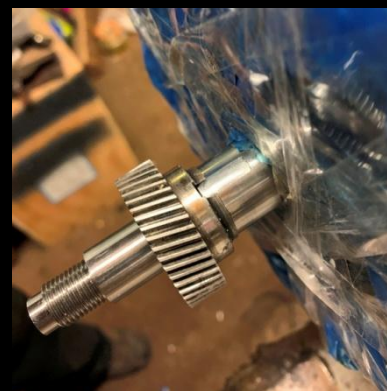
(The four photos above) show the Flywheel assembly all wrapped-up nicely in a polythene bag (sellotaped firmly in place) to ensure no dust, dirt or metal swarf / filings get anywhere near my new Big End Bearings. I also wrapped blue electrical tape around the end of the shaft to minimise the chance of me damaging the new crankshaft whilst 'Filing-down' the new "Woodruff Key".

The last two photos (above right) show the finished / reshaped Woodruff Key and the Timing Pinion 'slotted-in-place' ready for the next stage of the rebuild. All I have to do now is 'Turn' a new steel 'Shim' to go behind the pinion.

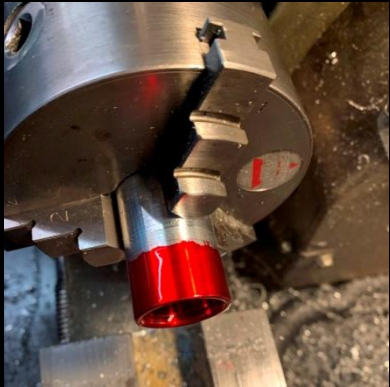
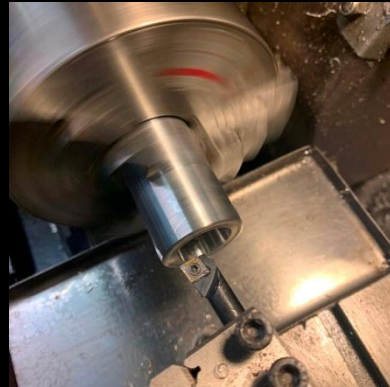
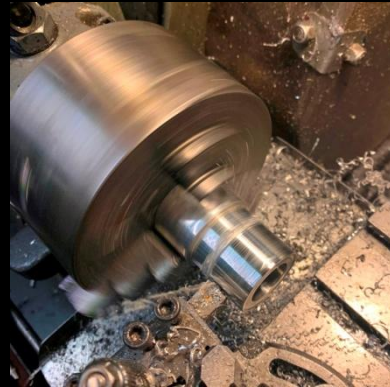
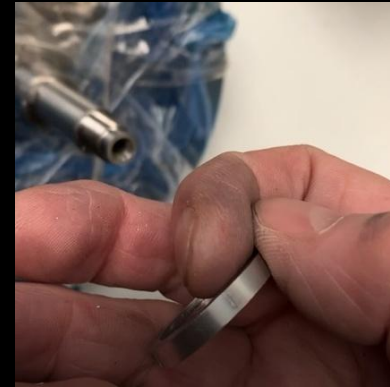
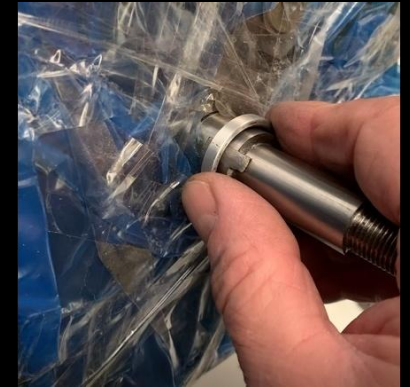
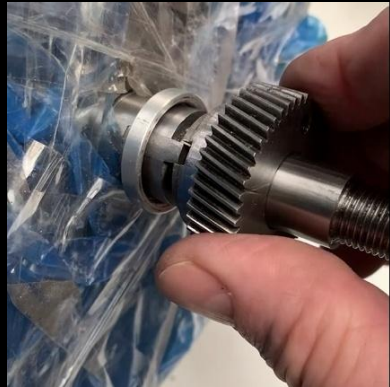
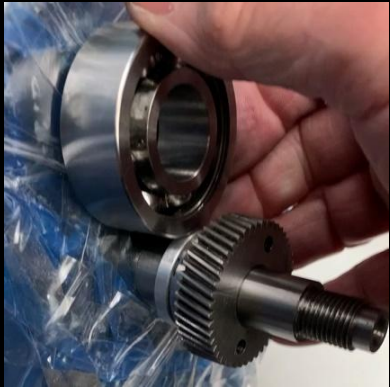
2023 Christmas Eve (photos below) A bit of 'Lathe therapy' in between Mince Pies & Eggnog; New Spacer made to fit between the crankshaft & timing pinion.

My solution; is to make a steel shim, that will fit between these two components thereby removing this 'Gap' once & for all.

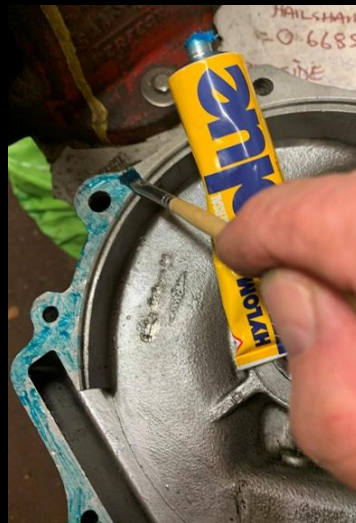
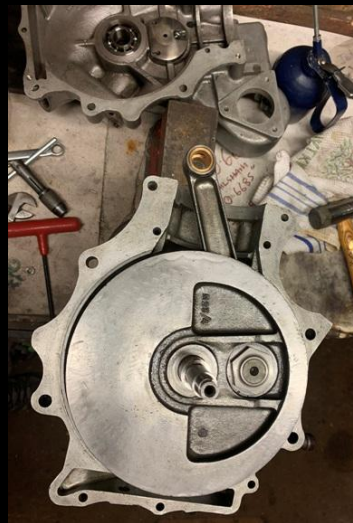
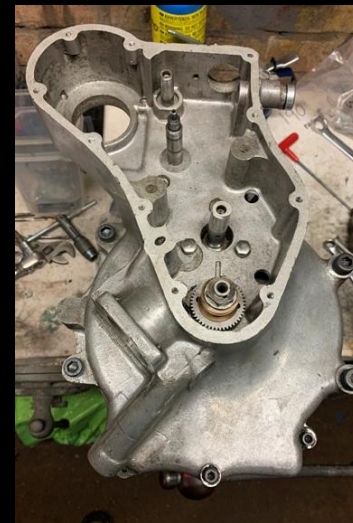
Monday 8th January 2024: The first three photos (above left) show the 'Crankcase Stud(s)' being fitted. Copper-Slip grease applied to these studs so they are less likely to 'seize-up' and to make it easier to remove on future engine strip-downs.

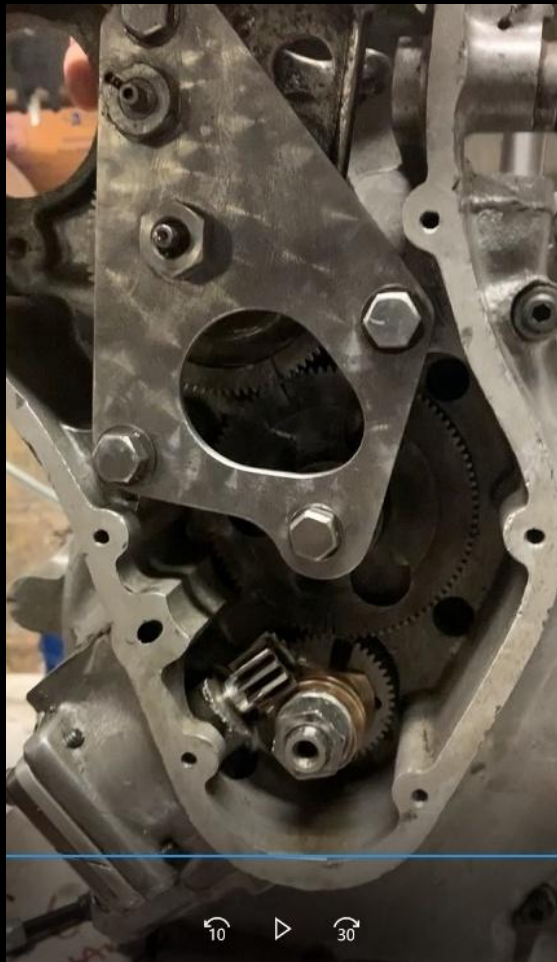
The photo above shows the Oil Pump cap-headed screws 'Lock Wired' in place. This is a bit of an over-kill, as these rarely come undone in service, but . . . I do love using my lock-wire pliers ☺

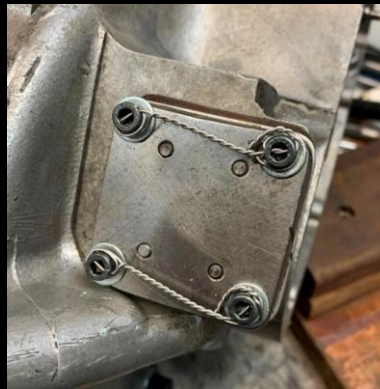
The photo on the immediate left shows my modified Timing Gear Steady Plate. I reshaped the (original) ROUND HOLE, to more of a Pear-shape, which allows the Intermediate Gear to be adjusted without the need to remove 'this' steady plate. ALL three intermediate gear fixing 'bolts' can be tightened without the need to remove this steady plate. I think it a reasonable solution (not to everyone's liking though!).

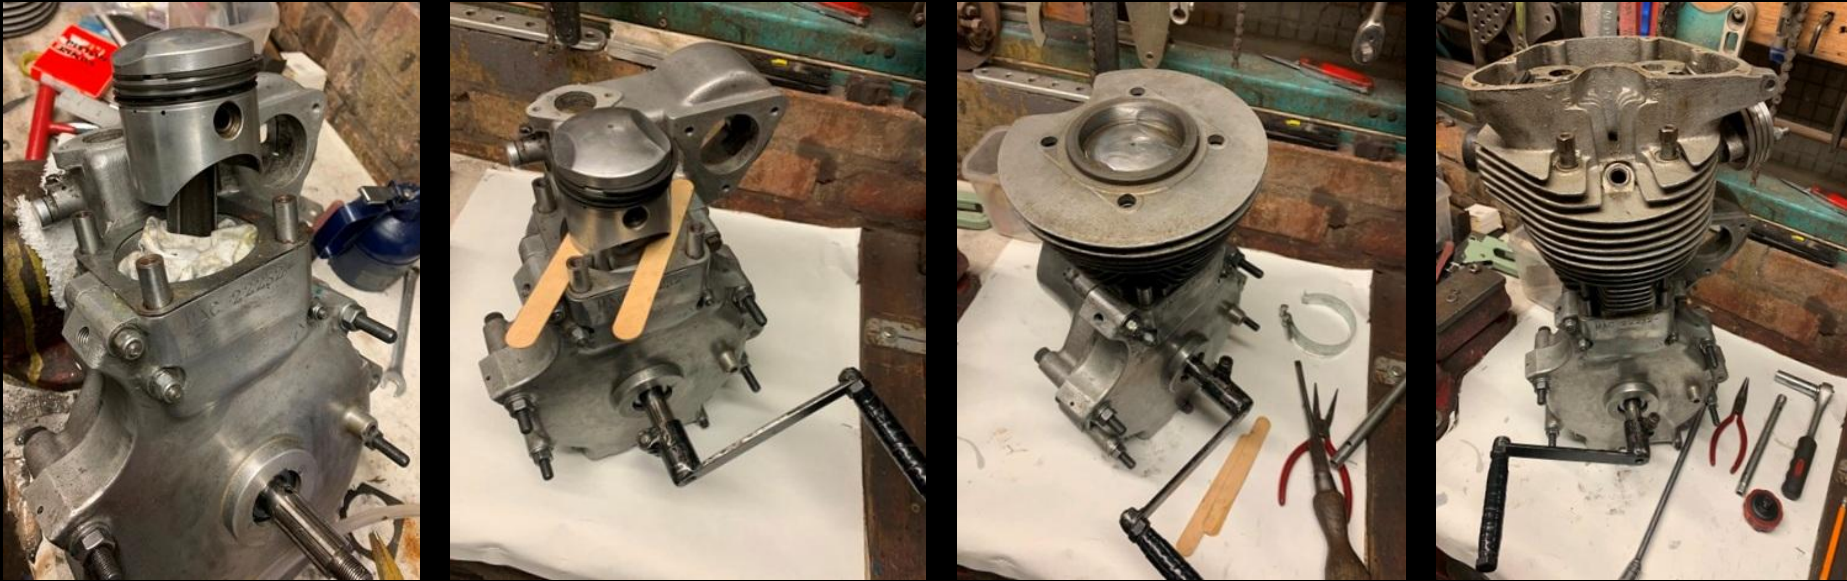
New piston rings fitted, new gudgeon pin 'Circlips' fitted to the piston and the barrel & cylinder head refitted ready to set the Valve Timing. Unfortunately, the valve timing marks on the 'timing gears' no longer line-up correctly with the correct position of the crankshaft / mainshaft to camshaft configuration due to the newly fitted 'Main Shaft' being fitted in a slightly different location in the Flywheel to the original one.

In other words . . . none of the timing 'marks' on the gears line-up as they once did. Fortunately for me, I am able to set the valve timing without these 'Marks' using a combination of crank fitted timing disk (a degree disk) and dial test indicator fitted to the head to check when each valve is actuated by the camshaft. As stated earlier, it is highly recommended to set one valve at-a-time whilst the other valve is disengaged (or rather no pushrod fitted) and vice versa.

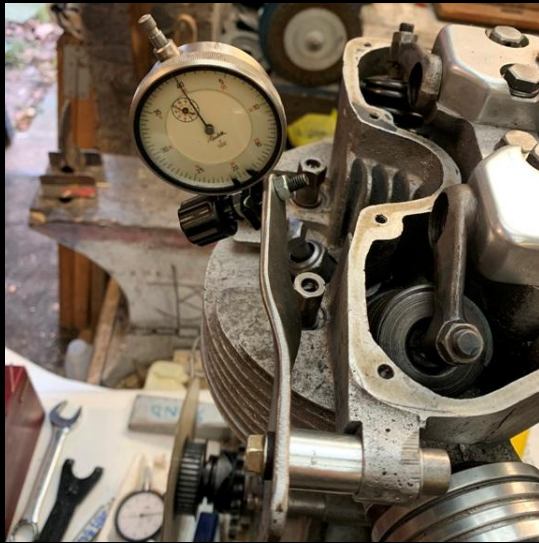
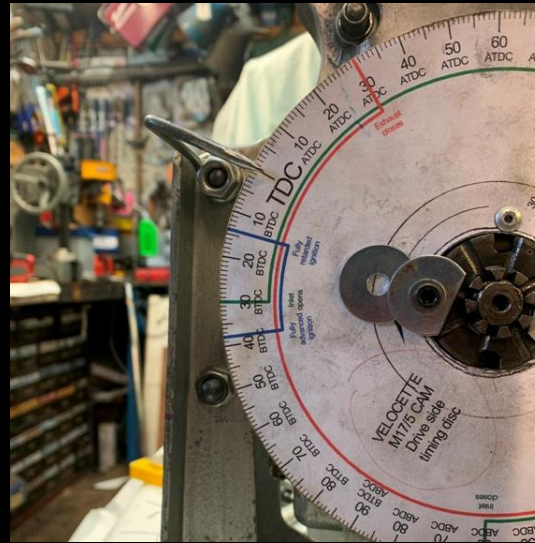
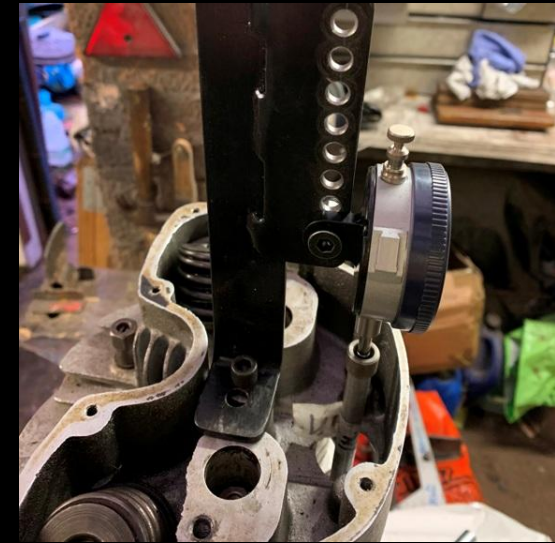
(First photo below Left) I've adapted an old spark plug – drilled-out to accept a short plunger that rests on the top of the piston. The dial guage (dti No.1) rests on the top of the plunger (via the home-made dti bracket) and as the crankshaft is carefully rotated the piston rises and falls steadily to identify exactly where Top Dead Centre is. The middle photo (below) shows the Timing Disk set at 'Zero' to indicate TDC. The 3rd photo (far right below) shows my second home-made bracket with a dial gauge fitted that rests on top of the pushrod to check the lift & fall of the cam.

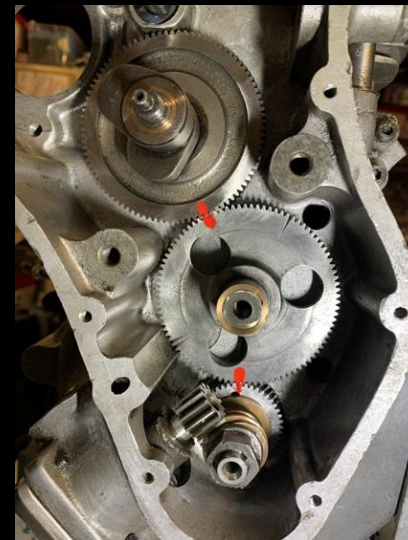
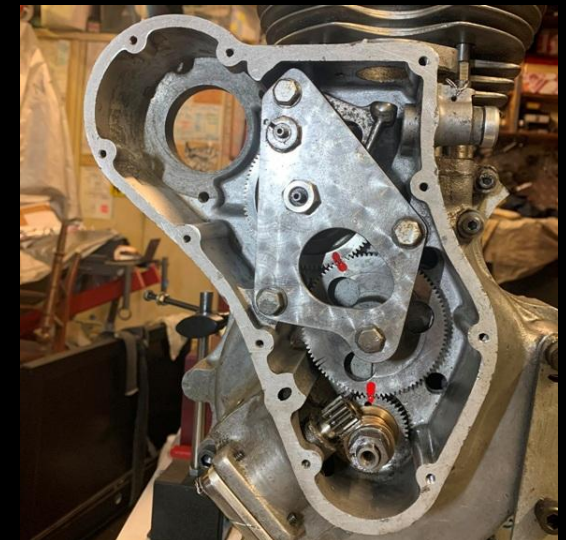
The two end photos (above right) show the new valve timing marks (painted red) set at TDC.

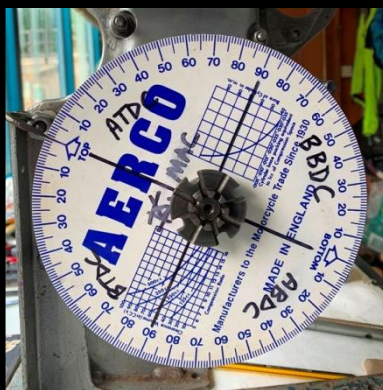
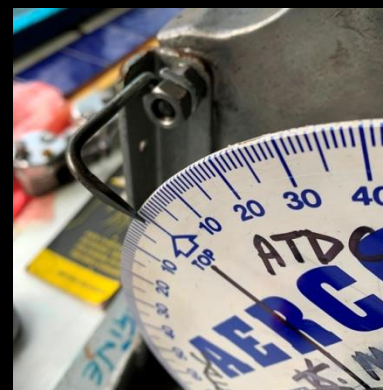
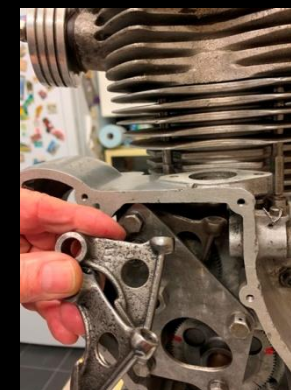
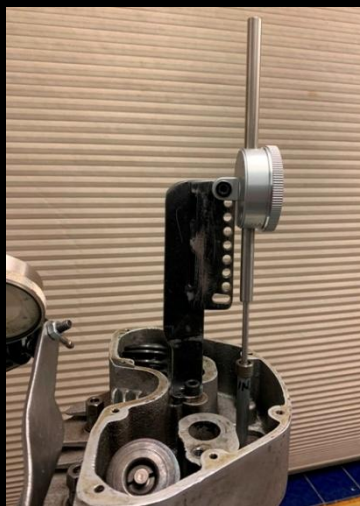
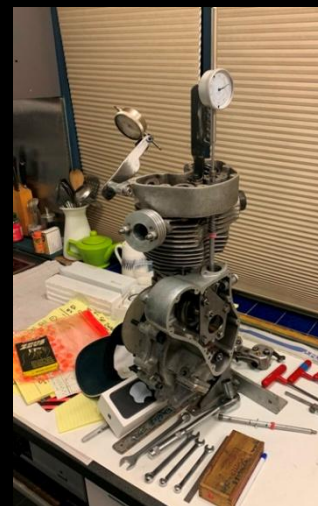
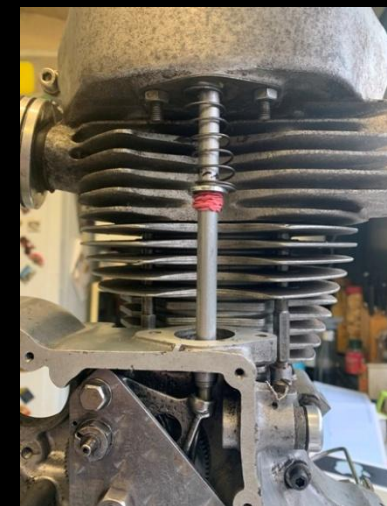
The chart below (next page) shows the travel, duration and lift (measured in ‘good old fashioned’ imperial ‘thousandths of an inch’) of the M17/8 cams (with long followers fitted (MAS118)).

The finished ‘Graph’ (below) was somehow supposed to help me understand this very complex subject which is akin to understanding the dark arts and alchemy, or understanding the intricacies and mysteries of the female species. Or even . . . understanding why people believe the internal combustion engine is the true cause of global warming ? With all of this in mind: I’ve tried at least five variations and combinations of timing positions and ‘Mapped-them’ (using two different M17/8 cams & two different pairs of long cam followers) all of which gave slightly different readings. So . . . even though I’m still confused, I have nevertheless explored several options leading to the following compromise.

Of all of the 'timings' that I did, I eventually chose the one listed below. On previous 'graphs' I managed to get the Inlet Closing and the Exhaust Opening very close (within a couple of degrees) BUT, the 'Down-side' was the Inlet Opening was way too 'Advanced'. I read (in several of the VOC magazine articles) that this advanced Inlet Valve Timing would be easier for starting, but would be detrimental to the engine performance as revs increased and was likely to cause 'Pinking' under load (similar to having the Ignition Timing too advanced). So, I made the decision to move the timing gears by one tooth, giving a difference of 8 degrees, which in turn retarded the opening of the inlet Valve. This is the 'Compromise' that I've gone for. **Only time will tell . . . if I have made the right decision !**

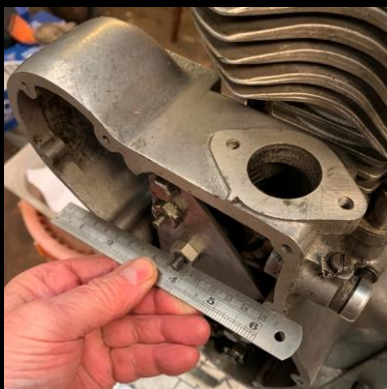
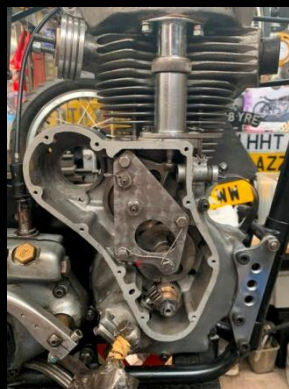
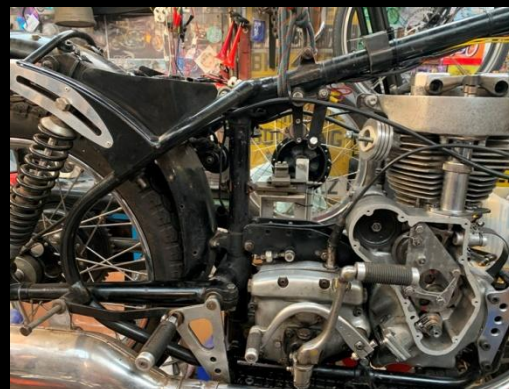
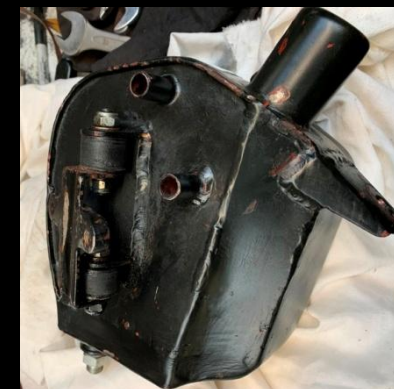
The nut that fits onto the camshaft (1st photo below left) needed turning-down on the Lathe to get it 'Flush' with the timing case 'Base' to enable the timing cover to fit properly (where the nut & oil quill fits into the oil hole in the timing cover) this was checked with a straight edge (i.e. a steel Rule placed across the 'faces'). The 3rd photo below shows the frame with oil tank removed. And the end photo; shows my rubber mounted oil tank.

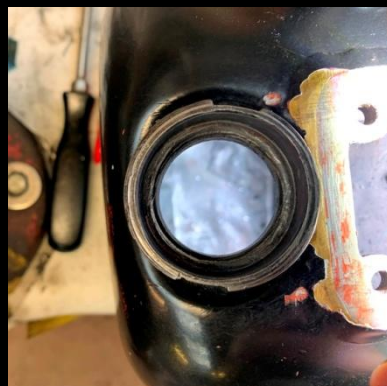
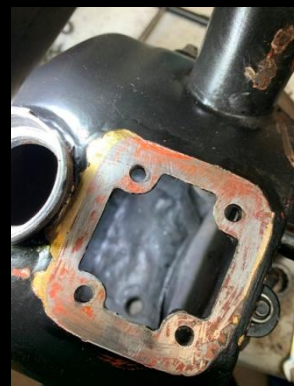
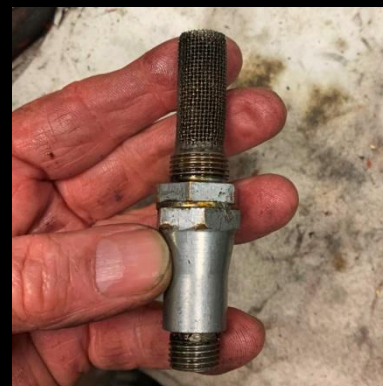
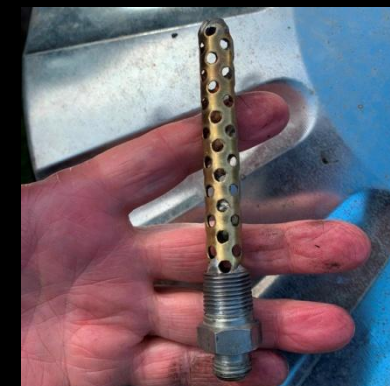
The first three photos (above left) shows just how clean my tank is now, also the 3rd photo shows the square inspection panel that I fitted a couple of years ago (which came in very handy during the oil tank cleaning duties). The 4th photo (above right) shows the old ball valve assembly with gauze filter and the final photo (far right) shows my new in-tank / in-line oil filter (made of brass plate, soldered in-place and cross-drilled).

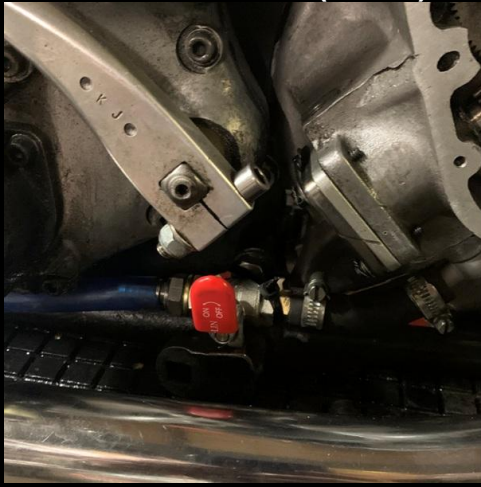
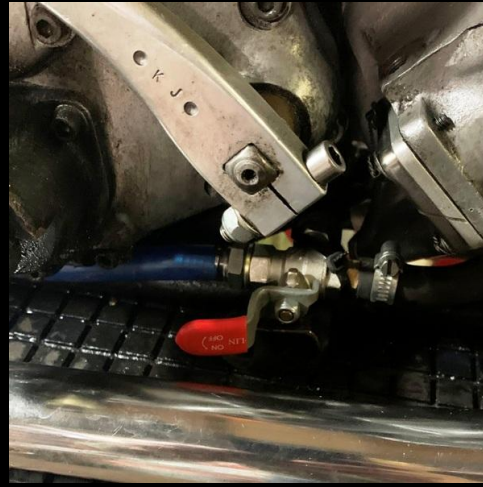
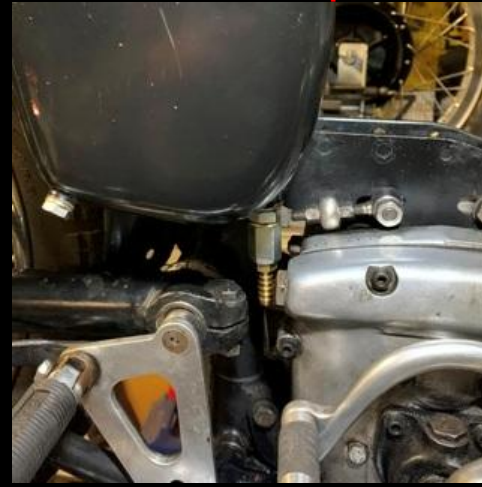
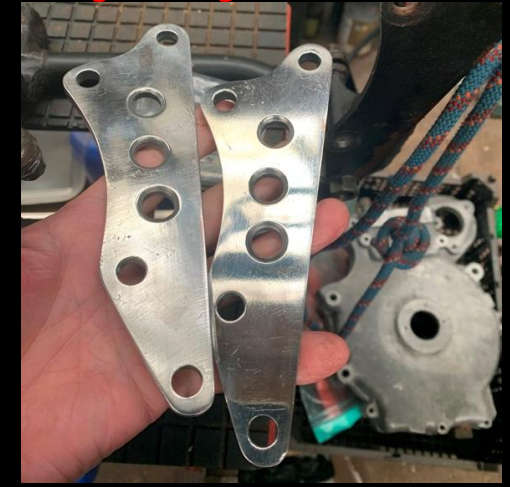
Shut-Off Valve fitted (below). All I need to do NOW is to REMEMBER to turn on the Oil Tap BEFORE starting the Engine !

I carried-out several 'Gravity Feed Oil Flow Tests' on my new engine oil delivery system (aka. new shut-off engine oil valve & brass filter) measuring oil-flow using a stop-watch to see how long it takes to drain the oil tank into a One Litre Jug and then 'Record' the RESULTS.

The initial 'Flow' was much slower than I expected so I tried several modifications to try and optimise said flow. On a PLUS side; my oil will be circulating through a Canister Oil Filter anyway which "should" (in theory at least) filter most (if not all) contaminants & metallic particles, etc.

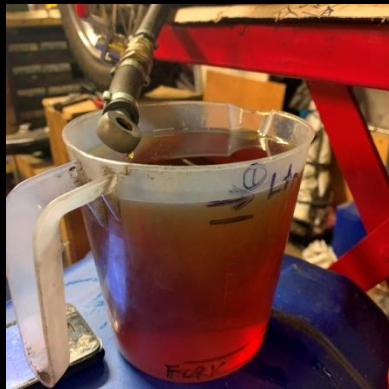
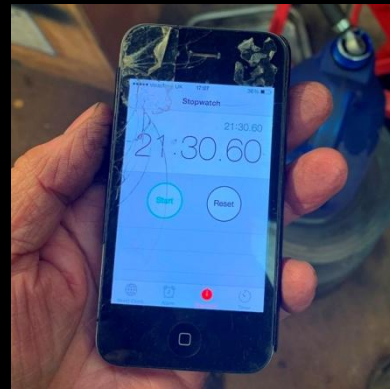
31/3/2024 MAC oil flow Test.
↳ ONE LITRE OF ENGINE OIL PASSING THROUGH THE FEED PIPE & OPEN CHECK VALVE

- 1 litre took = 21 min 30 seconds to drain from the oil tank to the litre catch - pouring Jug.
- 1,000 millilitres ÷ 21 min 30 sec.
- 1,000 ÷ 21.50 = 46.94 millilitres per minute.
- 47 millilitres (nominally) passing through the pipe each minute.

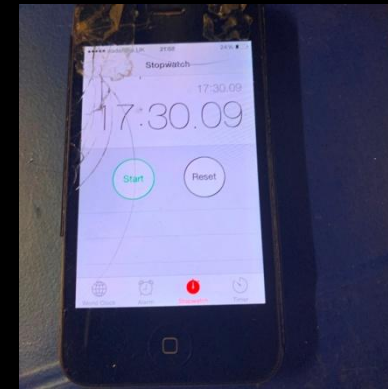
31/3/2024 MAC OIL FLOW TEST #2

- ONE LITRE OF ENGINE OIL PASSING THROUGH THE FEED PIPE & OPEN CHECK VALVE.
- BUT... THIS TIME I'VE CUT OFF THE TOP OF THE DEAS-FILTER (JUST LEAVING OVER ONE INCH PROTRUDING INTO THE TANK)
- ONE LITRE TOOK = 17.30 min to drain off FROM TANK TO CATCH JUG (AS BEFORE).
- 1,000 millilitres ÷ 17 min 30 sec.
- 1,000 ÷ 17.50 = 57.80 millilitres per minute.

57.8 millilitres per minute.

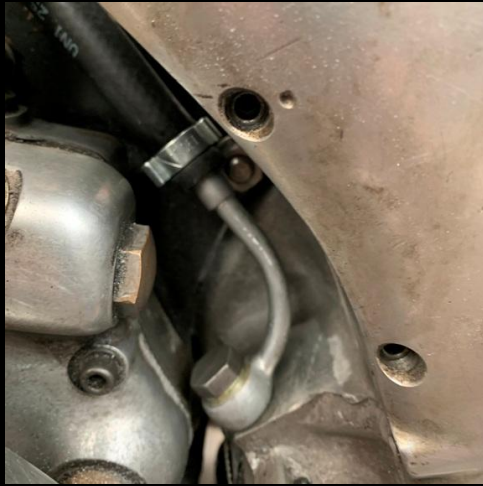
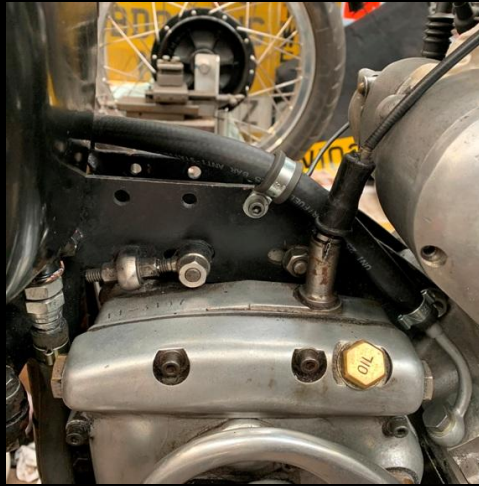
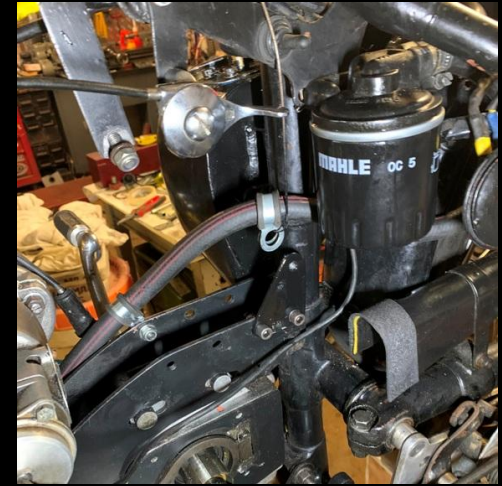
The new return oil pipe 'Route' (above) and the new Banjo Fitting that I had to 'make' (as the old one routed the pipe downwards and at a funny-angle. Also with the new oil shut-off tap is fitted, there was now little room for the return pipe to fit in the original place. So . . . I decided to 're-route' my new return pipe and fit it in this new position as this is the least convoluted route for the return oil pipe to take. Yes I Know, all you traditionalist velo fellos will frown at this method, but it tale one third less pipe and is definitely the shortest and most direct route.

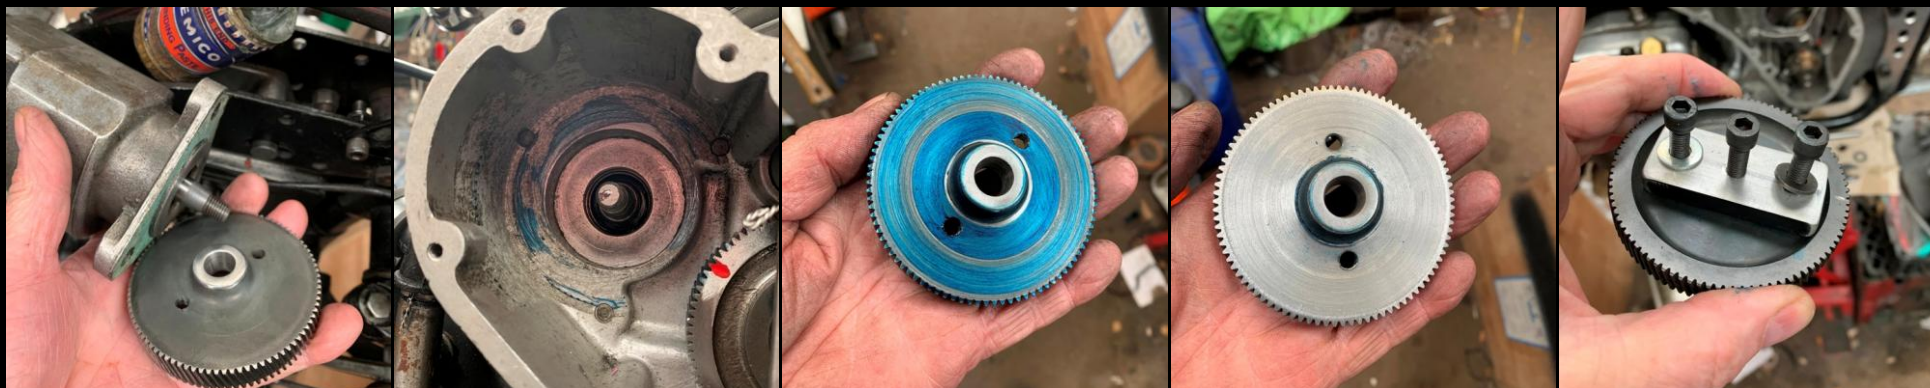
(1st photo below) When I tried to fit the magneto and drive gear (when setting-up the ignition timing) I could not get the drive gear to tighten-up on the magneto tapered shaft. My initial thought was that the 'Taper' needed to be 'Lapped-in' (using fine engine grinding paste & paraffin, similar to when lapping valves in). However, after completing the lapping procedure, the gear still would not tighten-up? Photos 2 & 3 show the casing and the gear with engineers blue – showing that the gear & case was in-contact – and therefore, the gear wasn't being allowed to locate properly onto the magneto 'Taper'. Photo 4 (below) shows the gear after removing metal from the back of the gear (using my trusty Myford Lathe), allowing sufficient clearance for the timing gear to fit perfectly onto the magneto shaft.

The end photograph (top right) shows yet another home-made tool, this time to release the timing gear from the now very effective 'Taper' in order for me to set the ignition timing to the required 38 degrees before top dead centre setting (as per the Velo Red Book). My home-made gear extractor tool came in really handy as I had to put on and take off again this gear several times before finally getting the ignition timing 'Spot-on'.

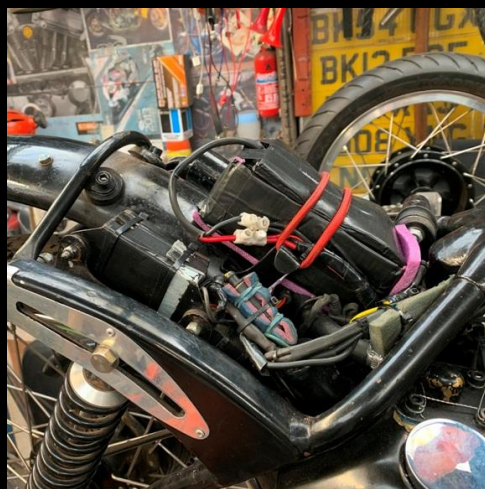
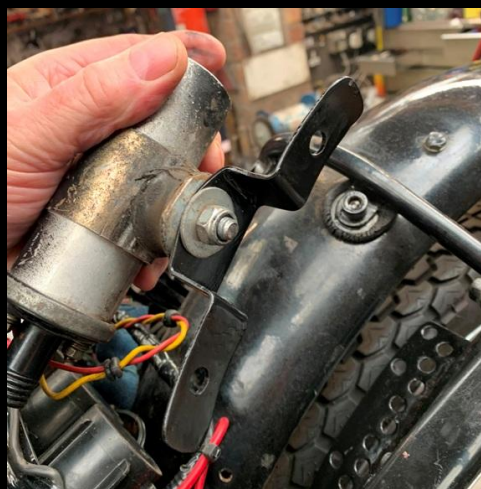
Photo above (left) shows my battery (now rubber mounted) under the seat. Photo 2: The ignition coil bracket is also rubber mounted now.
