Velocette MAC 350cc

Rebuild Project Part One, Year One

From October 2017

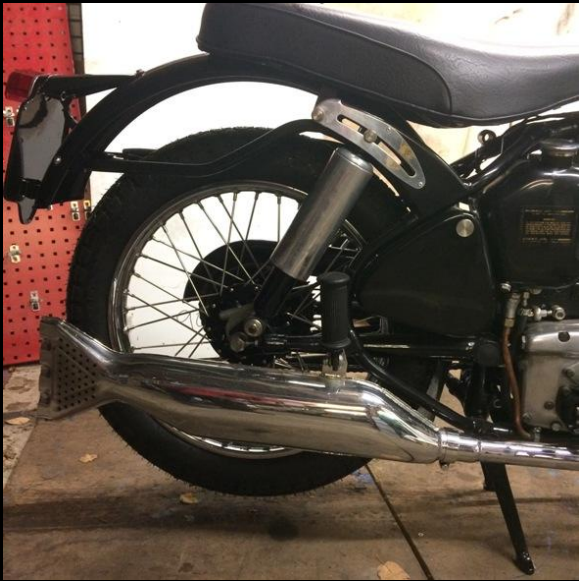
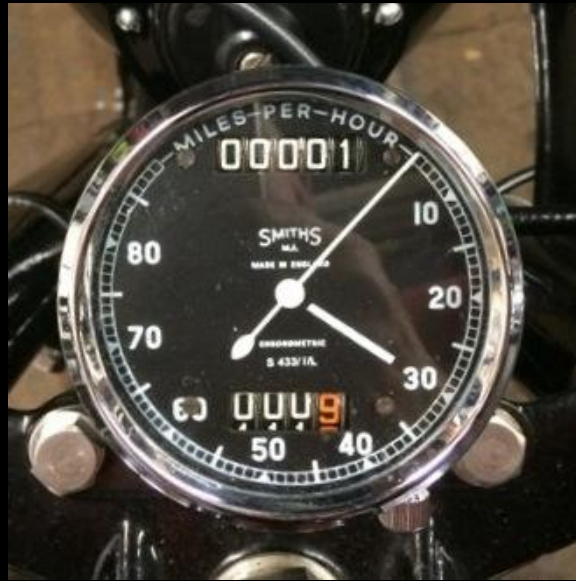
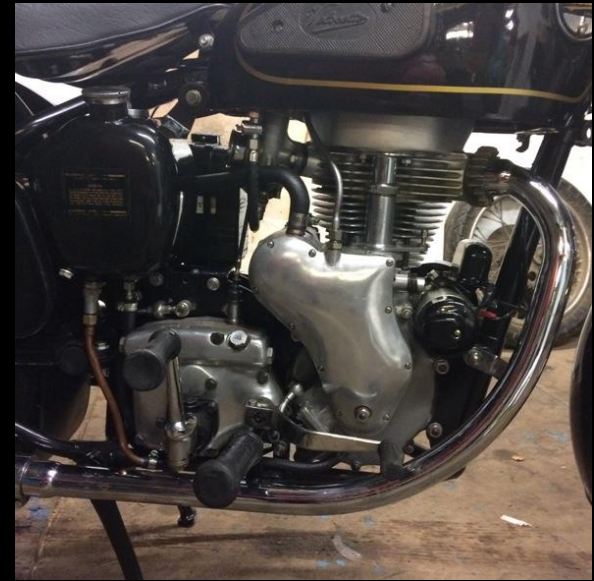
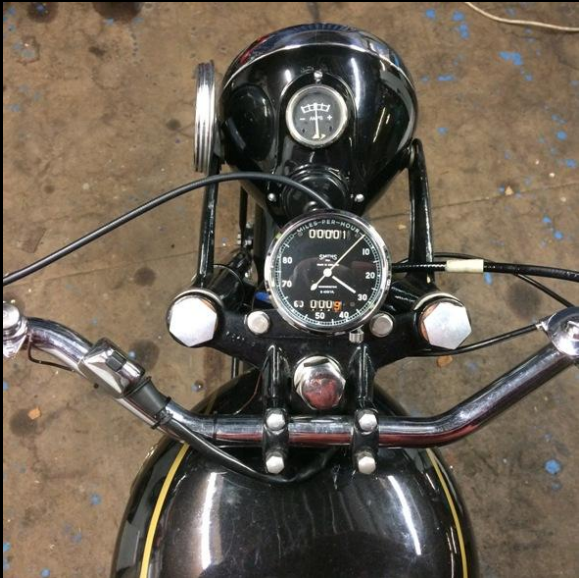
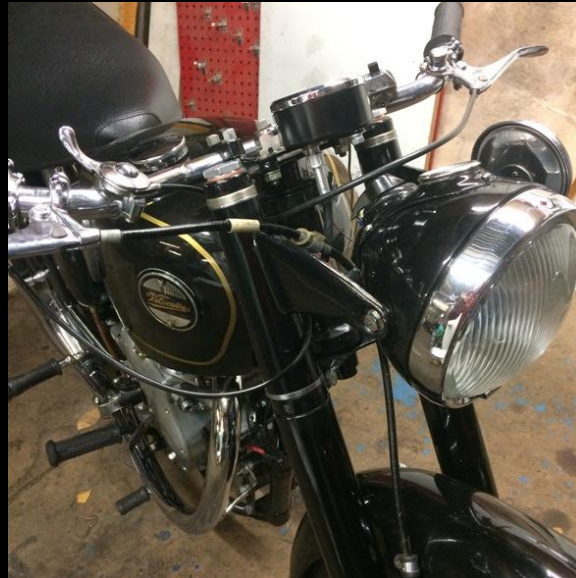
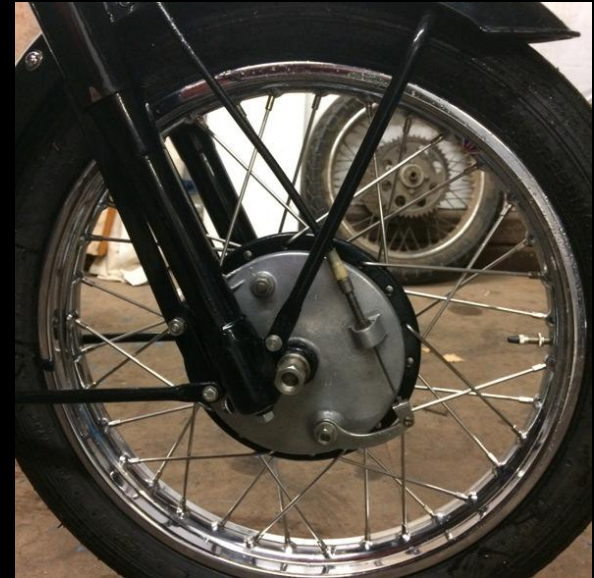
Start Mileage / Delivery Mileage – ‘One Mile’ on the Clock (one point nine miles to be exact!)

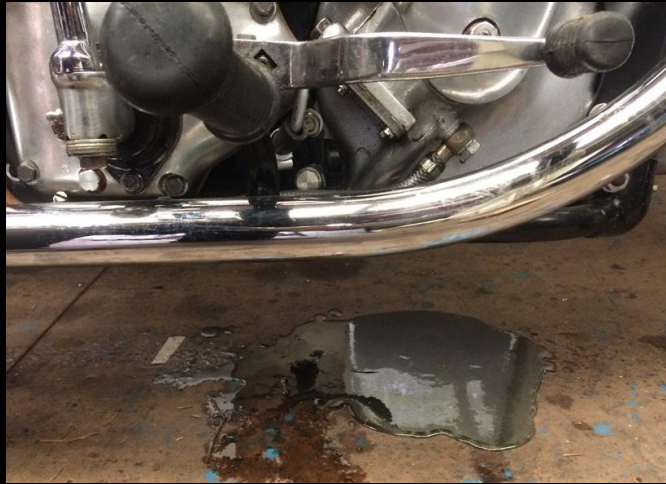
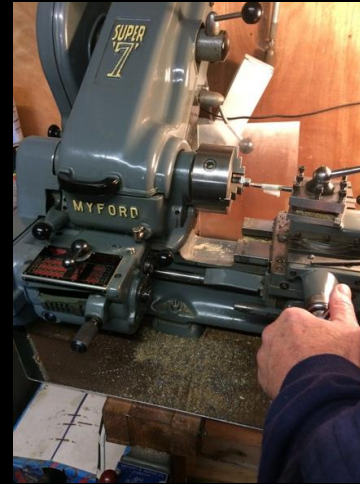
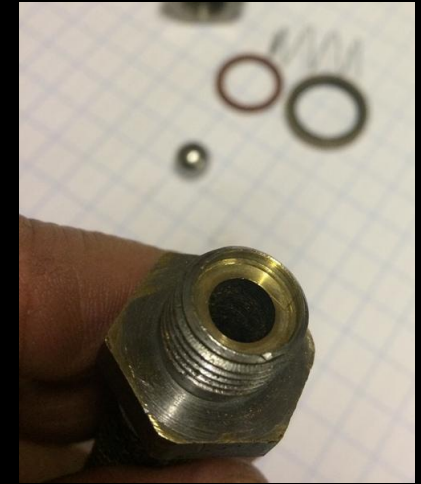
After several very short test rides (around the Block & Back): My first proper Ride-Out was to the National Motorcycle Museum 'Open Day' (4th November 2017). Well! That was the Plan. It started okay (the first five or six 'Kicks'). But; this journey was cut short due to Oil leaking quite dramatically from the Engine (I discovered later that this was caused by a faulty Oil Feed Check-Valve allowing Oil to pass from the Oil tank directly into the Crankcase). The excess engine oil that drained into the engine (*commonly known as 'Sumping'*) was then forced out of the Crankshaft Main Bearing into the Primary Chaincase (when the engine was running) and the result was = Oil 'P*ssed' through every orifice and dodgy seal that it could find, and it caused quite an 'Oil Slick'. This forced me to return back home where I changed 'Bike' and carried on to NMM in Coventry on my ultra-reliable Honda CB1000R instead).

This problem was later cured by my Velo Mentor Rick, who kindly 'refaced' the Oil Check Valve Face on his Lathe – reducing the 30 thousandth-of-an-inch plus seating (that was) down to a Gnats whisker. The Ball Bearing is now 'Seated' properly in the One Way Ball Valve Housing. An additional problem was the very tiny spring that pushes the Ball Bearing onto it's Seat was broken (it should protrude a quarter-of-an-inch above the Valve body), so we had to make a temporary fix to this tiny spring until I could order a new Spring. Fortunately, this *temporary fix* is coping well at the moment keeping the Ball Valve onto its 'Seat' and keeping the engine oil in the Tank (when stationary) and delivering the oil to the engine when it should do.

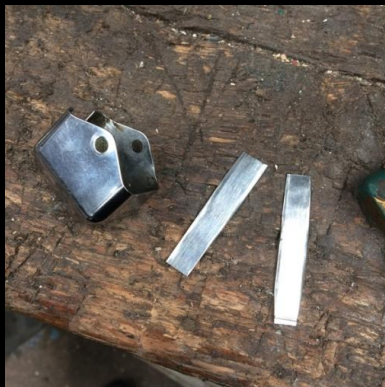
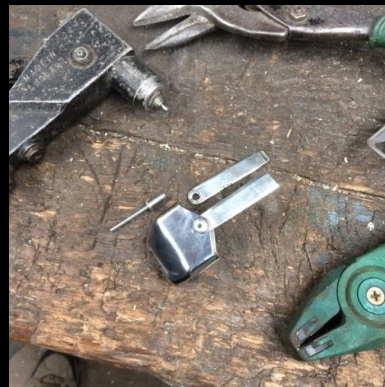
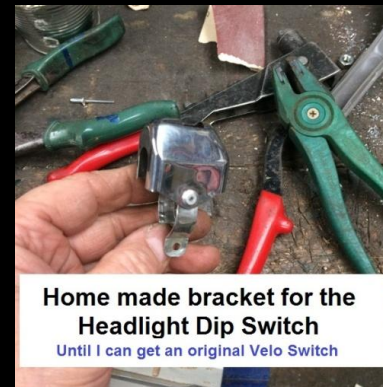
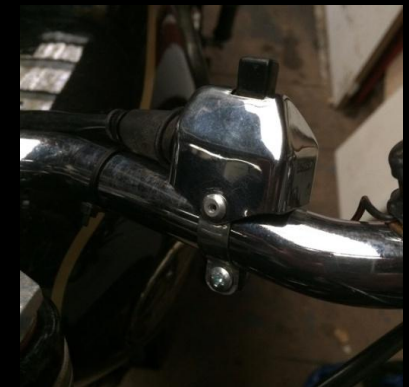
I made another temporary fix to the Headlight Dipper Switch that was fitted when I bought the bike (certainly NOT original Velocette). This 'Switch' was held on by a Cable-Tie (certainly NOT factory standard). So until I can source a proper Velocette one, my home-made *Fixing Straps* will have to do!

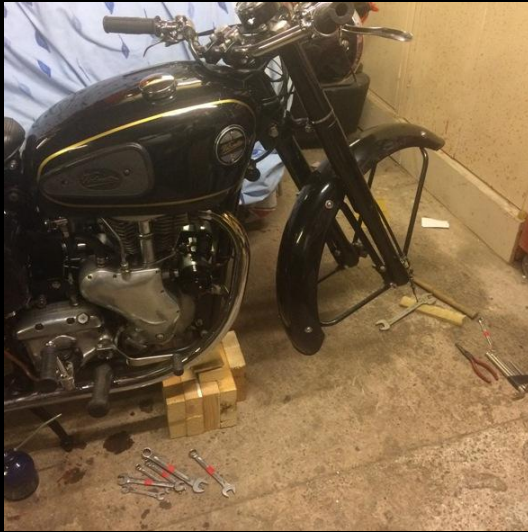
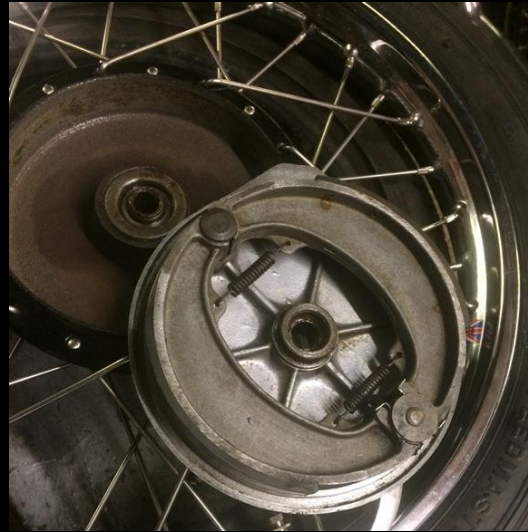
The next Job on my 'List' was to try and sort out the Non-Existent Front Brake. I WAS informed that the Front Brake DID NOT WORK (so no surprise there).

1) Wheel Out & Inspect Brakes. 2) OMG! Sit down, take an Aspirin & have a Cuppa, because the Brake Drum needs to be 'Skimmed' due to being both rusty & 'Oval'. 3) Fabricate New 'Over-Size' Shoe-Slippers & Fulcrum Spacers (as a temporary fix to get shoes to work). 4) Re-Fit Wheel & adjust Brake Cable.

Front Brake only slightly improved at this stage, but only marginally.

Sixty mph to Standstill = two days, three hours & 4 minutes approx. (only joking, because it does 'Stop' eventually, but only when an inordinate amount of pressure is applied to the front brake lever). Fortunately for me (and the general Public at large) the Rear Brake works really well.

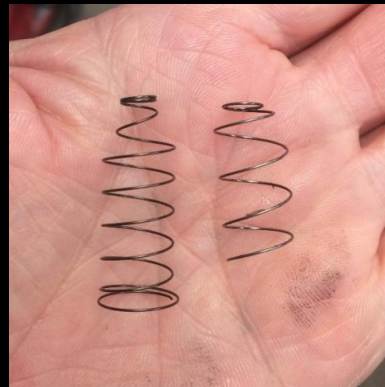
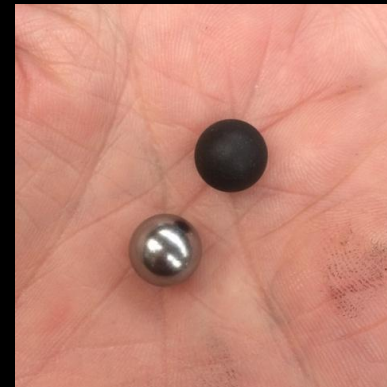
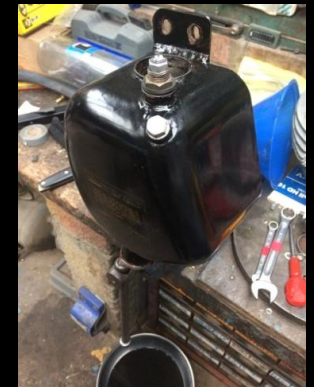
You can see the difference between the new longer spring (below) and the damaged spring next to it (which contributed to the 'Wet-Sumping' problem, together with the faulty 'Valve Seat'), now rectified.

I picked-up some new spare parts from Veloce Spares Limited, in Huncote, Leicester (**11th November 2017**). I managed to get a new Miller Ammeter (just in case!!!) and a new Miller Horn / Dip-Switch. Plus a bunch of Dowty washers, Timing Cover Gasket & new Cover Screws, a spare Clutch Cable (and Clutch Cable Rubber Boot (Gearbox end) and some other bits too. But . . . the most important items of the day was the new Ball Valve Spring & Ball Bearing for the Oil Tank Main Feed-line 'Oil Tank Check-Valve'.

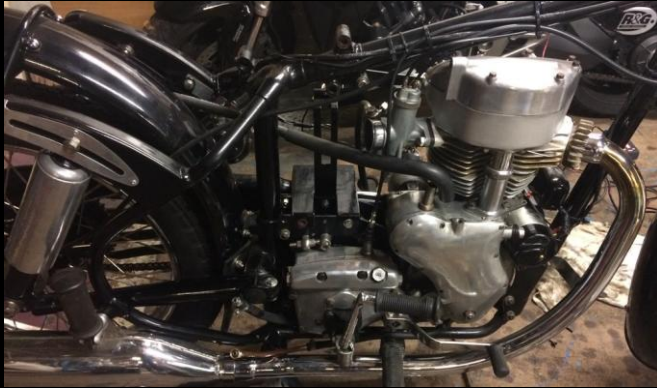
I drilled-out & re-threaded the engine/gearbox mounting plates (the two end photos on right), instead of using the two 5/16" nuts & bolts that were previously fitted.

As can be seen from the above photos (middle photo & far right photo) after 'Threading' the engine/gearbox plate I added three rubber pads between the Oil Tank mounting bracket & the engine plate and once tightened, I *lock-wired* said bolts into place (I've got a thing about nuts & bolts coming loose and falling off – that's why I try and lock-wire as many nuts'n'bolts as possible these days). Yes I know . . . it's called Paranoia (synonyms: fear, suspicion, mistrust, obsession and terror). So if I haven't lock-wired it, it's probably got a self-locking nut securing it, or held together with thread-lock (i.e. Loctite, etc).

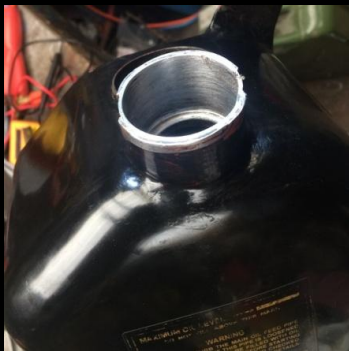
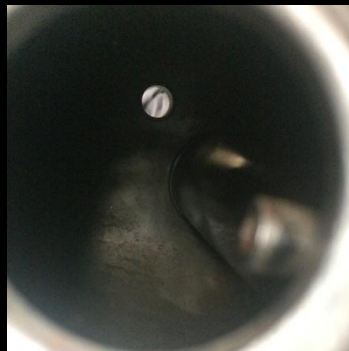
3) I found Grey Sludge and Muck in the bottom of the Oil Tank, which surprised me as the engine had been reconditioned and I would have thought that the oil tank would have also been cleaned-out, ready for the new oil?

The first two photos (below left) show how clean the Oil Tank is now! And, the third photo shows the Filter Chamber being pre-filled & sealed (Tank off the bike).

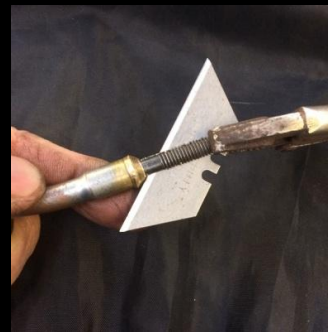
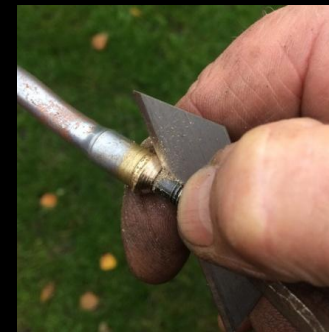
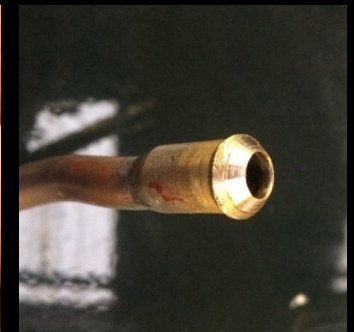
2) The Oil Tank empties its contents into the engine even when the bike is stationary & engine not running via the faulty 'Oil Tank Check-Valve'. And when the engine IS 'Running' . . . it appears oil leaks from the Rocker Box area and from the Rocker Oil Feed Union Pipe (from both ends i.e. top & bottom).

I made a simple cutting tool to *re-face* the bottom Oil Union End of the Rocker Oil Feed Pipe. By using a Stanley knife-blade attached to a 'slotted' bar (an old bolt with a slot hack-sawed into it) with the same diameter as the internal diameter of the oil feed pipe (which acts as a 'guide' – keeping the cutting angle in place) allowing this home made tool (set at 45 degrees) to re-face the end of the oil pipe fitting. Yes! Basic – but Effective (last three photos, above right).

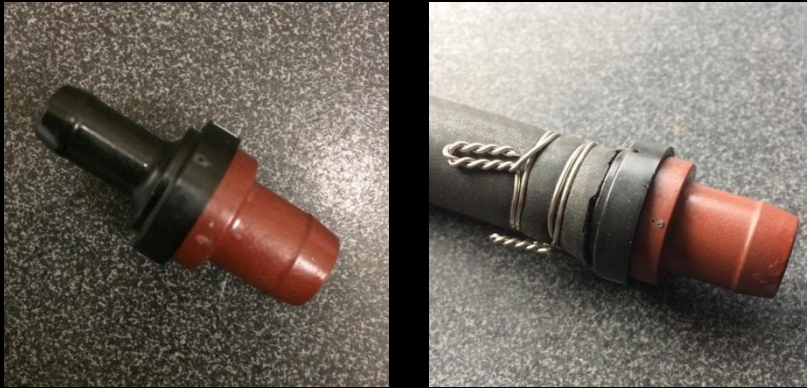
My next modification: was to add a Positive Crankcase Ventilation (PCV) Valve in order allow the release of excess crankcase pressure, whilst at the same time – to stop the usual ingress of air being drawn back into the engine (as the Piston starts to ascend on its reciprocal trip back to top-dead-centre). Yes! In other words, it's a simple one-way valve.

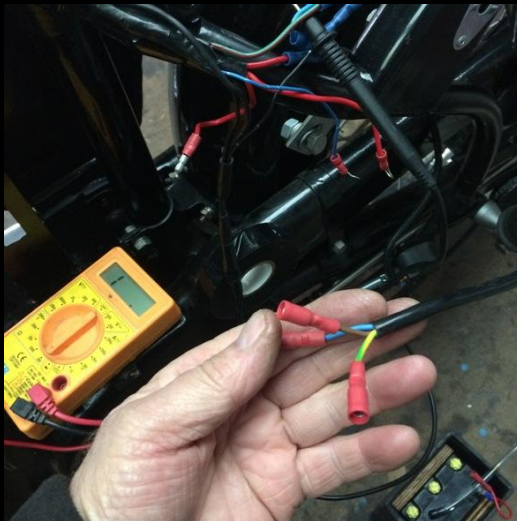
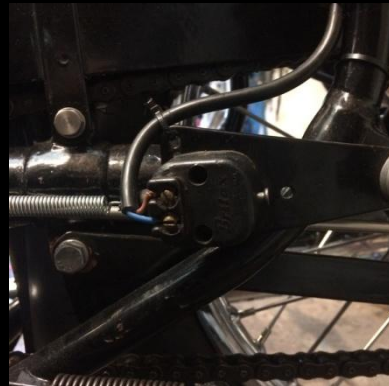
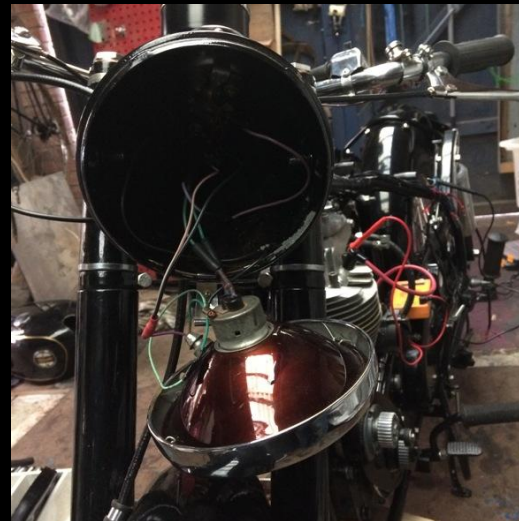
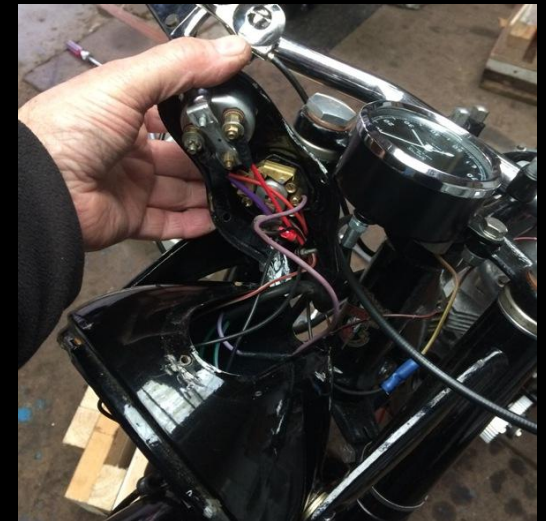
When I Read the 'Sales Advert' = "*Rewired and new cables fitted*" . . . my expectation was to see wires (to & from the various switches & electrical equipment) matching the correct colours as per the Velocette MAC Wiring Diagram. But what I actually found was more of a literal translation; i.e. new cables fitted! (none of which actually matched said wiring diagram colours). The First Photo Below (left) illustrates what I mean; with the three-core household 13 amp electric cable fitted to the rear light & brake light, and to the brake-light-switch. Whilst this type of wire may function adequately (regarding load capacity) I was expecting to see the correct colour-coded auto-cable used - as per the original Velocette wiring diagram (Silly Me!).

So, I decided to rip it all out. Yes, ALL of the existing wiring was removed in readiness for a complete 'Re-Wire' (as per the Velocette MAC Wiring Diagram).

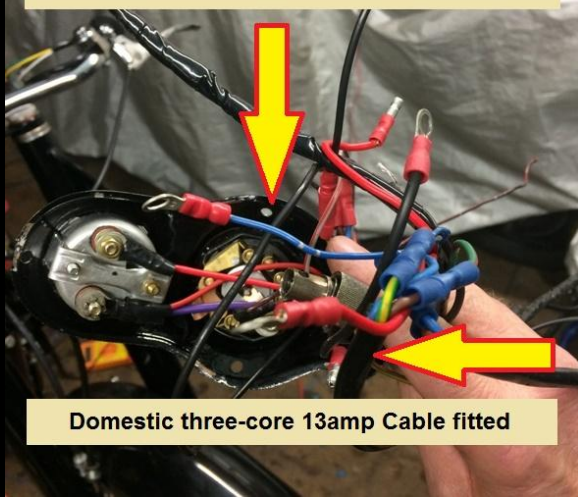
Non-Standard Cables / Wires used throughout and none matching the original MAC Wiring Diagram

Domestic three-core 13amp Cable fitted

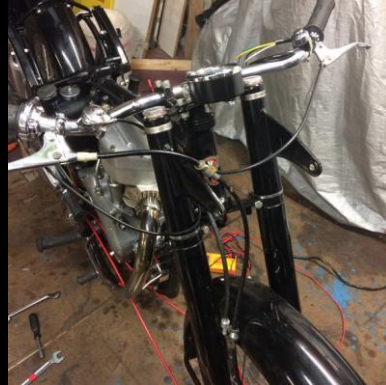
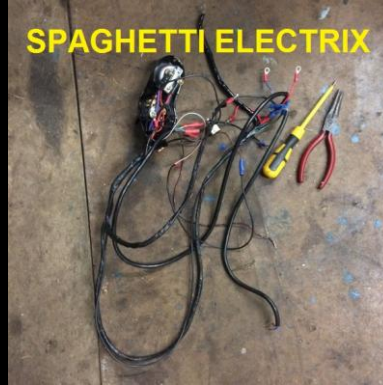
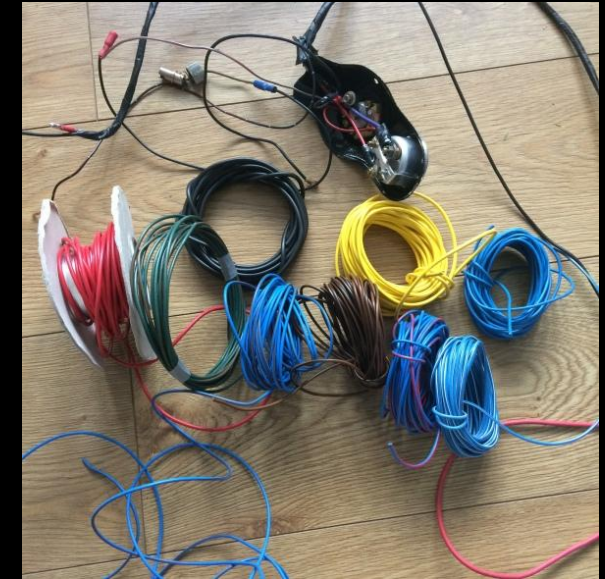
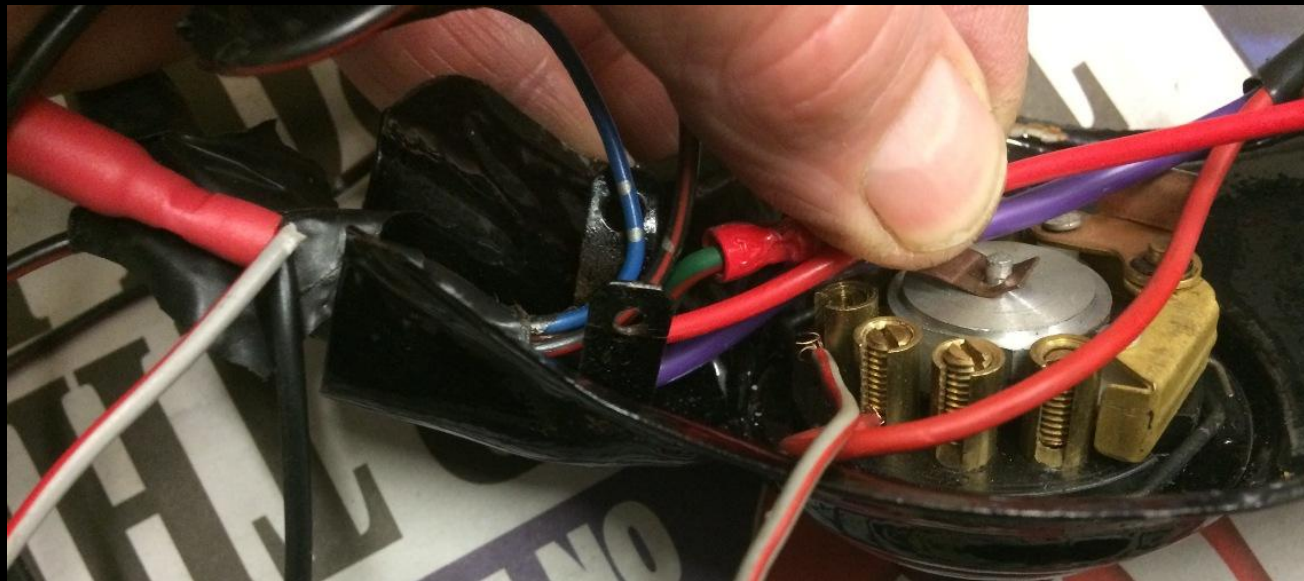
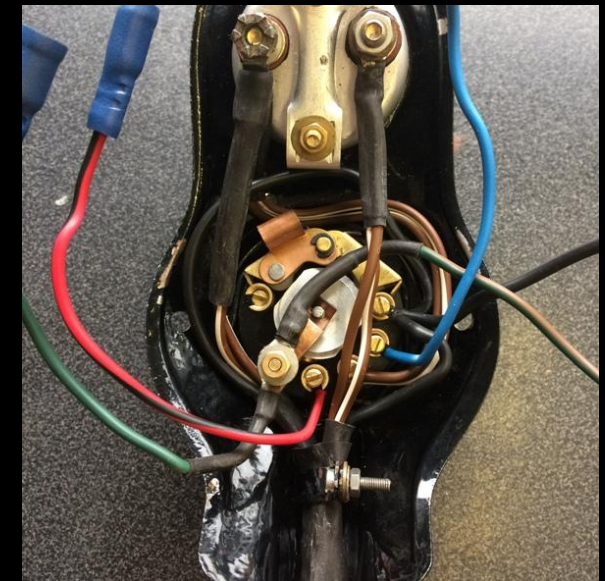
With the *Wiring Harness* removed; the next job is to match-up all this new Auto-Cable to the right Connection.

After lots of soldering, crimping & heat-shrinking the Wiring Harness together, the wiring loom is now ready for re-connecting to all of the switches, lights & other electrical fittings and put the whole lot back together again. But at least now, all of the 'Colours' will match the original Velocette MAC wiring diagram.

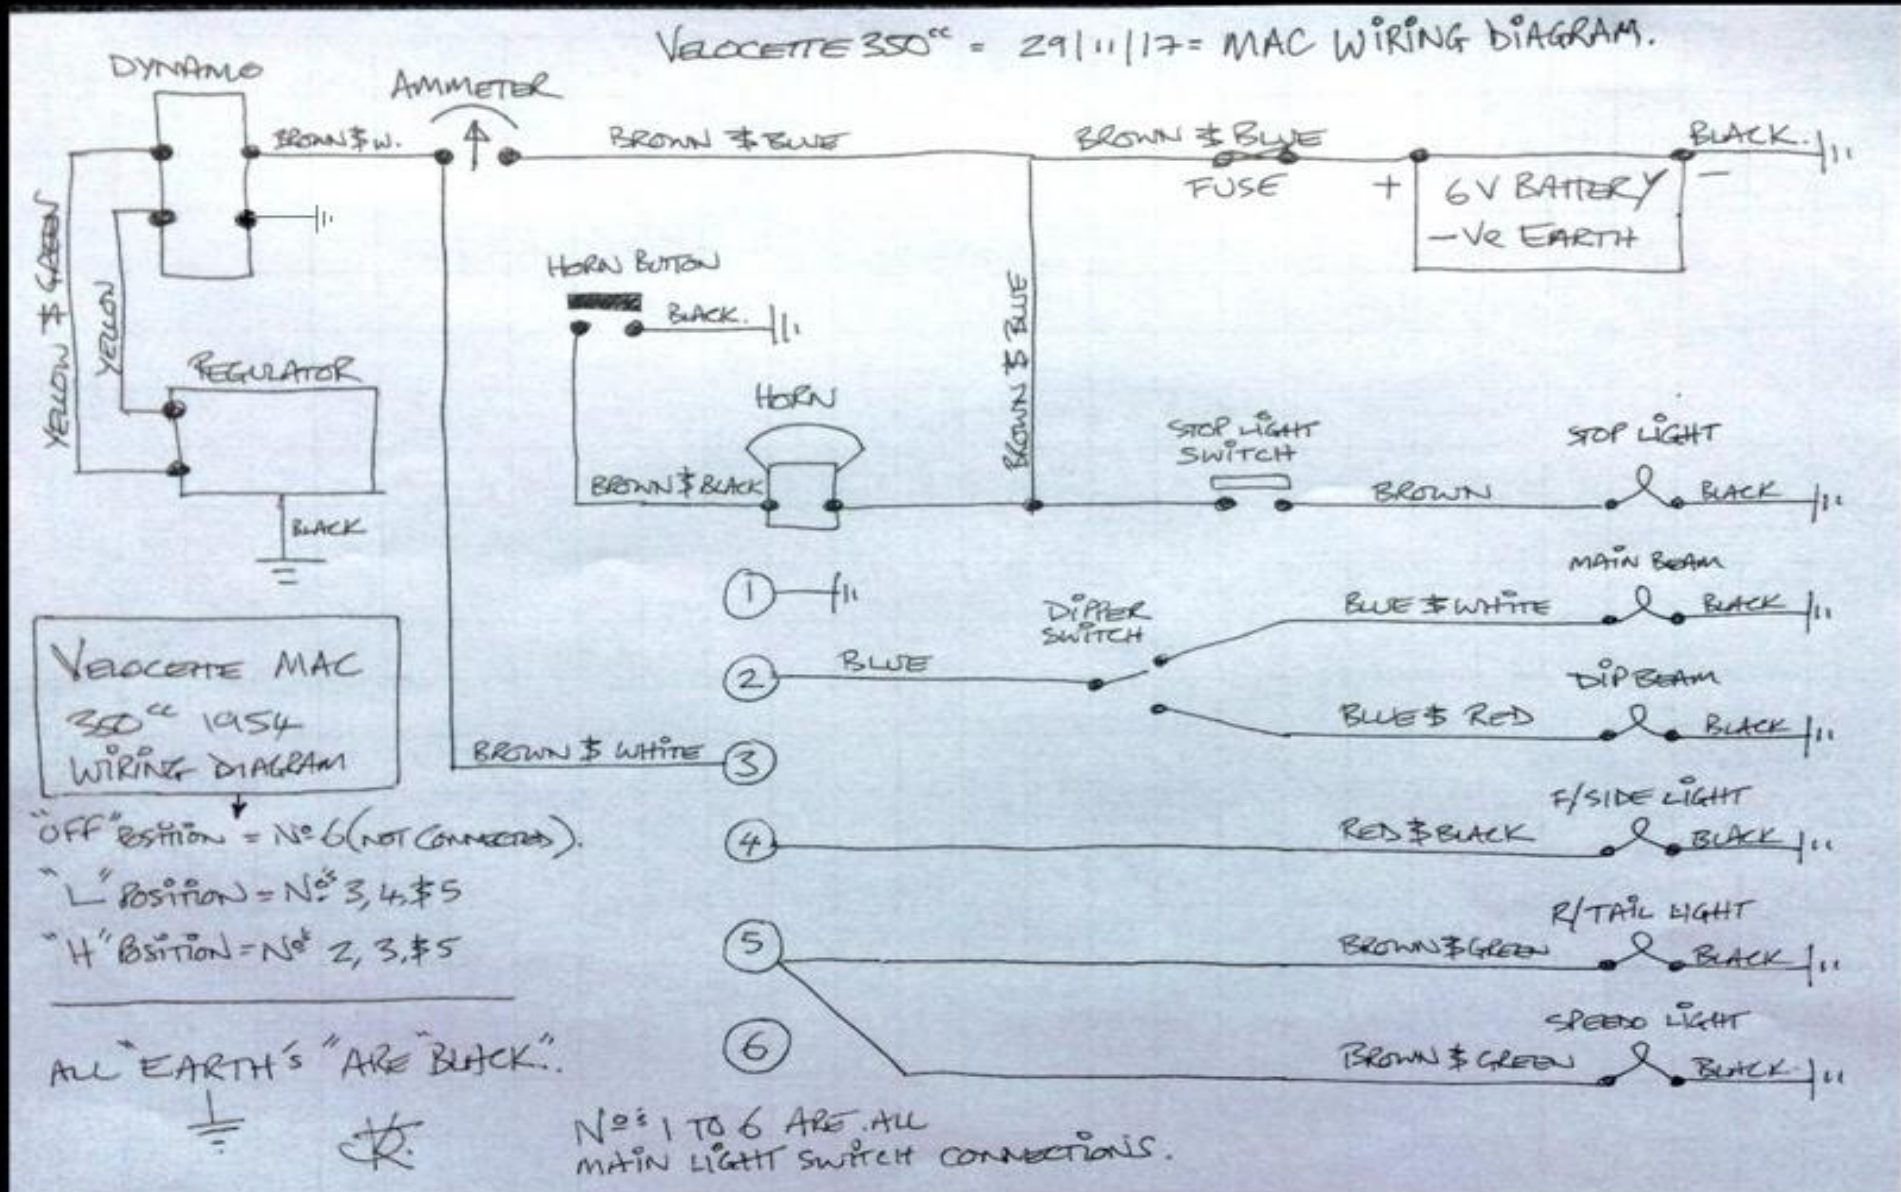
This is my 'Wiring Diagram' drawing used (copied from the Velocette Owners manual) with ALL of the wire 'Colours' matching the original Velo MAC scheme. I've also added a 'FUSE' to the system (although the term "closing the stable door after the horse has bolted" comes to mind).

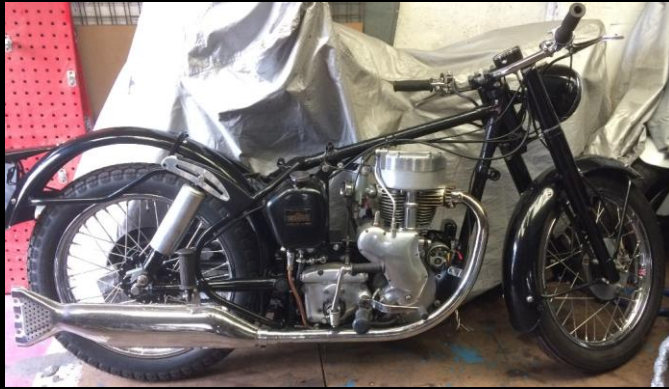
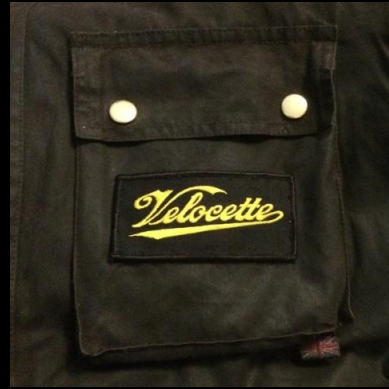
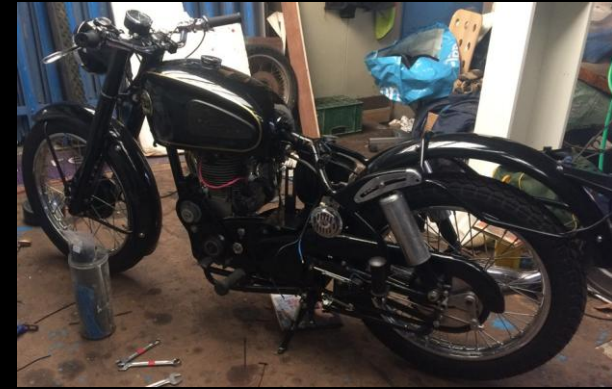
The only problem is; the Dynamo is still not charging? And this was supposed to have been completely overhauled? And with a new JG Regulator Unit fitted. I suspect the JG Regulator had been well & truly 'Fucked' before I took delivery of the MAC – hence; No Charge generated when the engine is running.

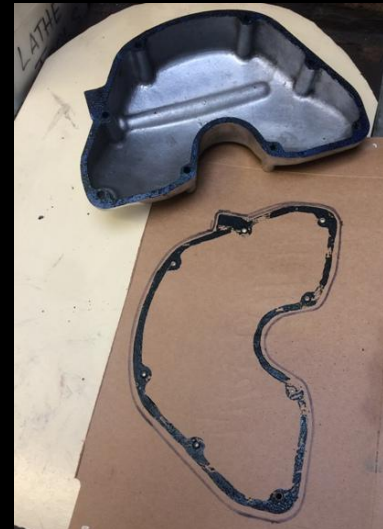
The 'obvious' answer was to start my search for this annoying oil leak at the top end of the engine – and work my way down until I could find the source of the leak. I removed the Rocker Box Cover quickly found the culprit. You can see on the photo below left - where the Rocker Box Cover 'Gasket' had moved when fitted (by previous builder) and had been pinched tight, but unfortunately – missing the sealing face of the Rocker Box – allowing oil to escape all over the engine. So, fingers crossed; my new home-made gasket does the trick & stops this oil slick.

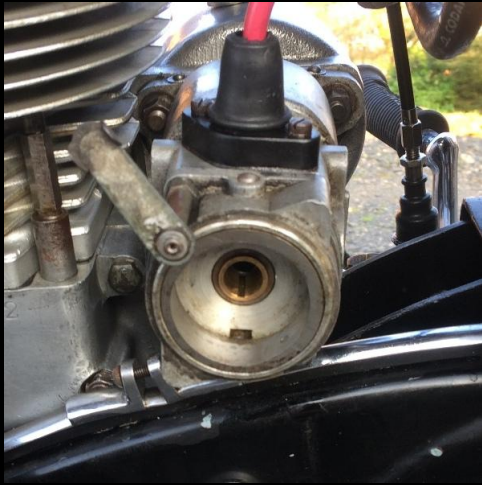
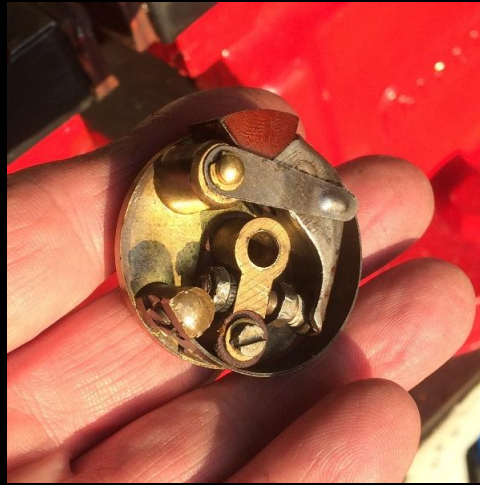
The photos below; show the Lucas K1F Ignition Magneto and Points Base Plate (removed).

When the Ignition Points Base Plate was removed we discovered the Contact-Earth-Brush & Spring had not been fitted. Fortunately for me, Rick has accumulated quite a collection of Velo spares over the years and had just the right part to reinvigorate my Magneto – at least - enough to get me home.

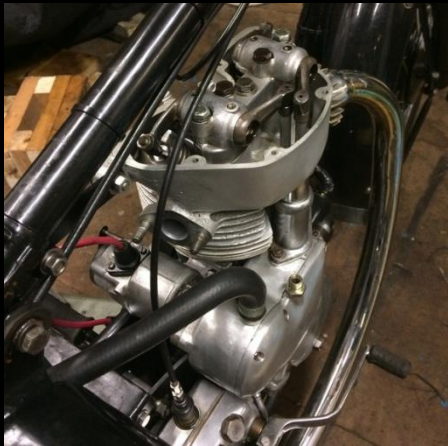
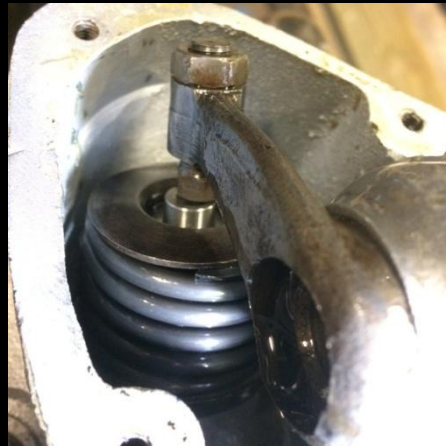
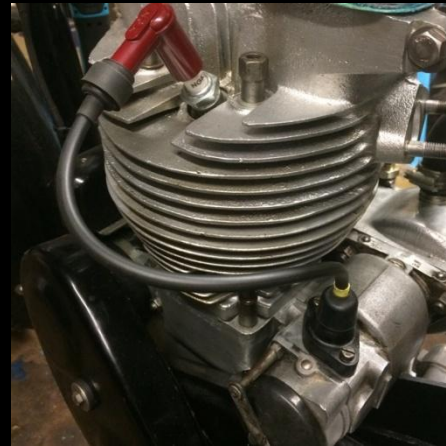
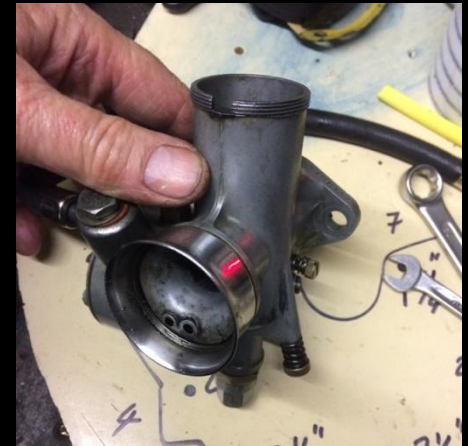
The Next Day; I did a ‘Compression Test’ (as you do) and found Cylinder Compression was below 20psi??? So, once more I removed the Rocker Box Cover I found a problem with the Exhaust Tappet. There WAS a gap – but only just! At this stage, I was convinced that I had discovered the reason why the bike started so easily when cold, but stopped as soon as the engine reached full working temperature (i.e. the Exhaust Valve not closing fully - hence the loss of compression). I presumed that the lack of cylinder compression when engine hot, was due to expansion of the valve gear, making it virtually impossible to start it with the Kick-Starter (but obviously, with a Push-start, there was just enough momentum to build up sufficient pressure inside the cylinder for it to ‘Fire-up’ and to start the engine running). Well . . . That was my theory anyway!

I reset the Exhaust Tappet to 6 thou’ just to make sure (even though the Velo Manual listed this as 5 thou’ for both Tappets) . . . and at the same time I removed the Carburettor completely and cleaned it out thoroughly (just to make extra-sure the ‘Carb’ wasn’t a contributing factor in all of this). I also fitted a new High Tension Cable & Cap, plus new Spark Plug - in an attempt to eliminate any weakness in this part of the ignition system.

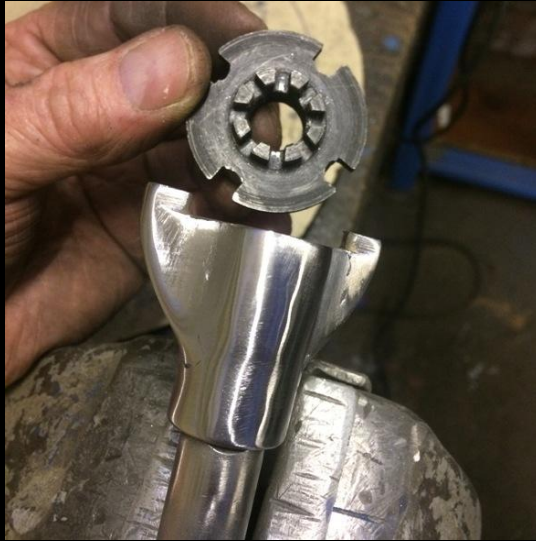
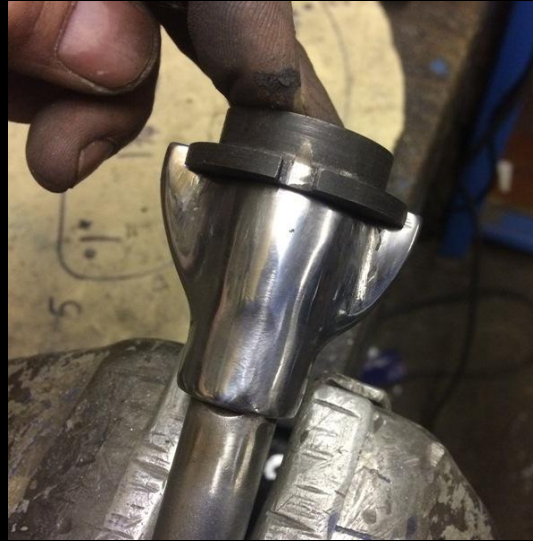
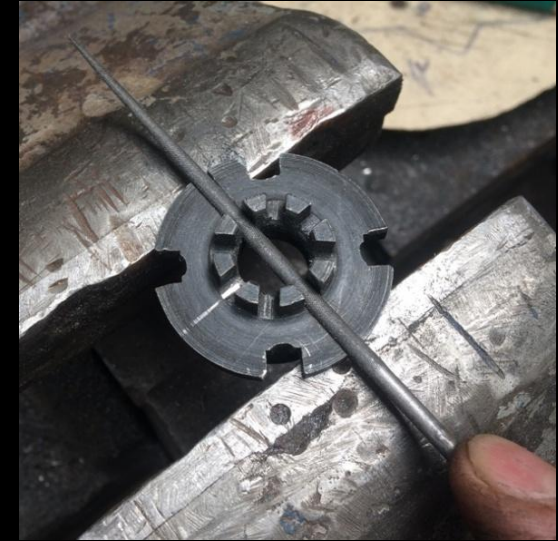
The previous 'Engine Builder' had not fitted a 'Split-Pin' to secure this Castle-Nut? Presumably because when the Nut was tightened, the Castellations did not line-up with the hole in the Crankshaft. So, rather than sort this problem out, they just left-out said split-pin!

I tightened up the 'Nut' fully and made a mark on the Nut to identify the 'position' of the 'Hole' in the Crankshaft, then filed a 'Groove' between the Castellations – just enough to be able to insert a 'Split-Pin' in to secure the Nut.

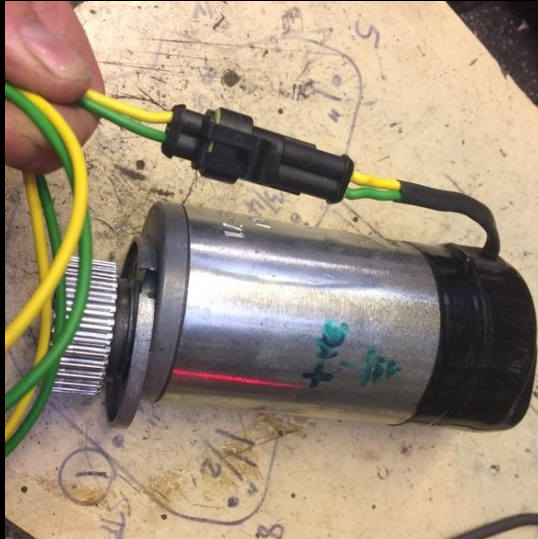
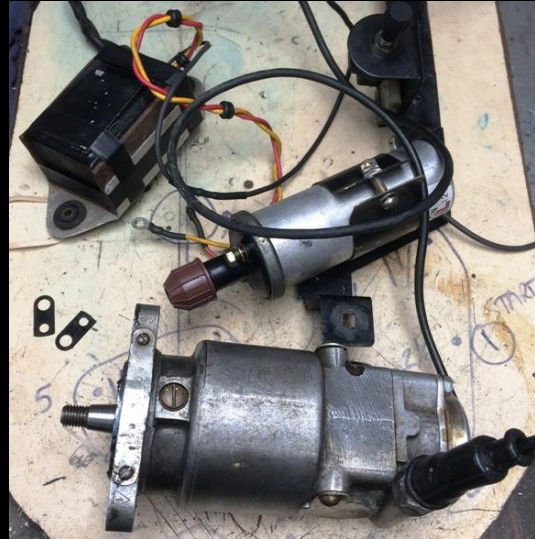
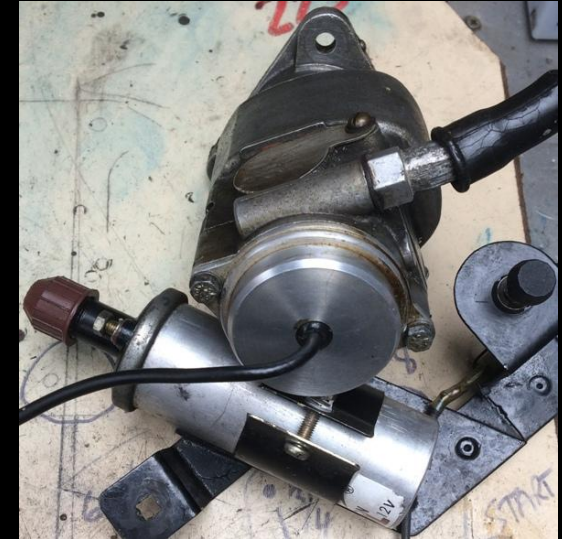
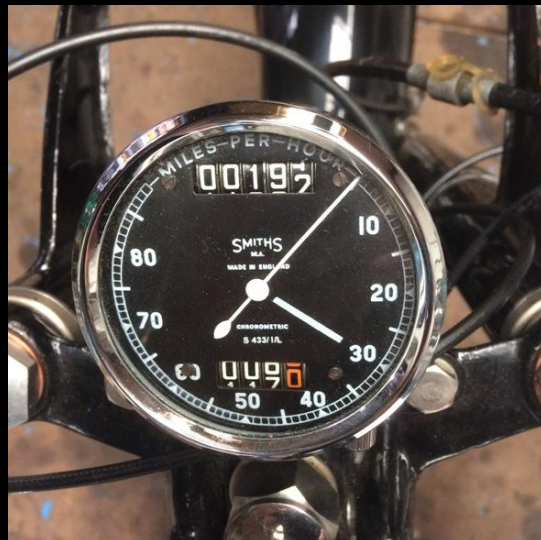
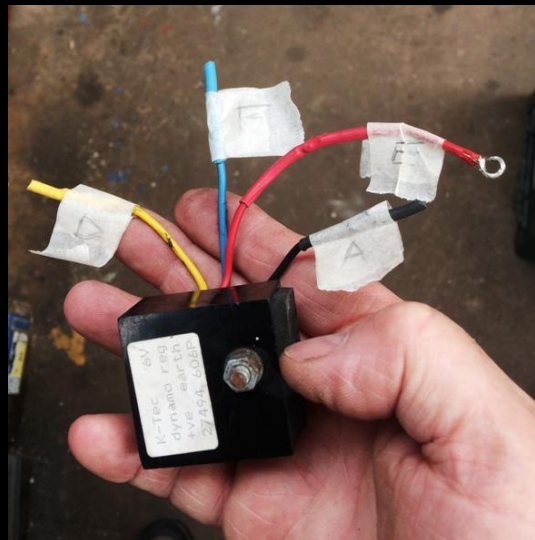
The first photo (below left) shows the new auto-electrical cables fitted (i.e. yellow to 'D' connector & green to 'F' connector) using a 'Durite' waterproof quick-release connector. Also, until I can get my BTH Magneto checked-over properly and reconditioned, I am going to use the Magneto 'on-loan from Rick. My BTH Magneto works *perfectly* when the engine is Cold. It starts **FIRST-time EVERY-time** when Cold, but as soon as the engine reaches full-operating temperature the Begger **JUST Stops!!!** And **TOTALLY REFUSES** to kick-start again until the engine has cooled fully.

Rick's Magneto (above photos) has been converted to 'Coil' ignition, and I have every confidence that this Magneto & Coil system will work and will Not let me down.

Also, Rick's Dynamo Regulator ready to fit (2nd photo left) with yellow, blue, red & black wires, and this should rectify my electric charging problems too.

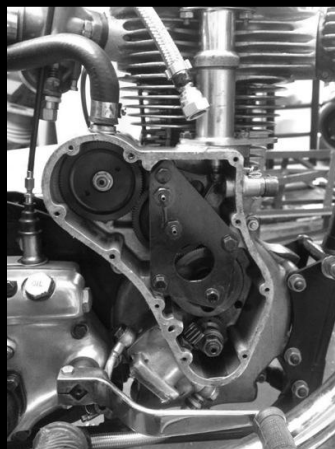
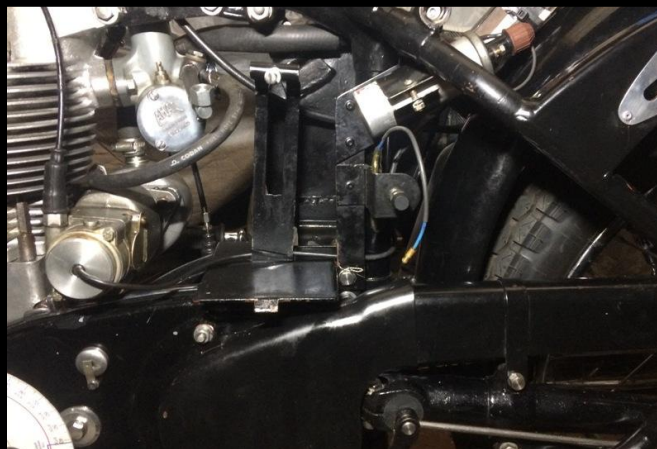
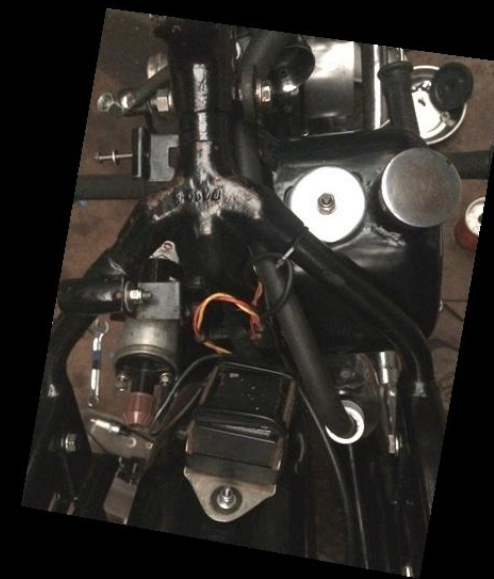
Timing Cover 'OFF" yet again . . . But at least I'm not worried about the timing cover screw 'Threads' this time as I've already sorted this problem out (by re-threading & fitting new Cap-head / Allen Screws). The timing cover was removed to gain access to fit the 3rd Magneto to go on in Two Months (in April I changed the Lucas K1F Magneto with the BTH N4 Magneto that I bought at Stafford bike Show).

And . . . now I've fitted the 'Loan' Magneto to see if this cures the unreliability problem that has plagued this bike from *Day One!* This one is an old Lucas K2F Magneto converted to single-fire contactless electronic ignition timing, with an external Ignition Coil, powered by a 6v battery.

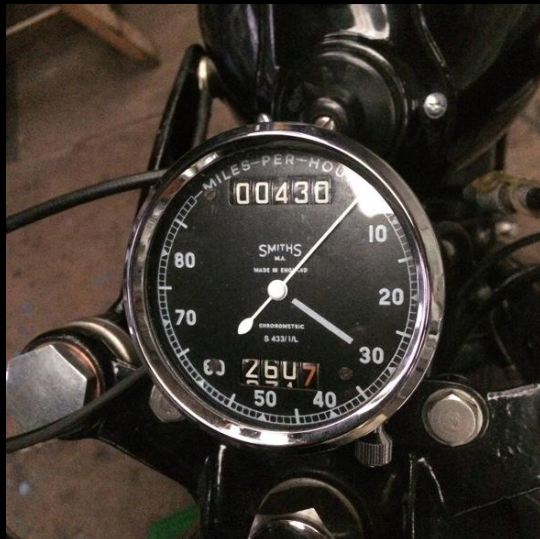
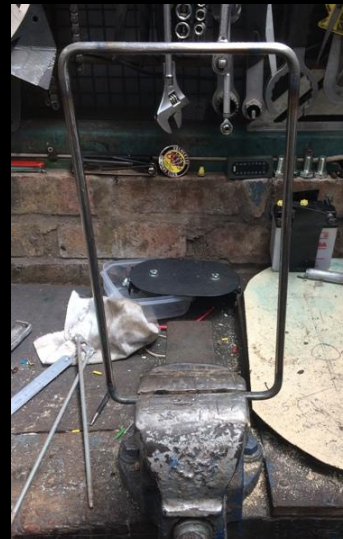
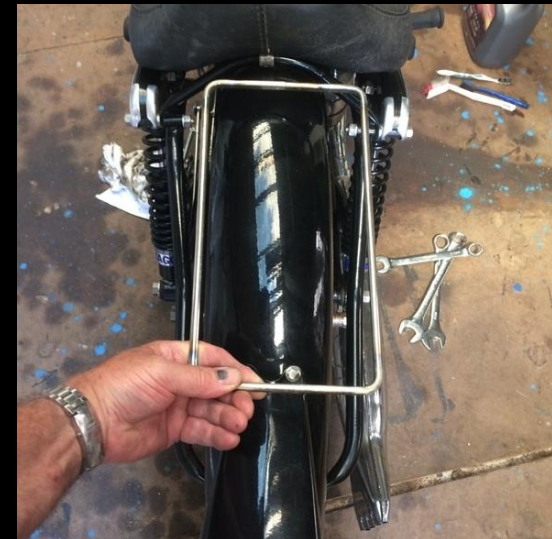
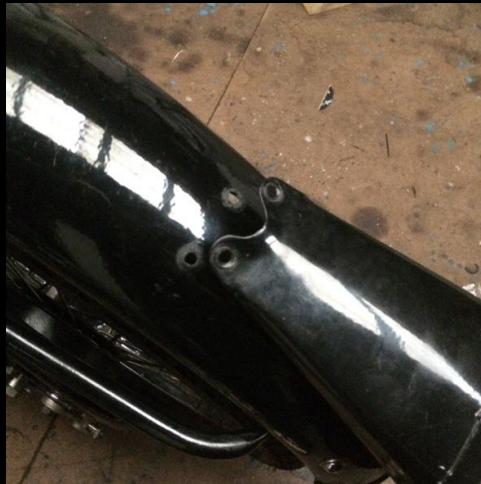
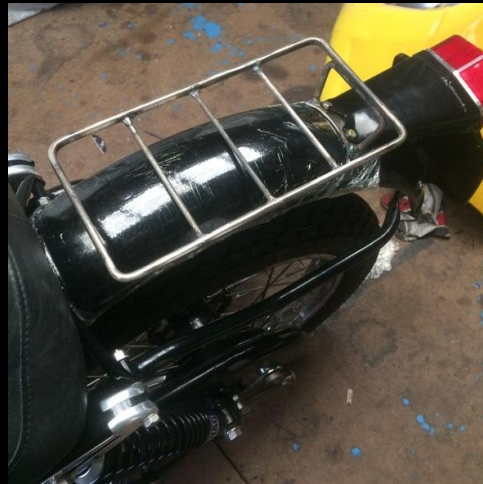
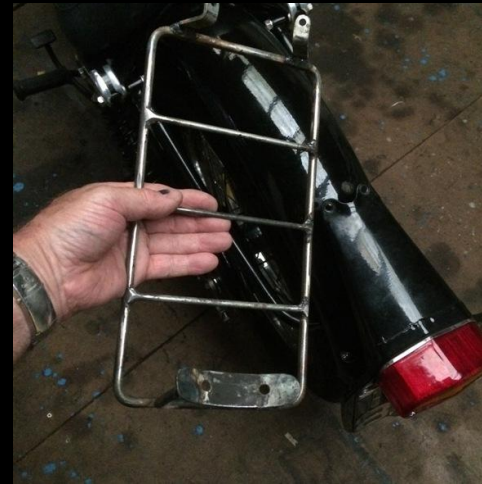
Since the Velocette Rally, I have now ridden my 'Reliable' Velo as much as I can and have managed to knock-up another two hundred & twenty-three miles on the clock. Making a total of four hundred and thirty miles completed since I bought the MAC (see photo below left for latest mileage). And . . . I'm pleased to say – my MAC has not once let me down with poor starting and/or breaking down when it gets 'Hot' (Thanks to Rick). It starts virtually every time now with just one (or two) kicks.

Also, in the two end photos (bottom far right and on next page) I've started to make a small-lightweight Rear Carrier Rack, to fit directly onto the rear mudguard. This should enhance the look of the bike (I think) and this bit of utilitarian fabrication work should come-in useful for carrying light luggage'n'stuff. (Finally, somewhere to attach my trusty old Flip-Flops to . . . whilst in transit – obviously). Did I mention it NOW Starts.

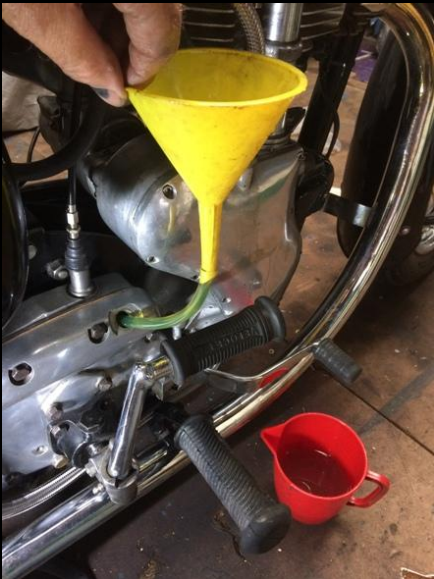
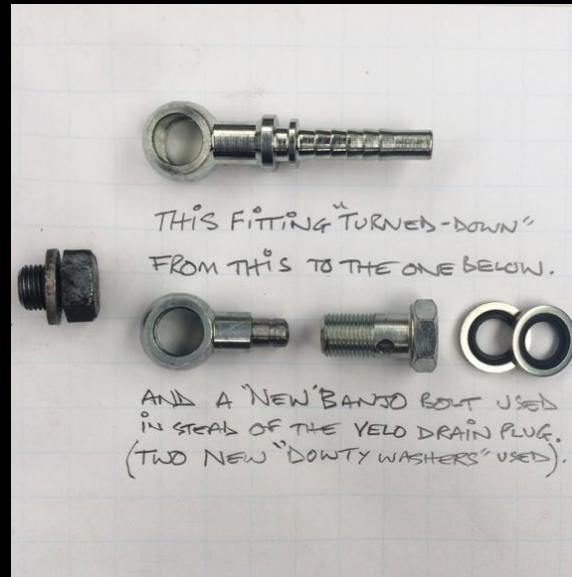
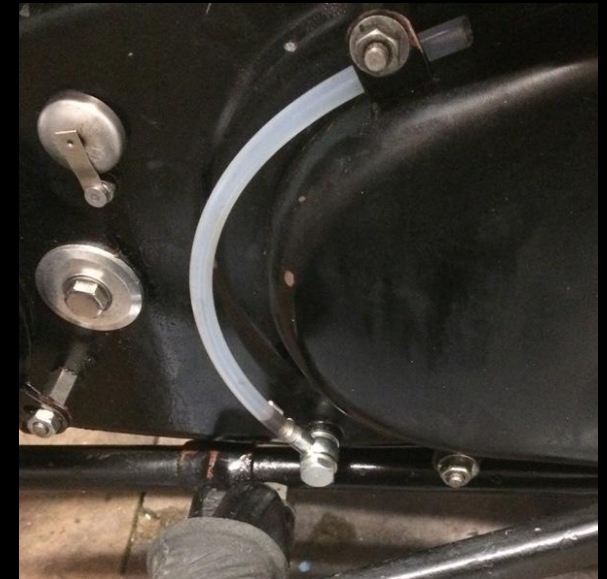
First photo (above left) = after 473 miles covered, the gearbox drained & refilled with new clean SAE 40 oil (as recommended). Next two photos (above right) show the latest improvement; a new Chaincase Oil Level Indicator made from hydraulic 'Banjo Fitting, Banjo Bolt and plastic pipe'. I shortened the Banjo fitting in order to be able to see the correct level of oil in the Chaincase. I did this by cutting-off the end of the banjo fitting and reducing the size of the fitting to accept a translucent plastic pipe (lock-wired into place). This 'banjo fitting' then screws directly into the existing Chaincase 'Oil Drain Plug'. And it works.
