Velocette MAC 350cc

Rebuild Project Part One, Year One

From October 2017

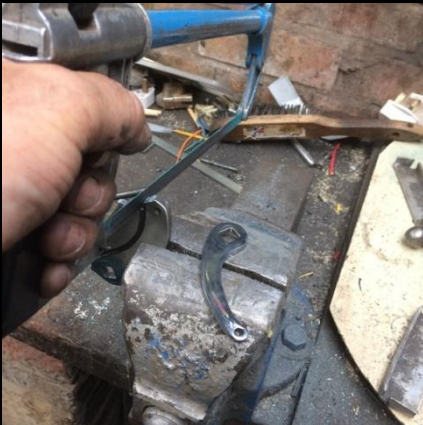
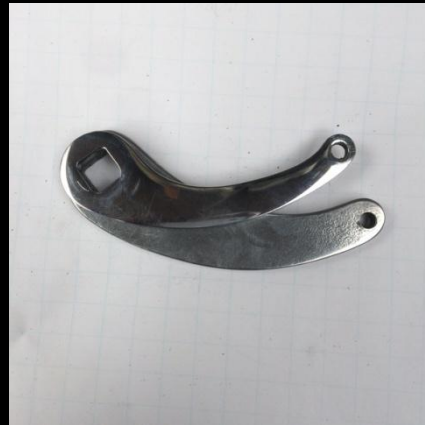
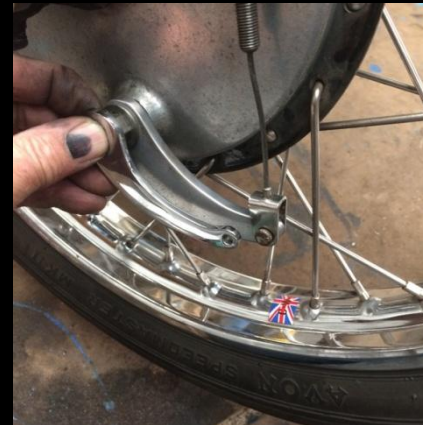
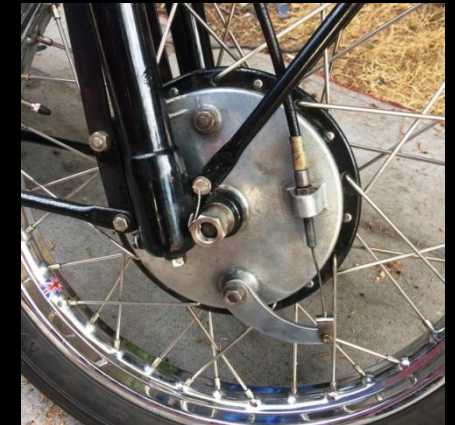
Four photos above show front brake work: Until I can get the brake-drum 'Turned' in a Lathe & new brake shoes fitted - my next mod was aimed at improving poor front braking issues by making a slightly longer brake lever arm. I've also made it slightly thicker (because the existing lever was too thin & wobbled-about - even though it had been 'Packed-out' with a couple of washers). RESULT! For the first time ever, when the front brake is applied, the front Forks actually dip & compress under braking conditions (which NEVER happened before). It's still not brilliant, but at least 50% improvement on previous braking.

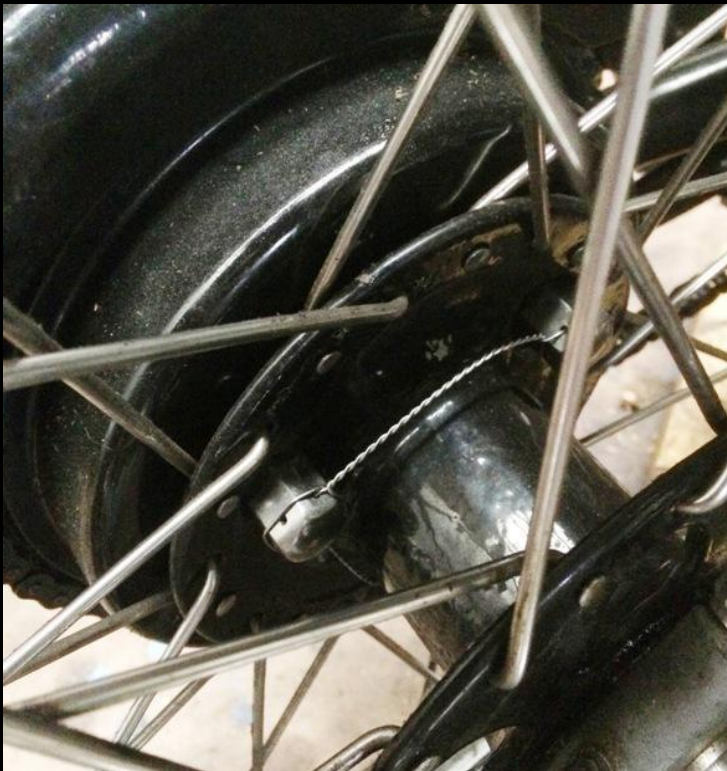
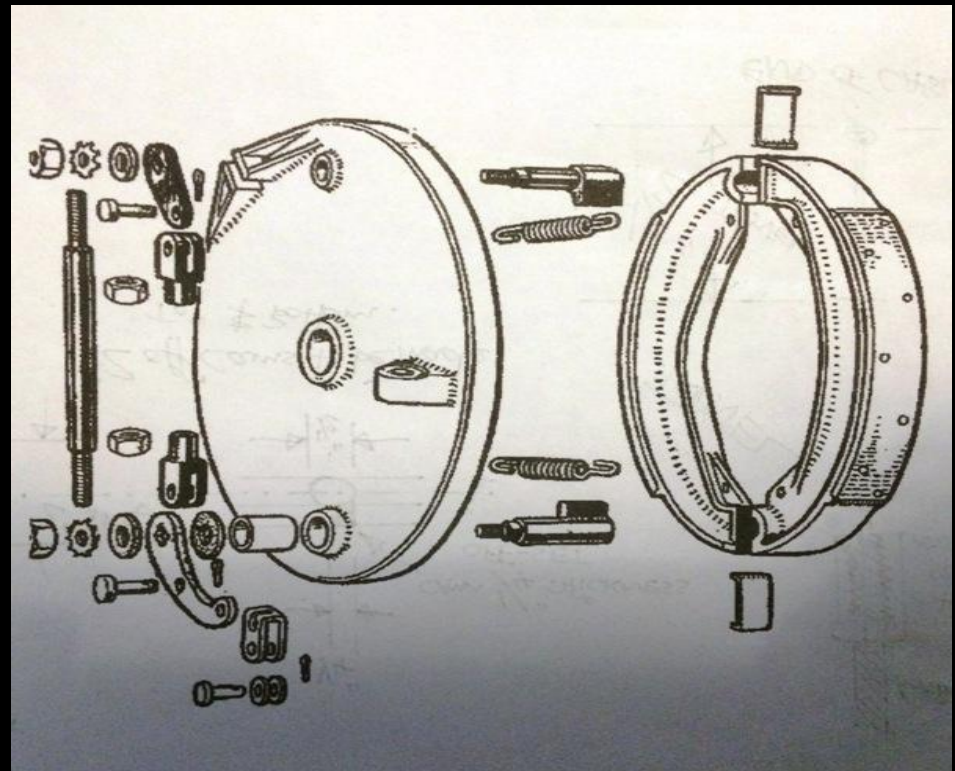
I managed to buy a spare Front MAC Brake Plate (advert in last month's VOC Fishtail magazine). This is the basis for my TLS Front Brake project. But on further inspection I discovered there are several considerations & challenges to doing this conversion based upon the drawing & article. This is what I found:

- The Pivot point & Fulcrum point are at different 'Centres' (from the centre Wheel Spindle Bearing) and are different diameters; i.e. the Pivot Bolt is 3/8" diameter and the Fulcrum Cam-Bolt is 1/2" diameter (fitted in a half-inch bronze Bush). The different spacing is to allow 'Sufficient Travel' at the 'Fulcrum end' and 'Less Movement' at the Pivot end. But after measuring up and a good long 'Think' about this new system, I decided to set both Fulcrum & Pivot Point Centres 'Equidistant' from the Centre Spindle. This then brings both leading edges of the repositioned shoes to locate in the correct position to work. Without this alteration / modification – it is virtually impossible to get the shoes & brake back-plate to fit back into the Drum (because of this offset).

- The original Brake Shoes are 'Sided' and will only fit on 'One-Way', so a second set of shoes are required to make this TLS work successfully. I tried fitting the Shoes as in the Fishtail Diagram but found that the shoes just would not fit the drum safely, in the configuration stated in the drawing.

- The top pivot point (in the drawing) shows the smaller diameter hole (i.e. 3/8") without the use of a Bush (& only the Brake Fulcrum Lever Hole is 'Bushed'). But I felt it necessary to increase the size of the original pivot point to 1/2" and to install a Bush to match the original Fulcrum Point (that is fitted to the lower part of the Brake Plate) to act as a proper bearing area for the top lever too. This will help with increased braking loads at the old (top) pivot point.

- Unfortunately, there is insufficient material at the top of the brake plate to accommodate a new oversized Bearing Bush, because the Brake Plate is too thin to house and support such a Bush and Joint Fulcrum-Pivot Shaft). So, my answer to this was to add a piece of Aluminium Plate (13mm thick) capable of carrying the new Bush (& Loads) for the new Joint Fulcrum-Pivot shaft. This new Plate to be 'Bolted & glued with Araldite' in-place before 'Milling' (to get correct height) and 'Reamed-out' to 5/8" for a bronze Bush to be fitted. The inside diameter of both Bushes to be Reamed-out to 1/2" diameter.

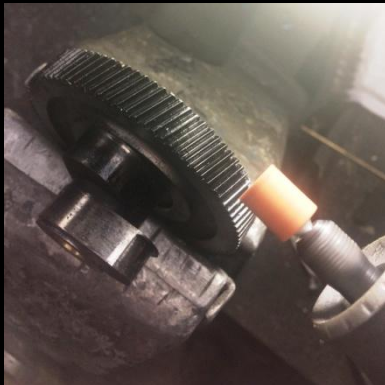
1)

BUT . . . In the meantime (on Monday morning – before going out to work) I had a bit of light relief (excuse the pun), because I took advantage of this small amount of spare-time to do a little Cam Pinion 'Tip-Relief' work on an old M17/8 Cam Pinion (given to me by my Velo-mate Rick). Did you 'spot' the damaged Cam Lobe (1st photo below left, probably the result of 'Oil Starvation').

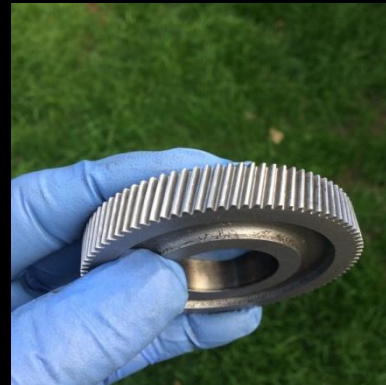
4)

On closer inspection; the black paint highlighted some 'Pitting damage' on several pinion teeth which can be seen on the 4th photo below right (if you enlarge the image). I think this Pinion still has plenty of 'life-left-in-it', but I might order & fit a new one anyway to accompany the new M17/8 Cam.

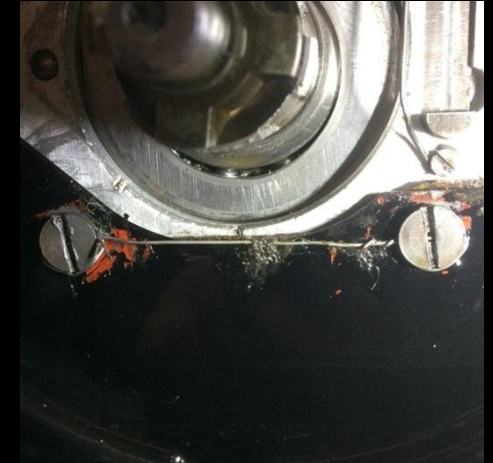
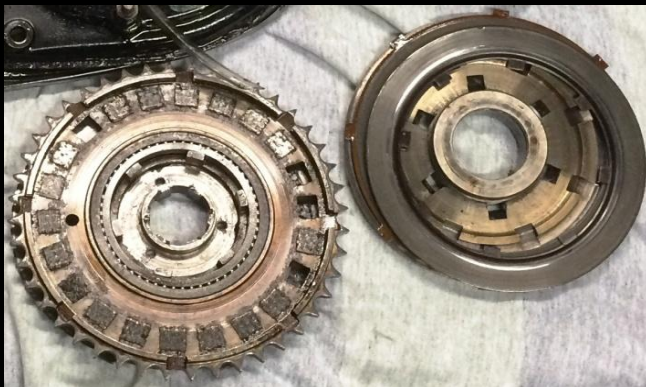
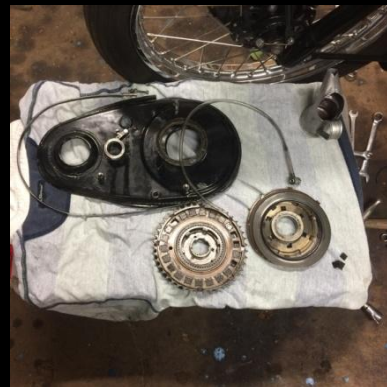
I managed to find a bit of time in between paid-work (mid-week) to start dismantling the chain case & clutch. Upon disassembly, I discovered that the Gearbox Bearing Retaining Ring (aka Sleeve Gear Nut) 'had' come loose and I am hoping that when the Gearbox Bearing Retaining Ring is retightened, and everything goes back together again and adjusted properly, etc. etc. ALL will be well with my MAC once more. Well !!! That was 'Plan'. But, unfortunately, on closer inspection, All was NOT well with the majority of the MAC bits that I had just dismantled. The whole of the Clutch thrust bearing assembly (MAS57) was totally 'fucked' – not just the spherical thrust ring – but most other clutch parts too needed loads of TLC and/or replacing. It also needs a new primary chain.

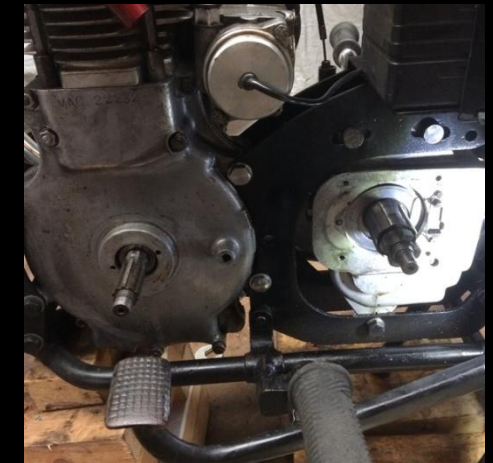
With some expert advice & guidance from my good friend & Velo Mentor Rick, we checked the Crankshaft 'End-Float' with a Dial Gauge. (see the photos on the next page).

Because there is so much movement on the Crank, this now leaves me with NO Alternative but to remove the Engine and split the Crank Cases for further investigation.

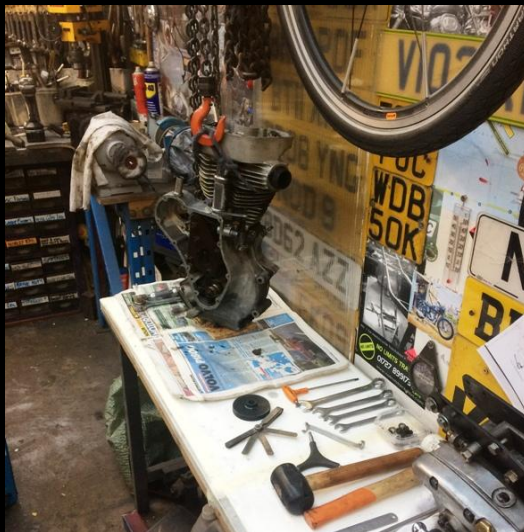
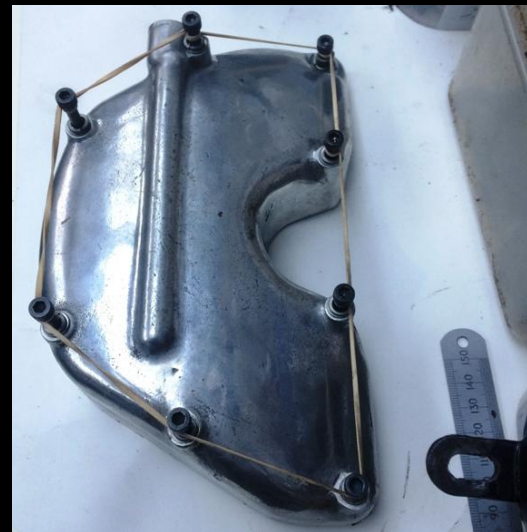
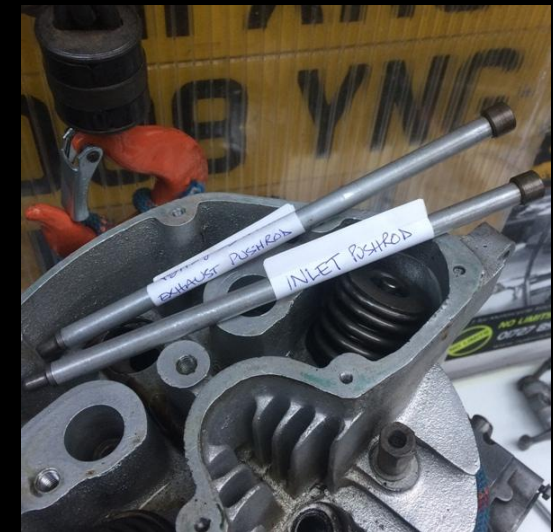
With the engine on a clean bench, I started the MAC strip-down . . . The main reason for this course of action was the need to identify the cause and reasons for the massive 'Crankshaft End-Float' situation. And also to identify further problems and the extent of mechanical condition and general wear & tear of this MAC engine. But it is already becoming obvious that there is a lot more wrong with this engine and gearbox than originally thought.

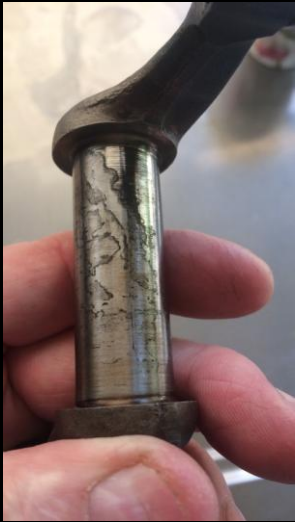
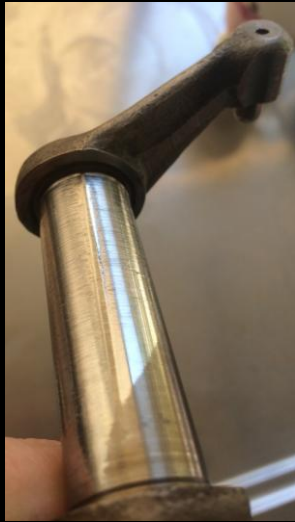
After removing the Rocker Box Cover the first thing I discovered that was in need of remedial work was the 'Rockers'. Both Rocker Shafts (and the aluminium bearing seats that they rest-in) show considerable wear and should have been sorted at the same time of the Rebores & Valves had been replaced. The wear was measured (with a micrometer) which was over .008" to .0010" in places, with quite bad pitting & 'Visible' ridges along both rocker shafts. Criterion Ltd offer a re-grinding service for worn Rockers and an up-rated bearing housing with an improved oil delivery system.

Very Worn Rockers (See first two photos below left). But what is not so apparent in the photos is the MASSIVE Ridges on both Rocker Bearing Shafts.

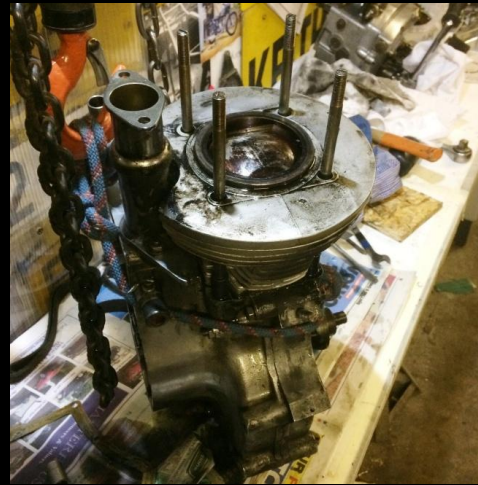
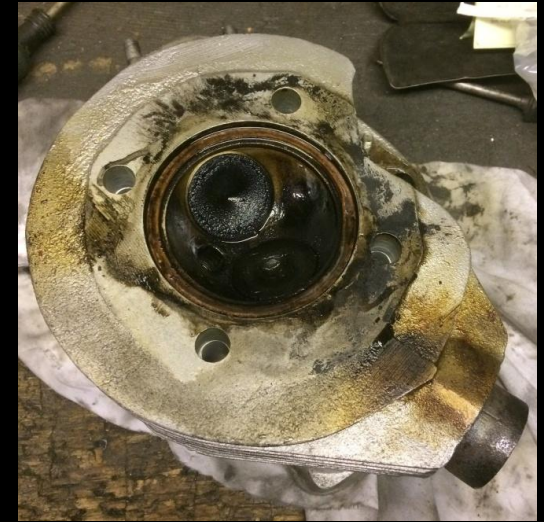
When the Head & Barrel was removed I was pleased and relieved to find that the engine 'had' been re-bored, and fitted with a new piston, gudgeon. The valves & springs appeared to be new too. At this stage, I couldn't find any apparent up & down movement in the big end bearing (Yet!). But more will be revealed when the crankcases are 'parted' and the Crankshaft and 'Bearings' are fully inspected.

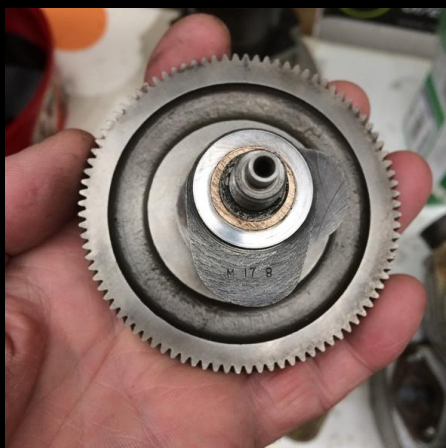
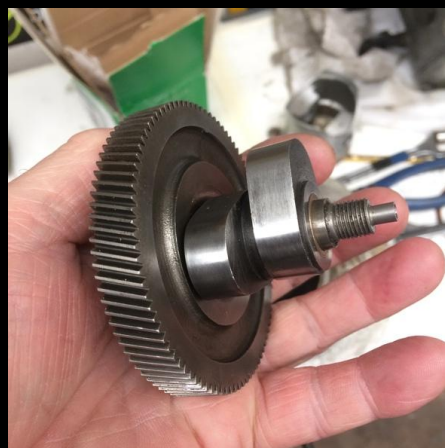
My new M17/8 Cam & Pinion with Cam Bearing Shaft (left) and the new 22 tooth sprocket, with the original 21 tooth sprocket next to it (photo right).

As a matter of interest the original Cam fitted to my Velocette MAC was an M17/5 (with a 30° / 60° / 60° / 30° profile).

In comparison the new M17/8 Cam profile is 45° / 55° / 65° / 35° and has a tad more lift too.

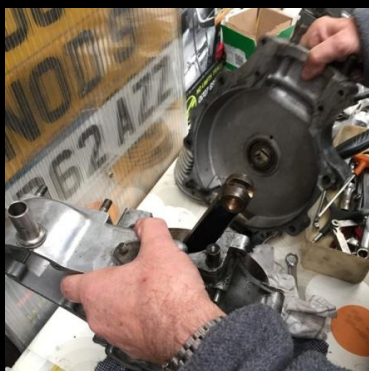
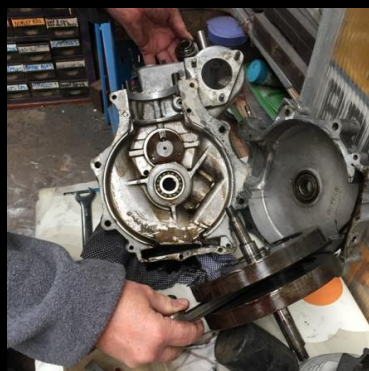
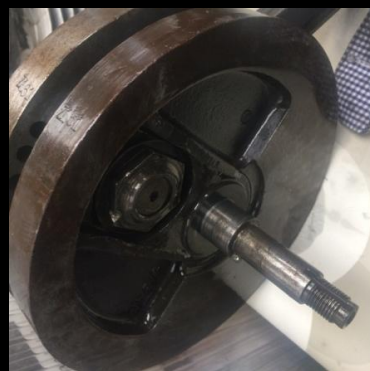
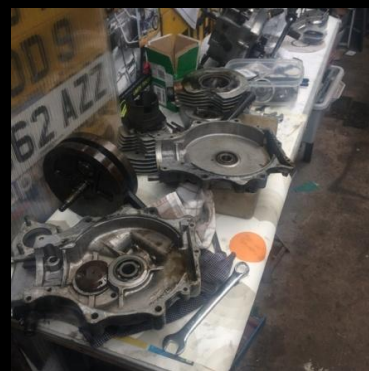
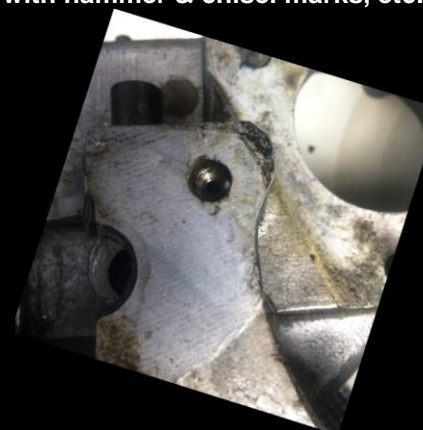
My Next job was to split the Crankcases & find out what is happening 'Down-there'? Unfortunately, what I found was a shoddily-put-together engine.

I found one crankcase bolt had been broken off, and someone had tried to drill-out the broken Stud, but without success (see the last photo below right). So! They just glued (Yes! I did say **GLUED!**) the rest of the Bolt back into the crankcase bolt-hole (to make it look as though it was bolted in).

That wasn't the only crankcase bolt that wasn't attached to anything. I discovered yet another bolt that wasn't screwed-in (that was also just glued into place, to give the impression that all of the bolts were bolted-down). The 'Glue' resembled something from one of those Hot-Glue-Guns? (or similar). This time, it was the bolt that passes through the left-hand side crankcase and should have a *nut & washer* fitted inside the Timing Case (just behind the Cam Gears). But that was also missing???

Shoddy work or What! – its bad enough to forget to put a nut on this bolt, but it would have been easy enough (once discovered) to remove the Timing Case Cover again and fit a new Nut & washer to finish the job properly – rather than just 'Glue' the 'Loose' bolt into place. Yet 'Another Horror Story' = the 'Cases' had been Silicon 'Sealed' together, leaving 'Loads' of solidified silicon overhanging the inside edges of the engine, with the potential for coming loose & entering 'Oil Ways' . . . with disastrous results. The Flywheels had also been abused, with hammer & chisel marks, etc.

Until I can spend more time on this engine, my 'Cursory Look' couldn't find the reason for the massive end-play – apart from one possible answer: i.e. whoever re-built the bottom-end, had probably not even bothered to 'Shim' or check the Crank end float? The MAC isn't like the Venom & Vipers (with a 4 thou" bearing pre-load), the MAC should have 'Zero' Crankshaft end-float. However, an article in Fishtail (#455) suggests a small pre-load is preferred.

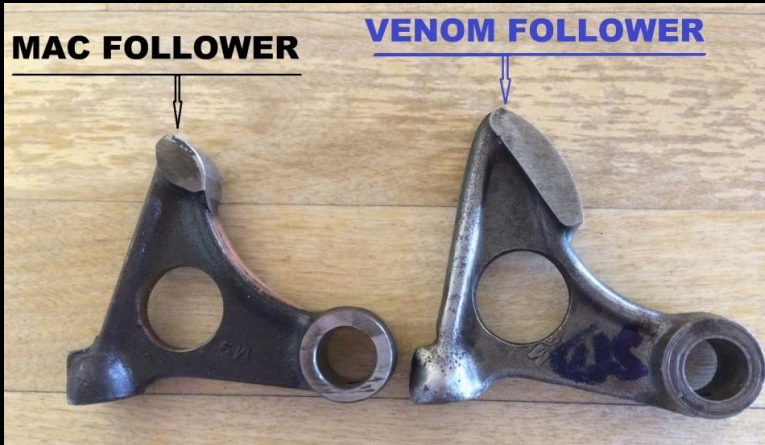
Comparison between the original MAC Cam Follower (Bottom Rocker M9/3 designed for the M17/5 Cams) and the Venom Cam Follower (Bottom Rocker MAS118 designed for the M17/8 Cams). The illustrated Venom Follower was 'On-Loan' for the photo.

These Venom Cam Followers are needed with the M17/8 Camshaft in order to obtain the correct 'Opening & Closing' Profile.

The longer / extended Cam Follower 'Heel' (shown on the right-hand side of each photo) is also designed to act as a 'quietening ramp' which hopefully controls unwanted valve bounce and will help achieve the required overlap.

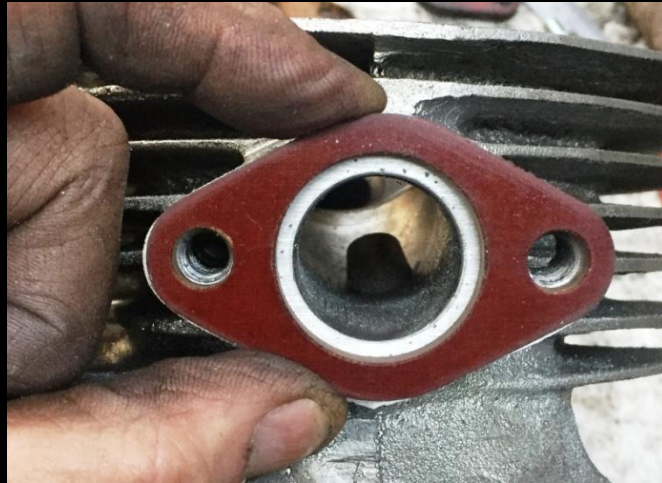
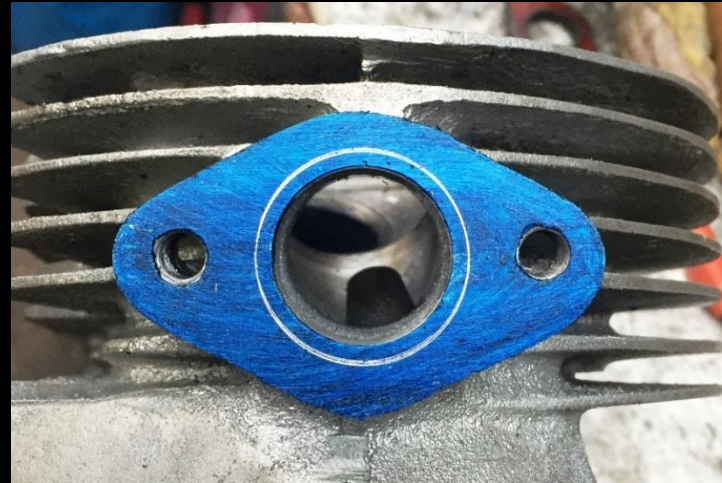
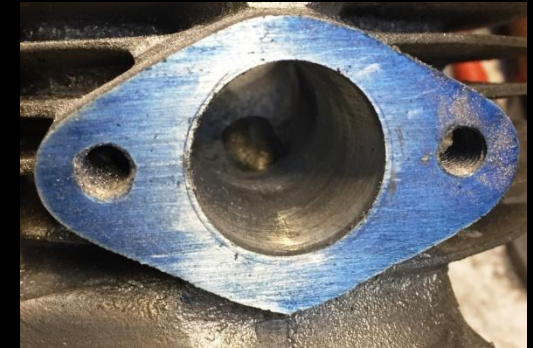
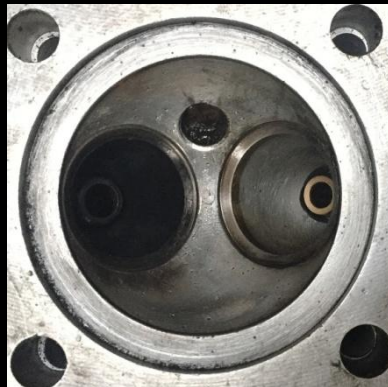
It appears the Inlet Valve & Valve Guide (& Valve Springs) had been changed (quite recently, probably at the time it was 'Re-Bored'), but the Exhaust Valve 'Stem' showed noticeable wear, with quite a lot of play in the Exhaust Valve Guide (which didn't look new at all). So, because of this, I decided to replace both Valves & both Guides (as part of a 'Quality Rebuild'). By using 'Better Quality / Much-Improved' Parts I will be giving the 'Cylinder Head' the very best chance of 'Being the Best it Can Be'.

You can see from the photos below 'How Much' material I have removed from the Inlet Manifold & Port to improve the MAC 'Breathing'. Plus: plenty of polishing to help with 'Gas-Flow'.

(photo left) Valves out for a bit of 'porting work'.

This is the part of the rebuild where the Inlet Port aperture has been increased to accommodate the larger carburettor that I intend to fit.
