Velocette MAC 350cc

Rebuild Project Part Three

From January 2020

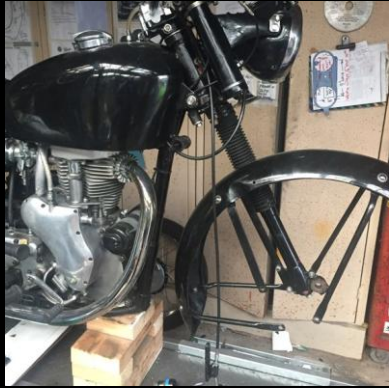
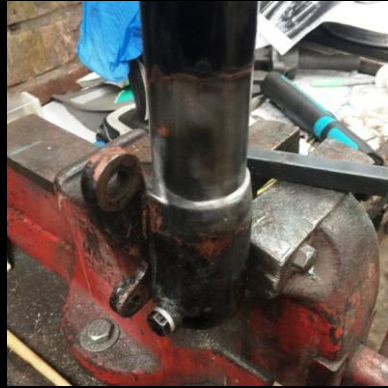
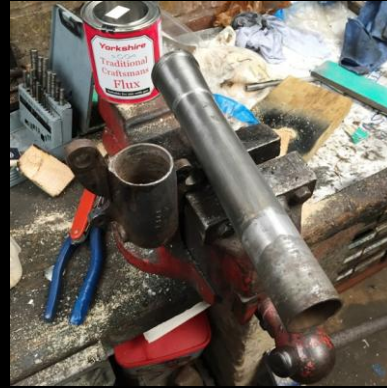
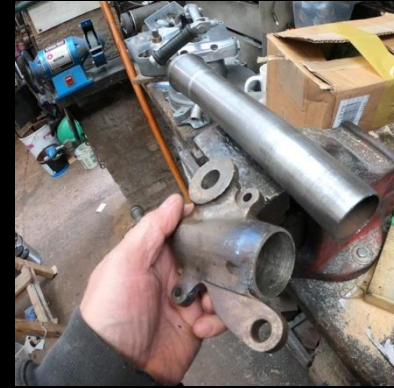
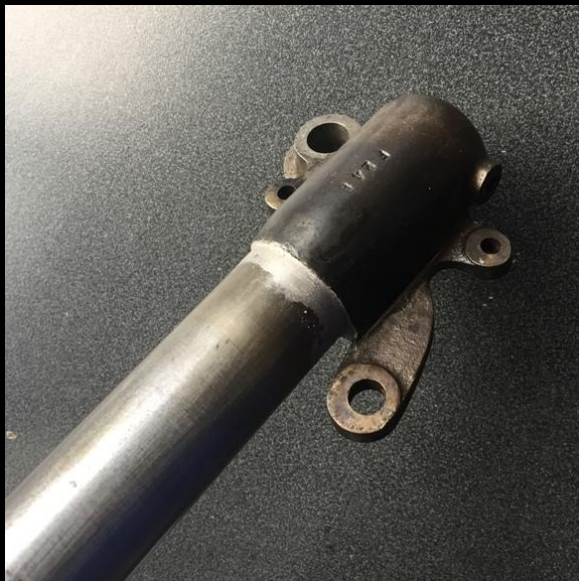
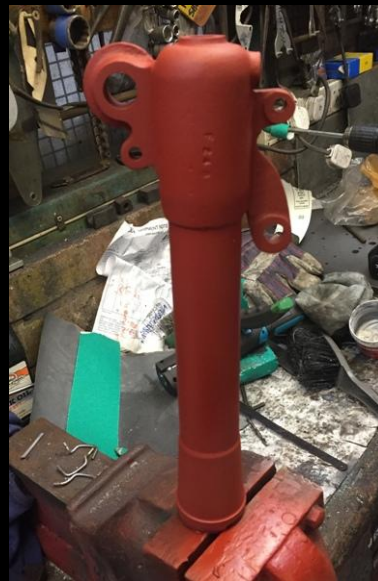
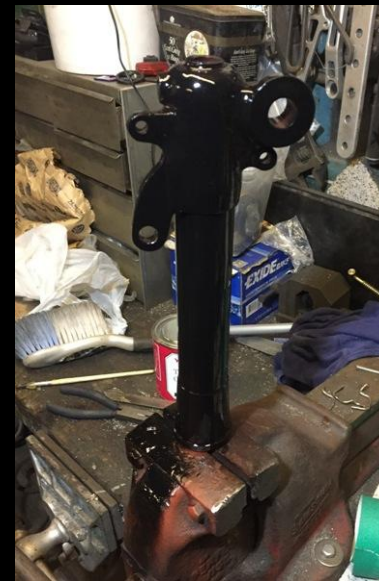
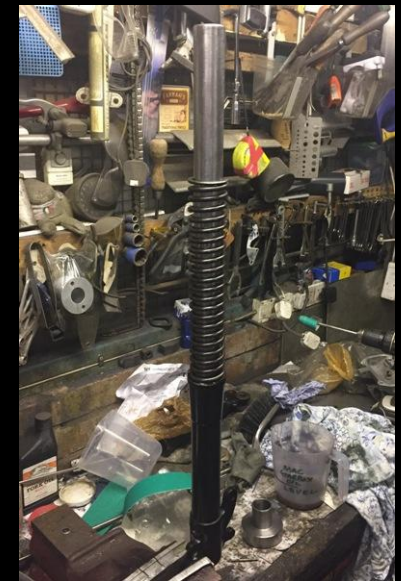
Forks now refitted, tried and tested, and are working perfectly. **As previously stated = RESULT!** However . . . I do have a concern (not with the Forks) but with the Clutch. On a long run, I have experienced clutch slip. Not all of the time, and only on very steep up-hill sections of my journey. I have adjusted the Clutch on numerous occasions (EXACTLY to the Letter of the Velocette RED BOOK), but to no avail. All is well when I set out on a journey (no sign of clutch slip) and it 'Rides' wonderfully . . . until I get to those pesky long hill-climbs, which then gets the better of my MAC Clutch. So, the only option open to me now, is to strip the clutch down again and investigate to see if I can find a reason for this mysterious clutch slipping problem. Upon my return from an extremely wet Ride the main Fuse blew and all power was lost? (Water ingress I guess?).

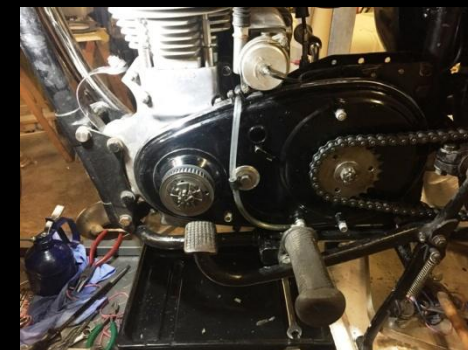
Photo Right: My Mac is almost re-assembled again.

Using this reference chart, it became evident that I had inadvertently assembled the Clutch using 'mismatched' Plates.

I'm hoping that it was this combination of said mismatched clutch plates that was the likely cause of my 'Clutch Slipping' problems (Fingers Crossed . . . I certainly hope so).

I can't wait to get my MAC back on the road again and this time . . . I am optimistically confident that ALL of my Clutch Slipping Problems will be resolved.

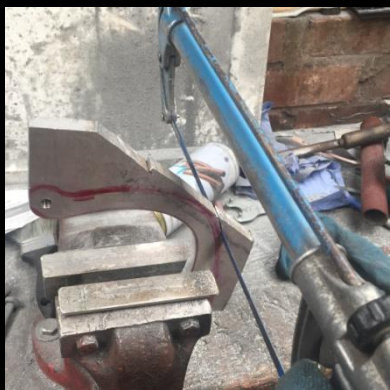
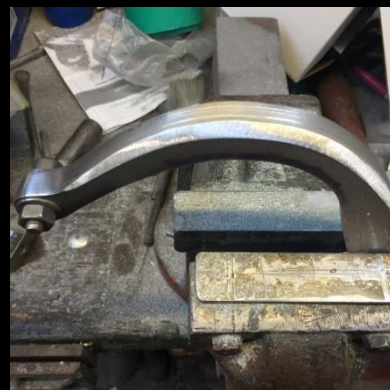
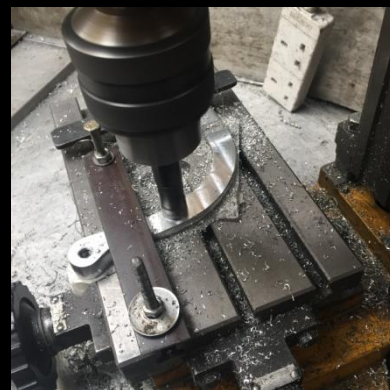
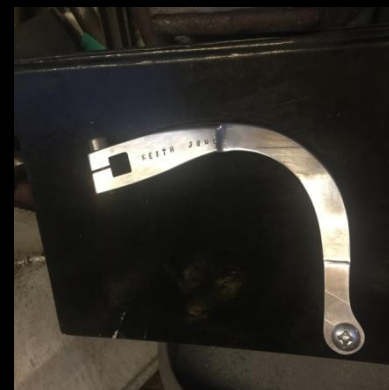
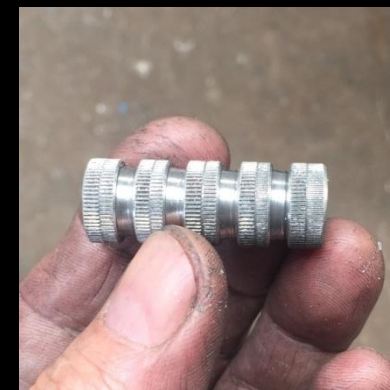
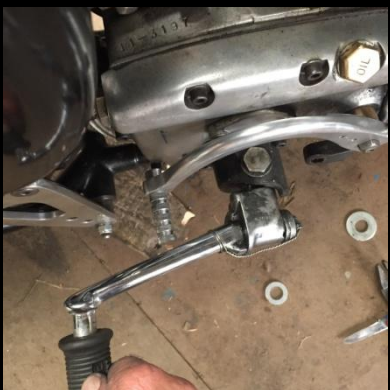
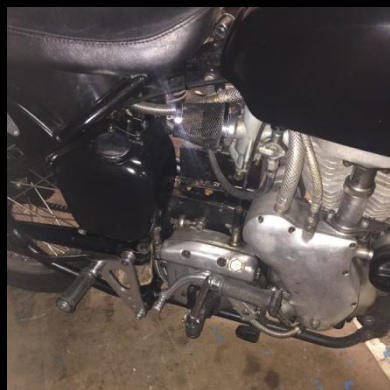
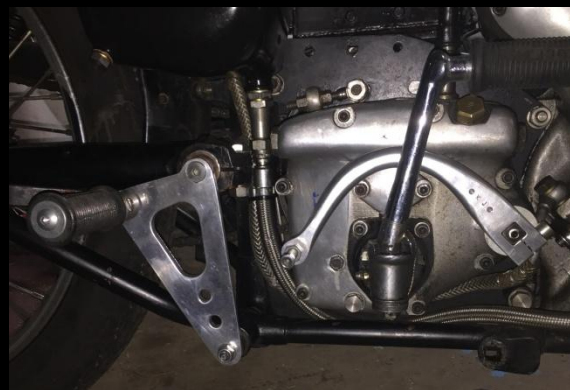
After many weeks of Covid Lockdown . . . which I have spent most of my 'Self-Isolating / Lockdown' time working on the Venom rebuild (go see the Venom progress by 'Clicking' onto the Venom Link on the home page). So, the latest work done on the Venom has found its way onto the MAC. I decided to 'Try-out' the new Rear Set Rest Footrests (that I've made for the Venom) on the MAC. But before actually using them . . . I had to make a new Gear Change Lever – to go with the new Rear sets. I made the Lever out of a flat sheet of 13mm thick Dural plate. I made a cardboard template and then transposed the shape to the Dural plate. Hand-cut and shaped, milled and drilled, turned a few things and finally (after removing the original footrests and gear change) I fitted the new parts.

After fitting the new Rear-Set Footrests and gear change mechanism, I took the MAC out for a good test ride.

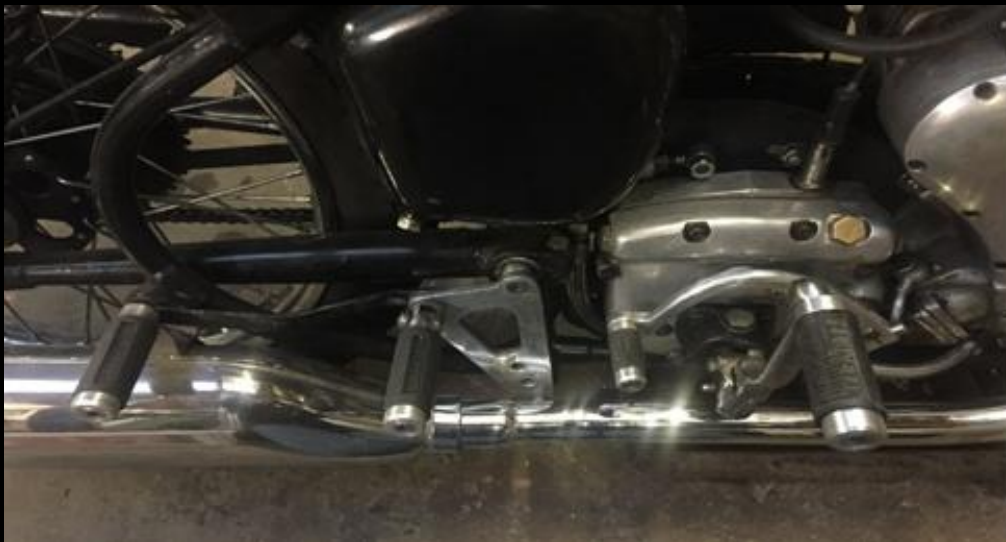
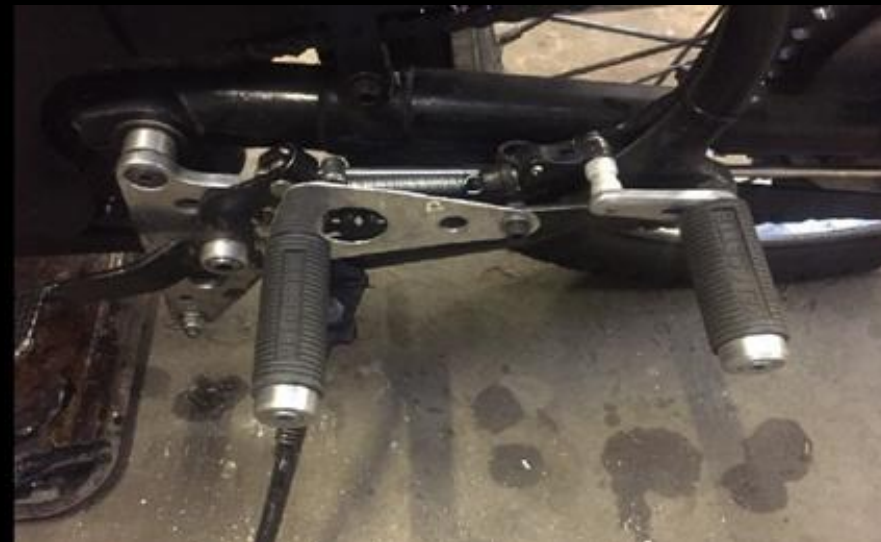
31st August 2020: I've finally got around to finishing-off the end of each footrest with an aluminium-turned-boss. Each one is now held in place by a stainless steel cap head bolt (countersunk into the aluminium boss), including the new (amended / redesigned) gear change lever. I decided to make three 'Fixed' footrests (rather than the usual 'Folding Footrests'). The only folding footrest now is on the front off-side (to clear the Kickstart Lever).

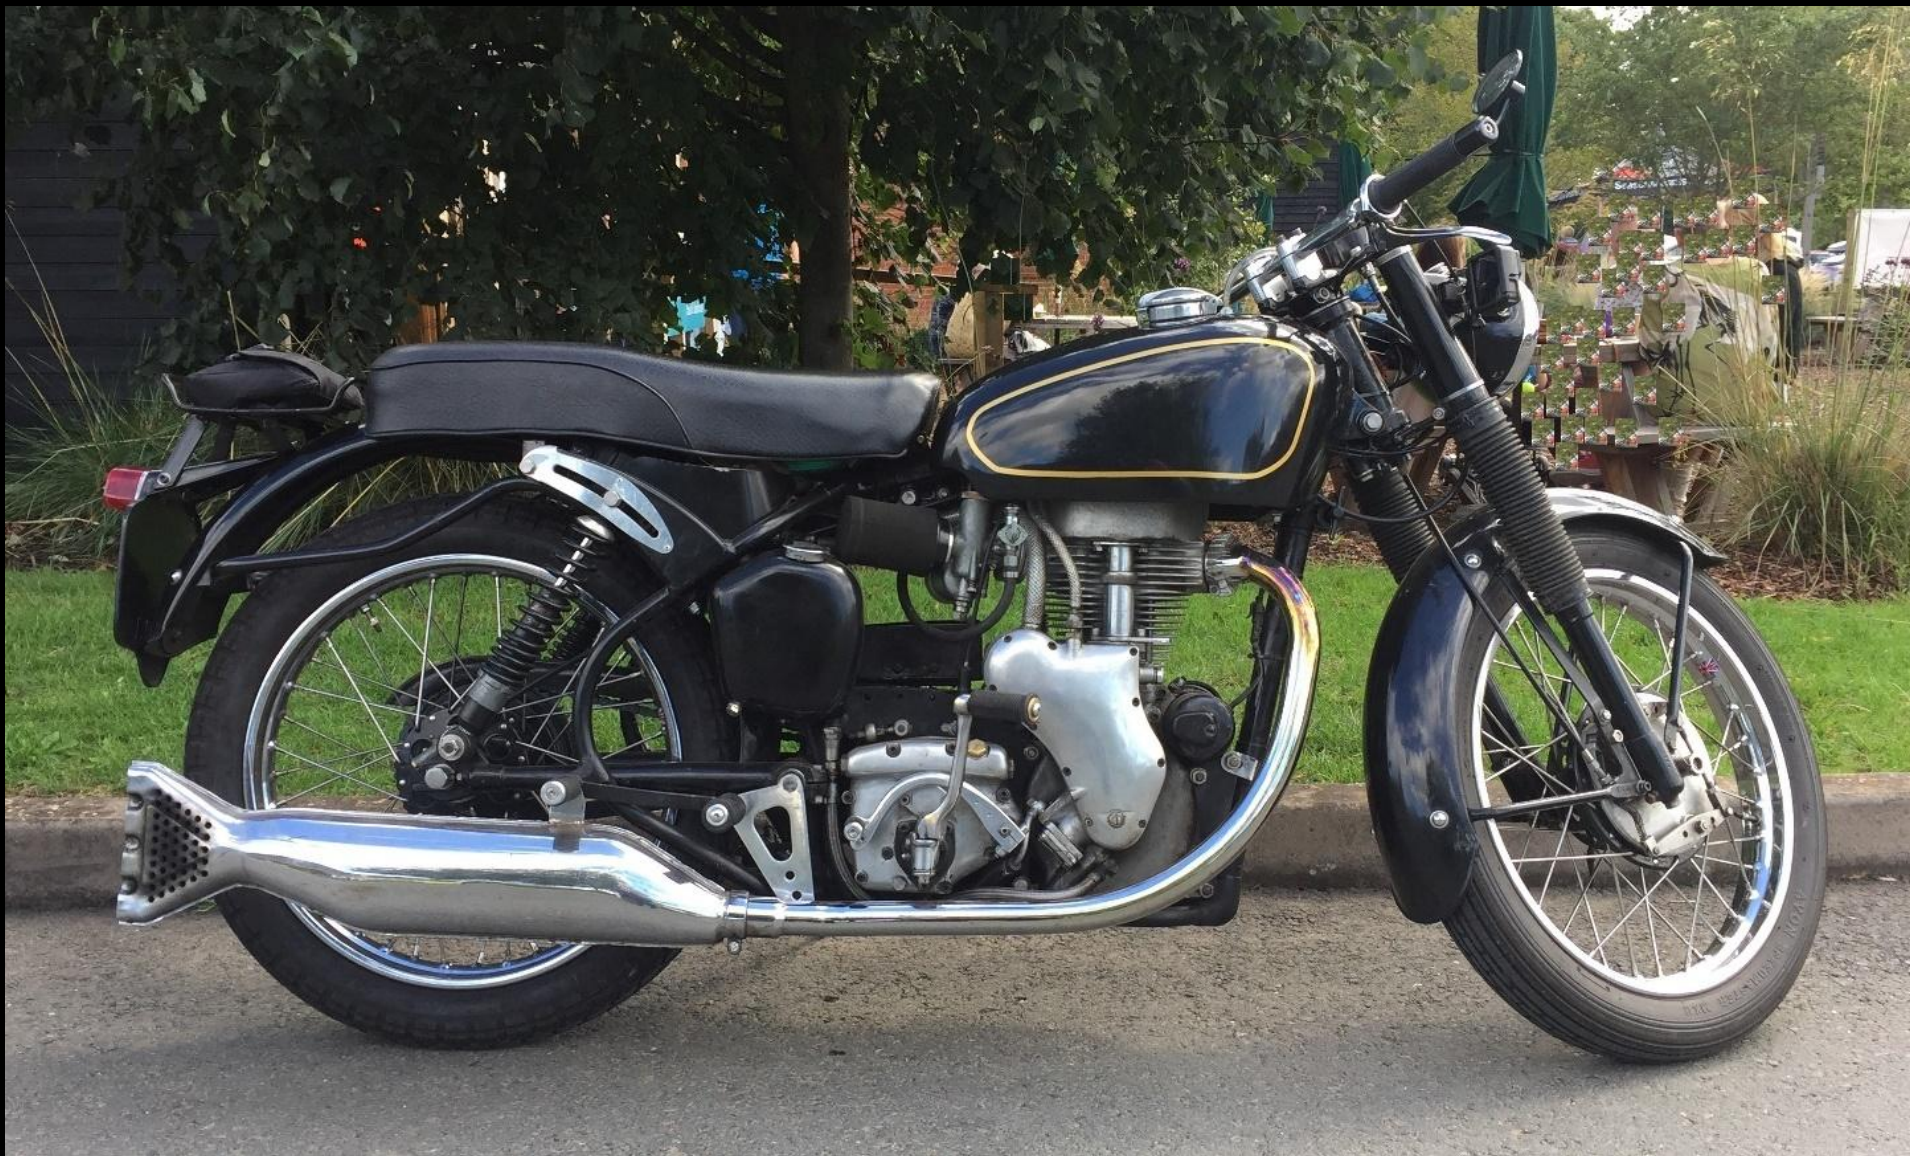
Photo below: as can be seen . . . I've finally put the gold stripe onto the MAC Tank. So it's looking a lot more Velocettified than ever.
