Velocette MAC 350cc

Rebuild Project Part Two

November 2018 to November 2019

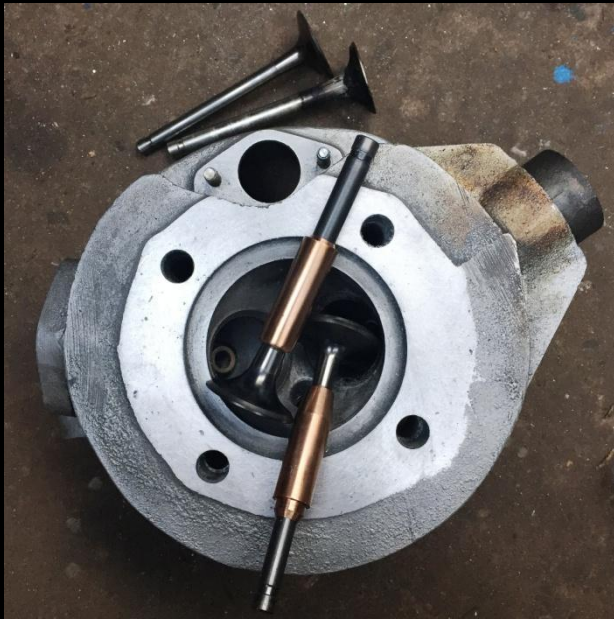
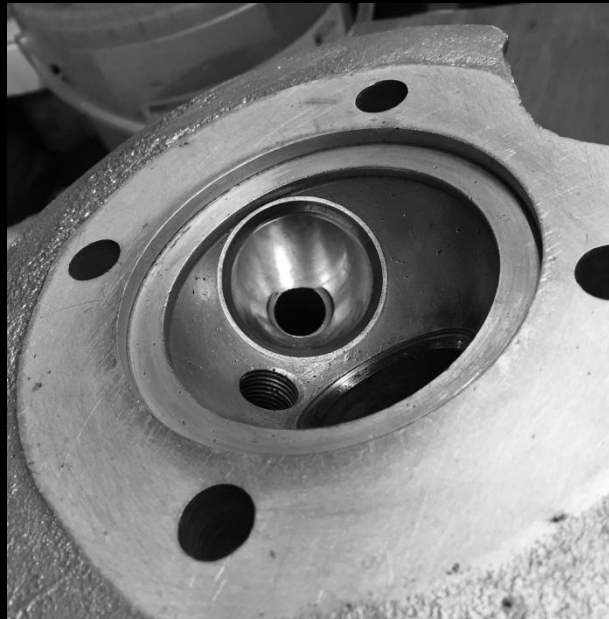
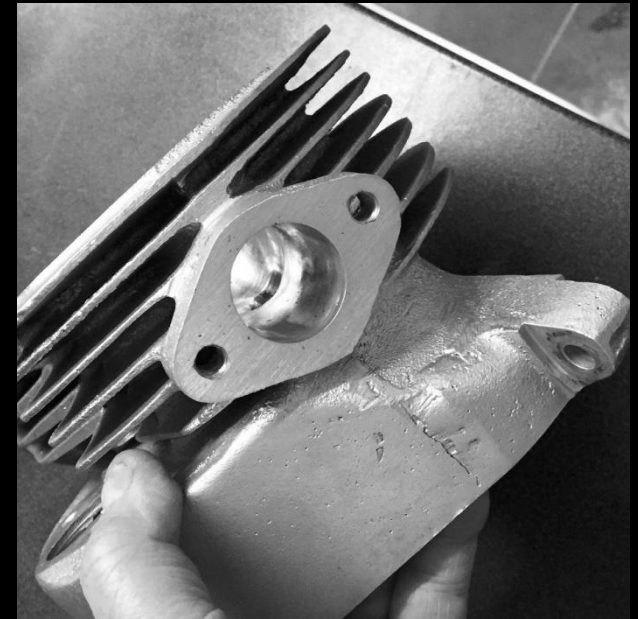
(Photo above Left) My new Inlet & Exhaust Valves with 'Plasma Nitrided Stems' and a pair of high duty Venom Colsibro Valve Guides to be fitted, as well as a pair of new Valve Seats to be inserted (suitable for Non-Leaded-Petrol) which will be expertly machined to fit as I have entrusted this job to Criterion Engineering Ltd. I removed the old Guides after heating the Head in the Kitchen Oven for 35mins, and then polished the rest of the Valve Port (nearest the combustion chamber) to match the already polished inlet manifold end. Tony Mortimer (via Criterion) will be fitting the new Alpha Bearings Big End to my MAC Flywheels.

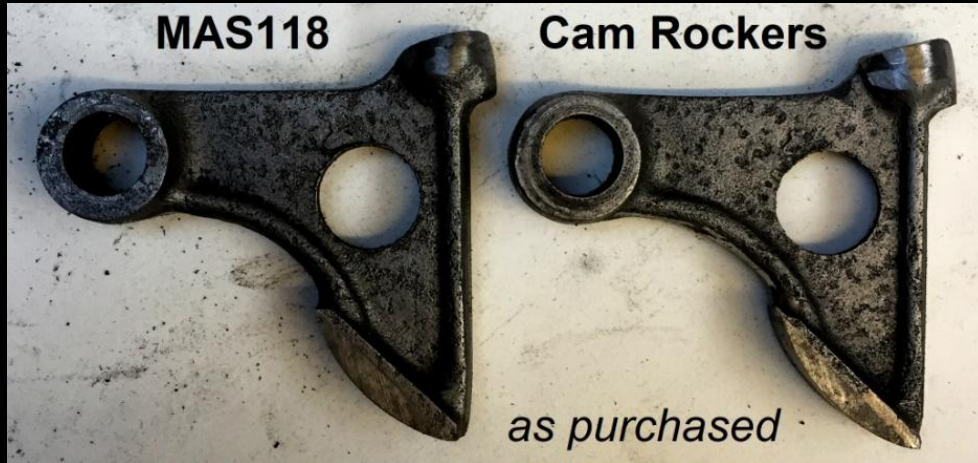
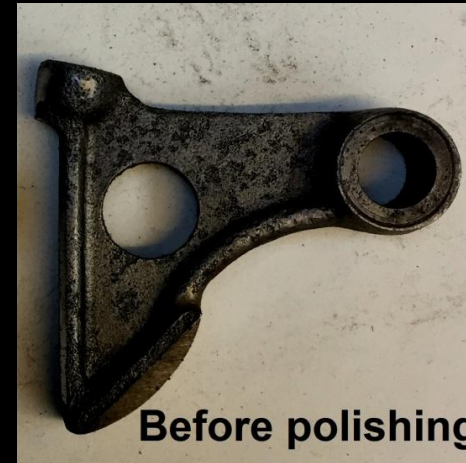
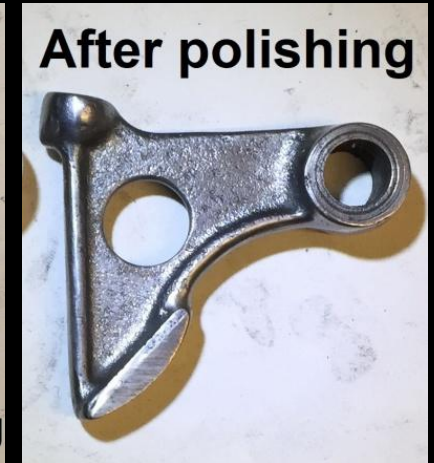
Once more, I need to Thank Rick, who managed to source a pair of MAS118 Cam Rockers / Followers, via a VOC acquaintance of his. This enabled me to purchase a pair of MAS118's. They did cost an 'Arm & a Leg' and are apparently "as Rare as Hens Teeth" or as my old Granny would say . . . "these Followers are as Rare as Rocking Horse S**t"! Okay! Granny would NEVER have said that, but these 'Followers' are 'Quite Rare'. Also; because there are NO MORE NEW ONES available . . . the condition is . . . Well! They are; "as they are, and as they come, and as you can find them". So, I just had to buy them whist I could!

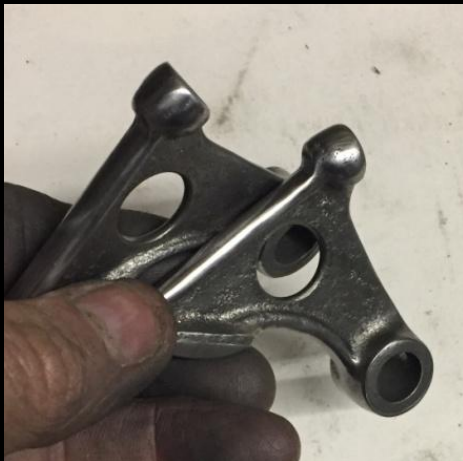
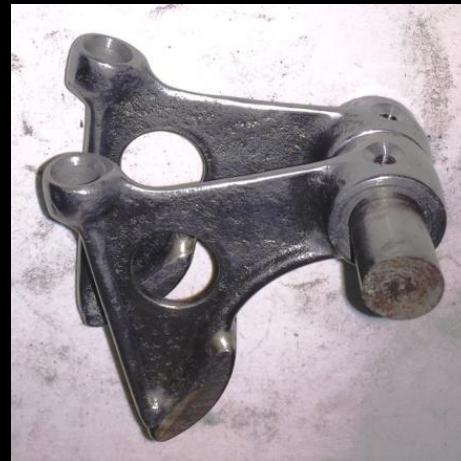
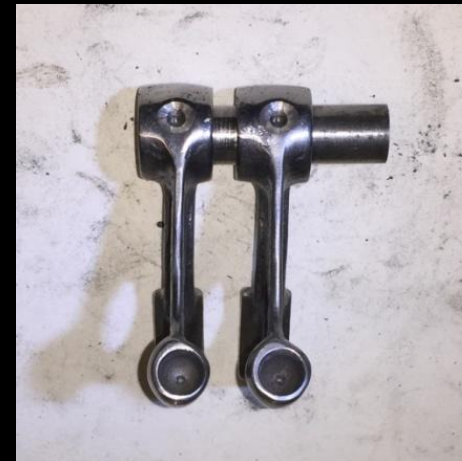
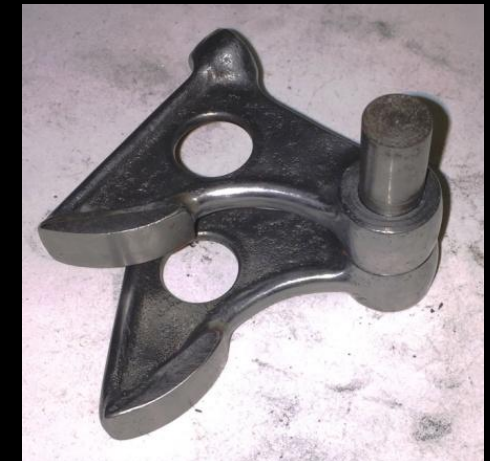
Photos below: A selection of different views of my polished MAS118 Cam Rockers. I know this is a bit OCD, but I've even got each 'Cam Follower' to weigh exactly the same. I have increased the probability of the Cam Followers getting 'MORE OIL' to the Bearing Surfaces & Follower-Shaft by increasing the size of the Lubrication Hole in each Follower and then 'Counter-Sunk' each oil hole (to provide a mini-funnel effect) to help guide vital lubrication to where it was originally intended to go.

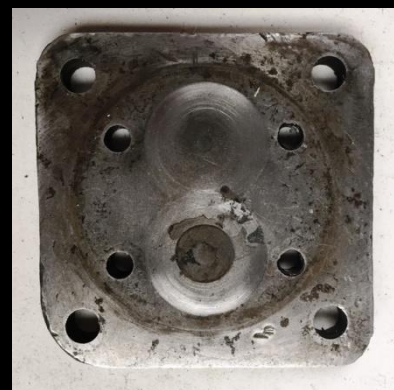
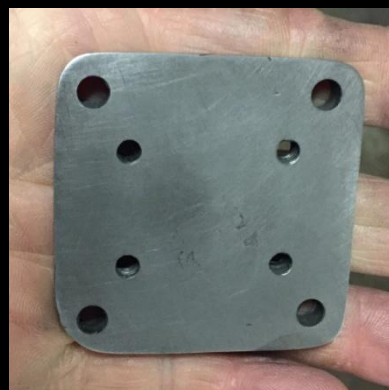
As you can see from the bottom row of photographs (the first two photos Left), I have re-ground the Base-Plate on the internal bearing face. I used fine Grinding Paste (mixed with oil & paraffin) and very laboriously 'Hand-Ground' the Base-Plate on a Machined Steel Flat-Plate. The result is quite evident.

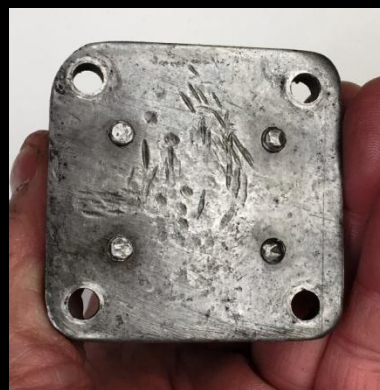
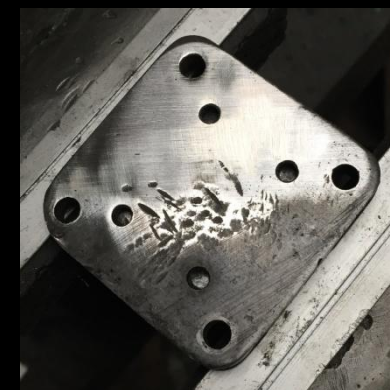
The next two photos (Right): Show the brutal hammer marks that some ham-fisted moron had inflicted on this poor little Pump fitting it into the Engine Crankcase.

p.s. the last photo (above right) shows a half-done base-plate

Unfortunately, the 'Hammer-Marks' on the base of the Oil Pump are not the only signs of damage. It looks like some ham-fisted *Numptie* had tried several attempts to hammer-home the oil pump into the crankcase (Dhoe!!!), and in doing so, has caused quite a few unwelcome gouges & worrying marks. I will obviously have to sort this problem-out before the Pump goes back in, although I'm not exactly sure how I am going to overcome this 'Challenge' yet.

The condition of the external Base-Plate is more cosmetic and so 'Linishing' the dents & marks out was a lot easier and a less arduous job.

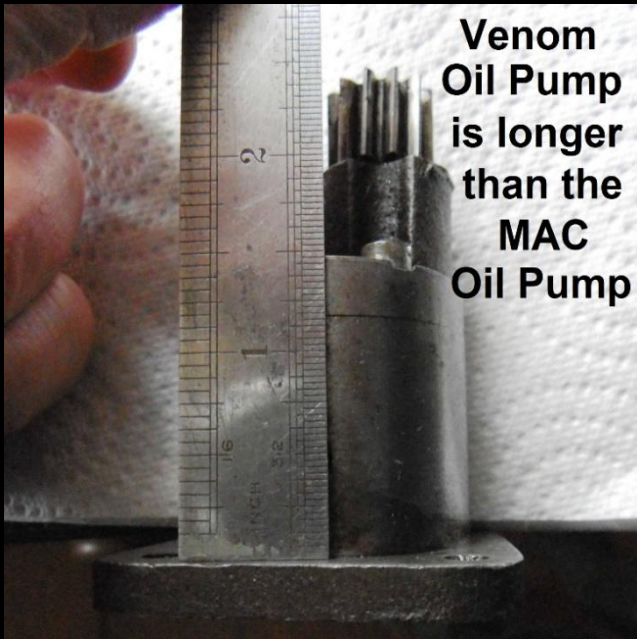
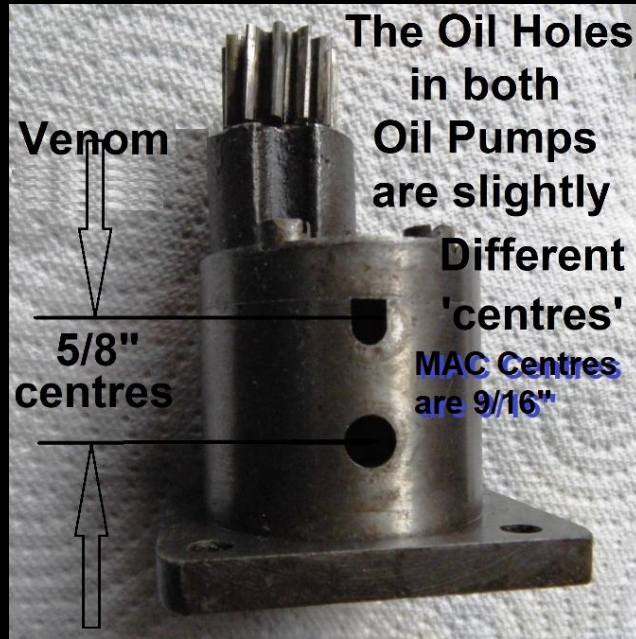
As stated above; my Velo Mentor & Friend Rick has provided me with this Venom Oil Pump, which is in great condition (see photos Left).

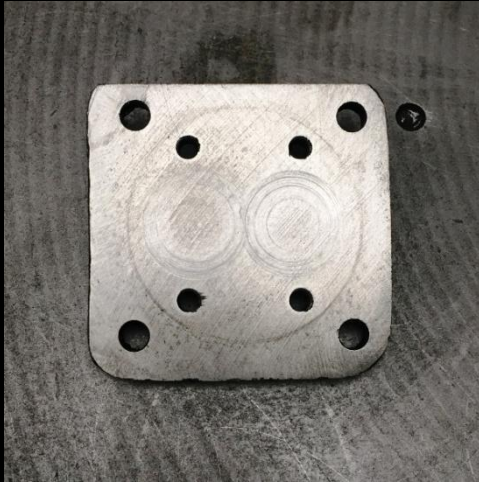
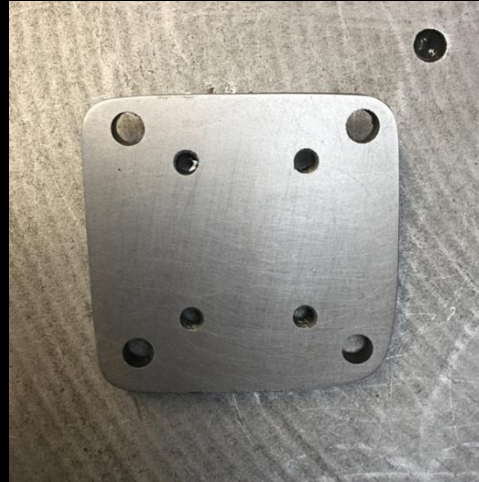
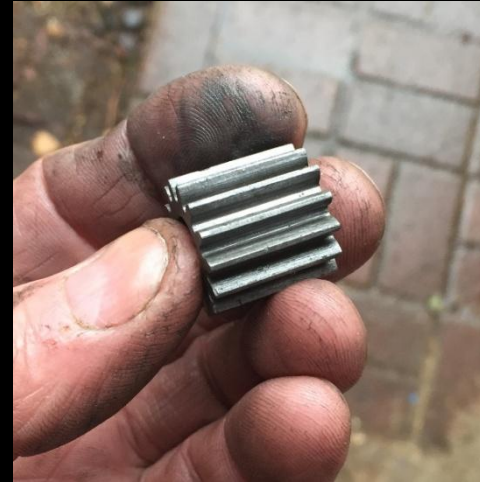
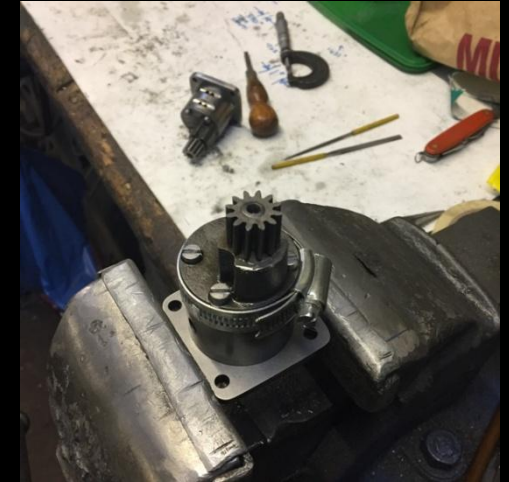
First Photo below left = Venom Base-Plate, showing only slight marking (made by the Gears). Second photo below left = shows the base-plate after it had been 'ground-flat' on my Surface Plate (fine-grinding paste, oil & paraffin). I also used my own 'improvised Tool' for lining-up the Pump Body; instead of Veloce Tool X2719 (photo No.4 below right). Yes, it's a simple Jubilee Hose-Clip, but it appears to do the job of the more expensive version just as well.

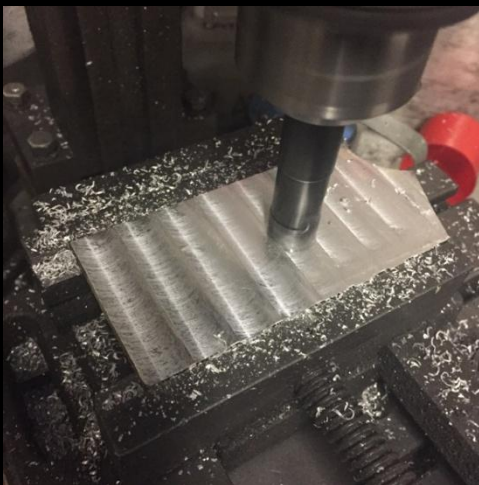
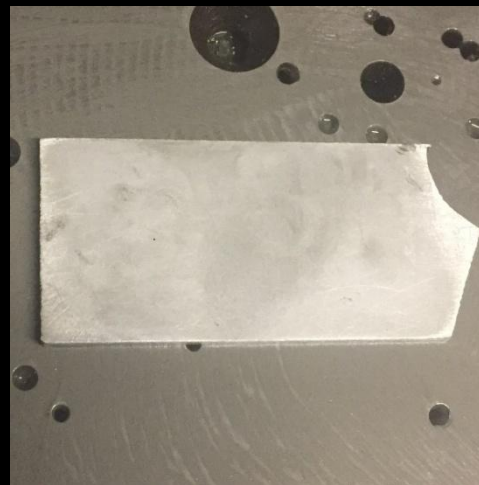
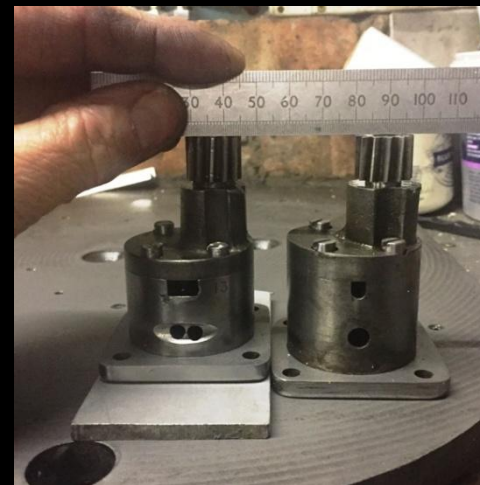
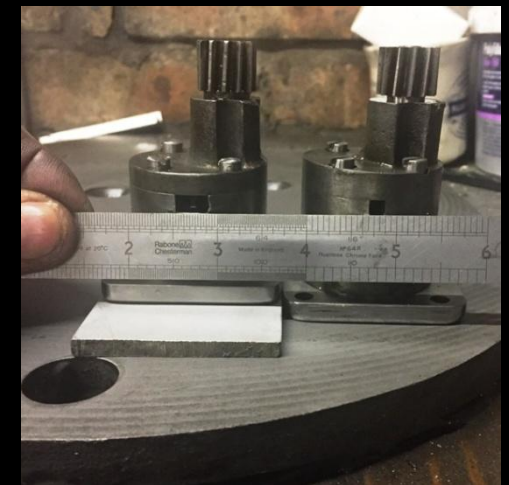
I used a sheet of 6mm Duralumin plate (I've always known this as duraluminium) to make the 'Packing Piece' for the Venom Pump. I milled it (& then hand-ground it) to the desired thickness (see the first two photos below), ready to be re-shaped and drilled to fit over the Venom Pump Body. The difference in height between the two Pump Bodies is 5mm. I was also going to 'recess' this plate with a couple of chamfers on each 'Face' to accept 'O-Rings' to help seal this additional packing plate, but after some thought, I reckon a gasket between each plate (together with Hylomar sealant) should work just as good as the original.

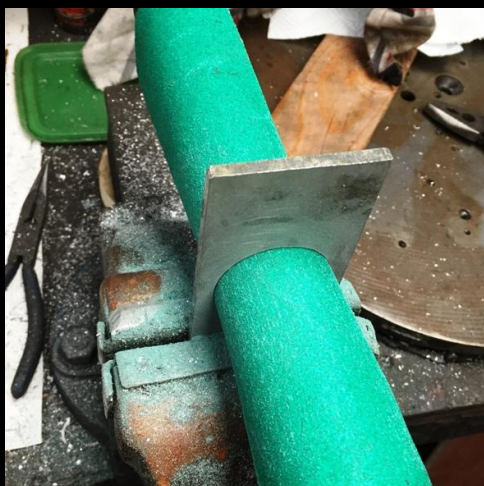
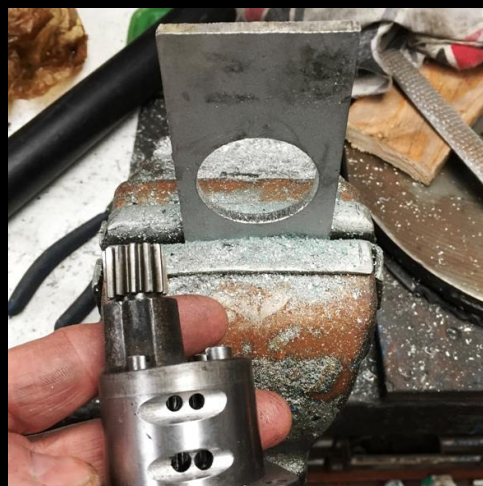
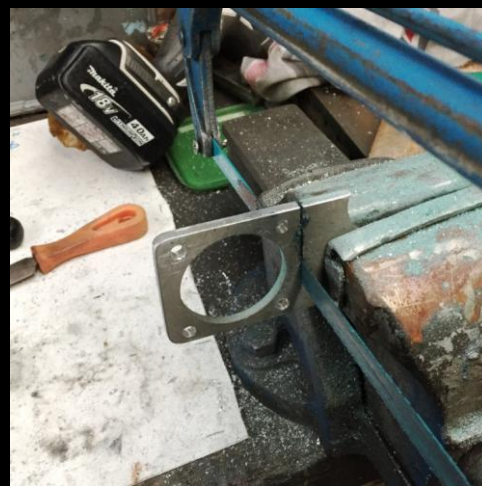
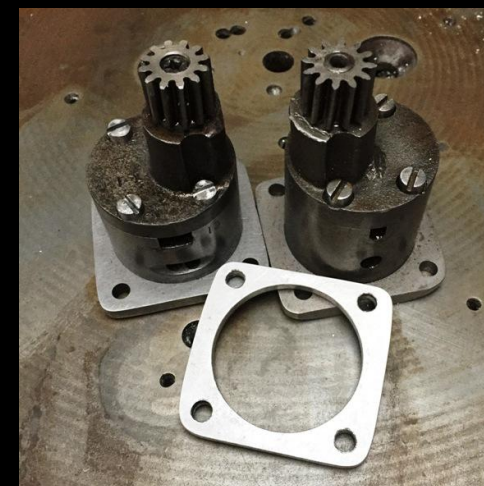
The photographs on the next page show the new 'packing plate' being completed; i.e. drilled, filed, sanded, sawn, and a final lapping, etc (for Venom Pump).
Another 'Job' . . . near completion.

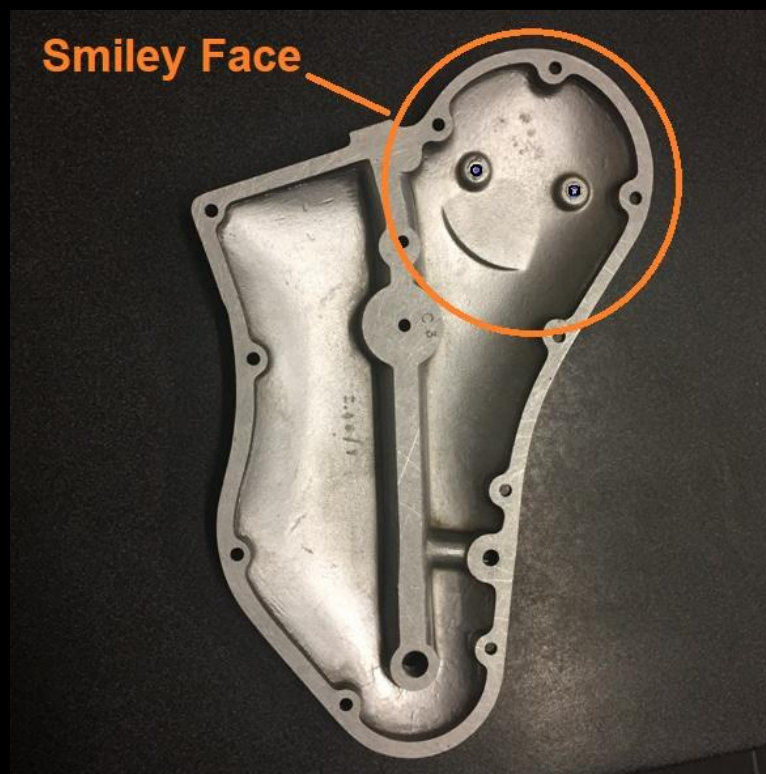
The Timing Case (photo right) shows the gasket-joint-face of the inside cover that I ground flat. Once more, using fine grinding paste & oil mixture, I lapped the timing cover 'Flat' on a Steel Ground-Plate. Using a figure-of-eight motion for some considerable time, but the end result was well worth the effort.

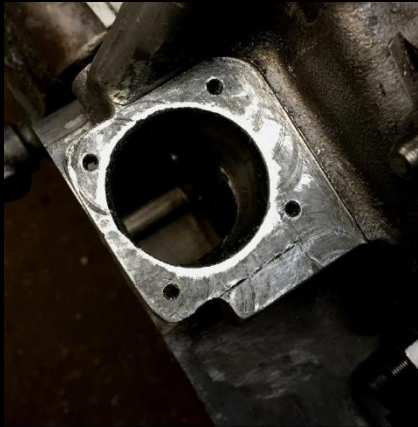
The first photo on Left, show the face of the Oil Pump Base (at the bottom of the crankcase) in poor condition due to abuse, with deep scratches, grooves & dents, and chisel marks.
The second photo on Left shows the Metal Scraper Tool that I used to 'Scrape & Level-out' the Pump Joint-Face.
The last photo on Left (bottom photo) shows the finished (Scraped) surface of the Oil Pump Base.

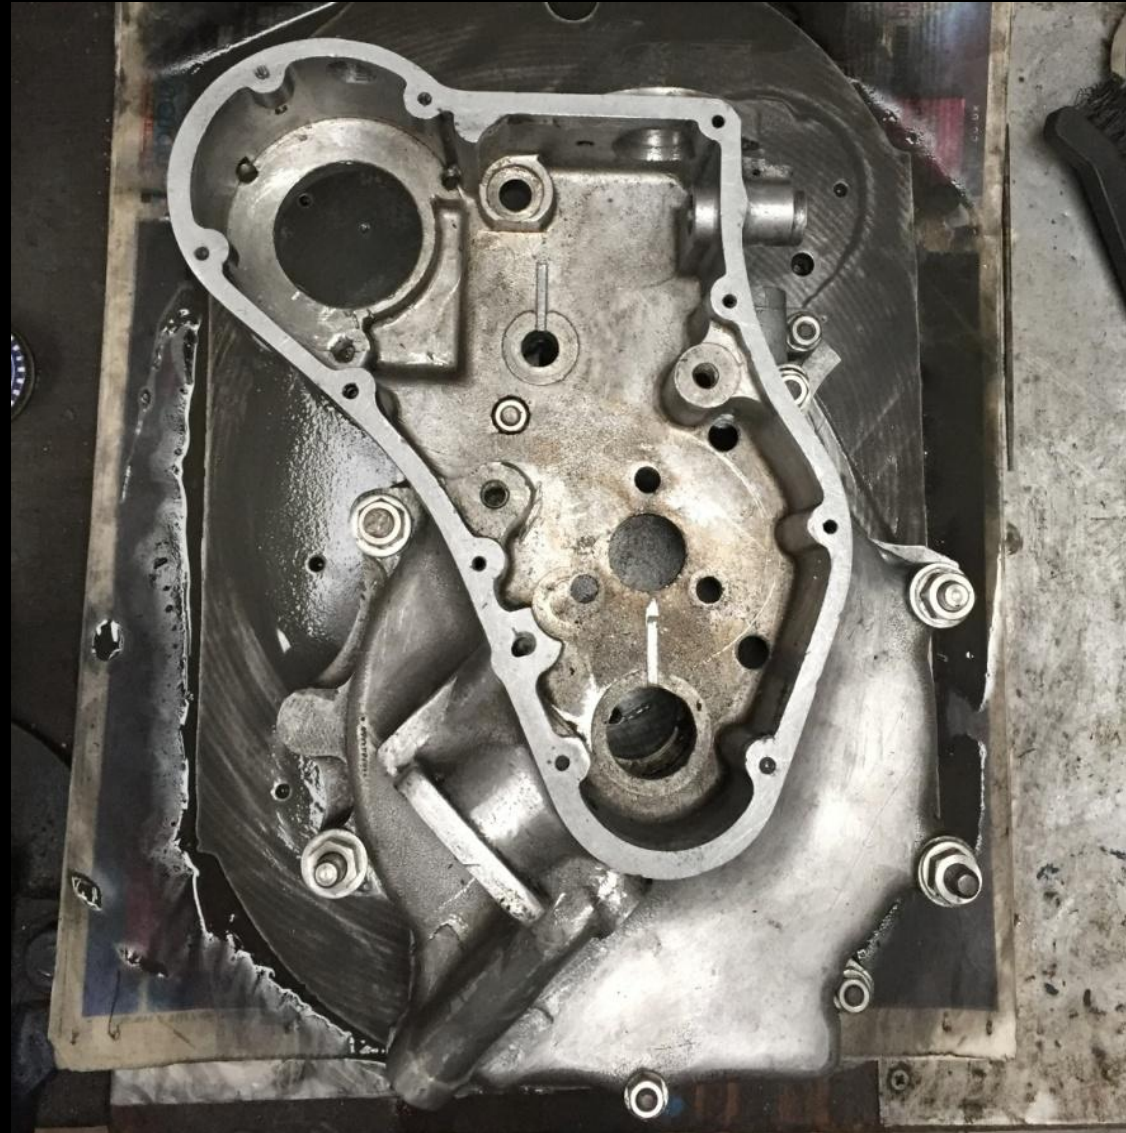
Photo below: shows the Timing-side Crankcase, after 'Lapping' the gasket-face (on my Steel Ground Flat Surface Plate), ready for the *re-faced* Timing Cover (that in true Blue Peter fashion I prepared earlier). The expectation from this rebuild is quite high; regarding the matter of 'Oil tightness'. I'm expecting it to be as oil tight as a 1950's Bike can be.

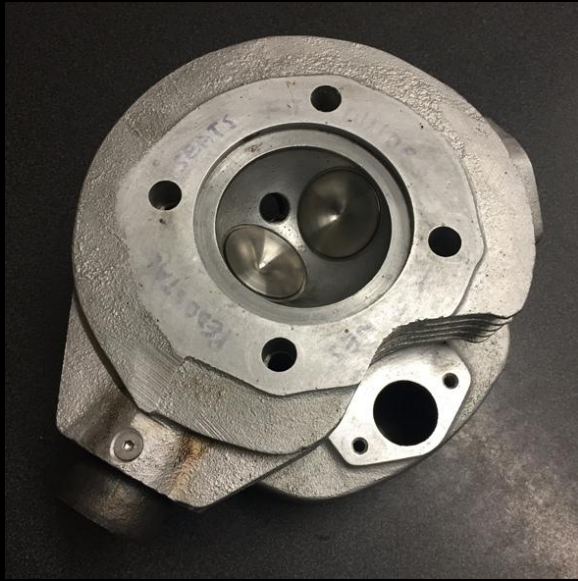
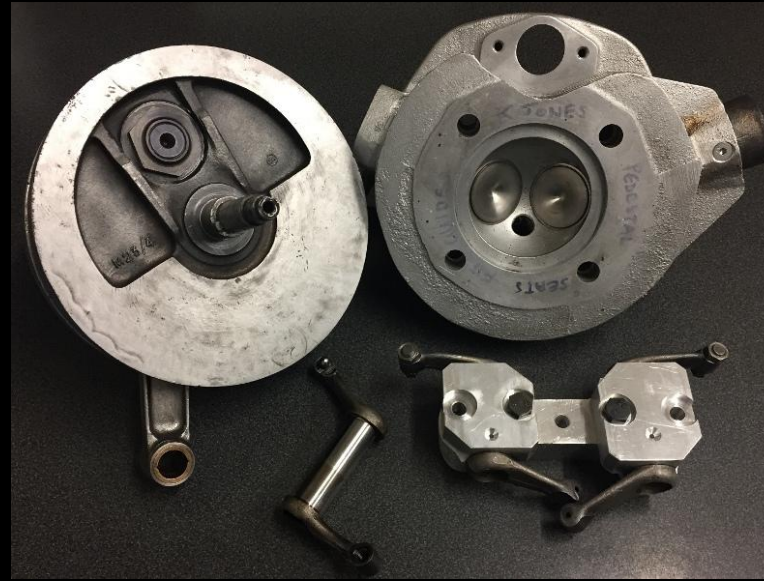
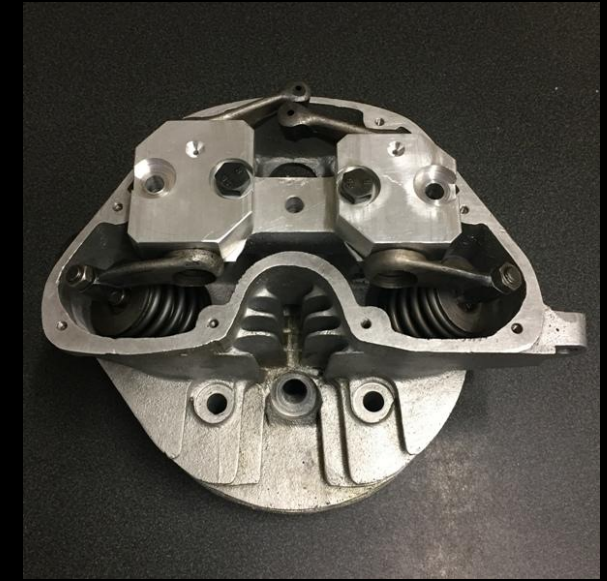
The reconditioned cylinder head & crankshaft (& a completely new & improved Rocker Pedestal) collected from Criterion Engineering on Friday 14th December. An excellent service provided by Stuart & Tony, that will provide me with hours and hours (and hours) of fun, games and enjoyment – reassembling this lot, back together again over the Christmas Hols. Yeah! Just a quick recap: the main new parts fitted being: new 'Plasma Nitrided' Valves, new Colsibro Valve Guides, new Valve Seats, Re-ground Rocker-shafts fitted to new pedestal. Plus new Alpha *Big-End* Bearings fitted into the original MAC Flywheels. Fab-Job-Well-Done.

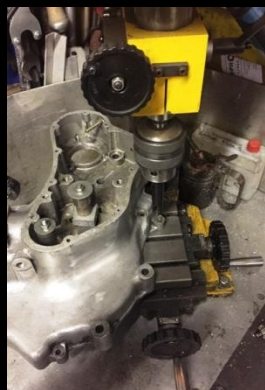
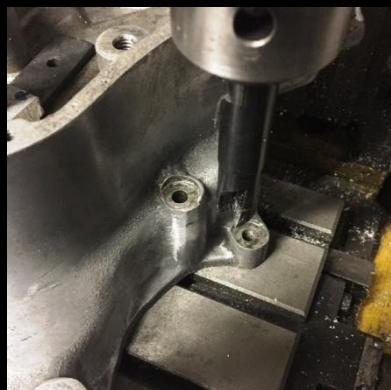
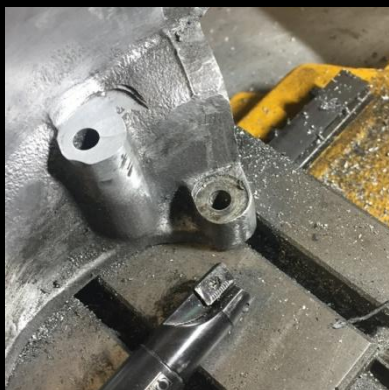
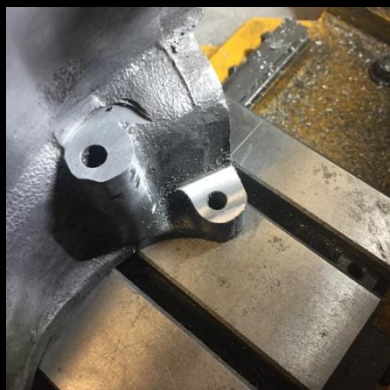
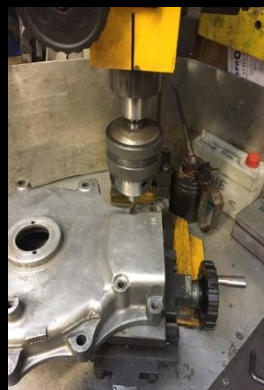
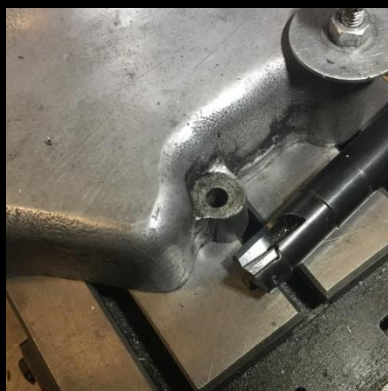
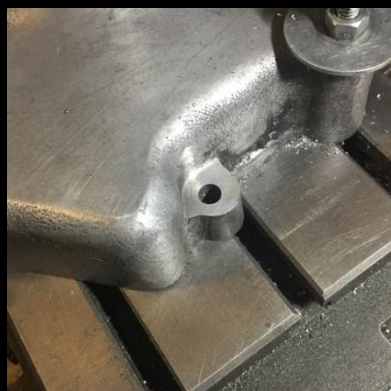
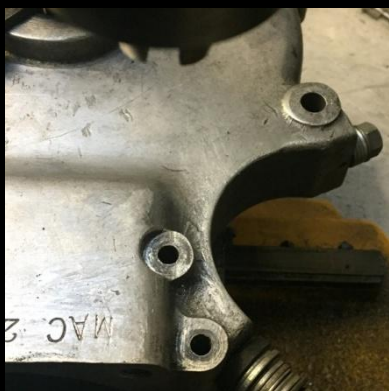
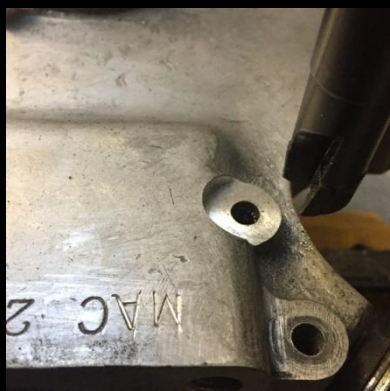
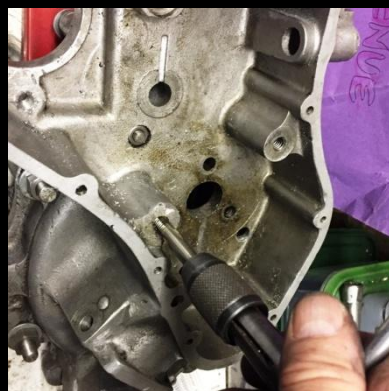
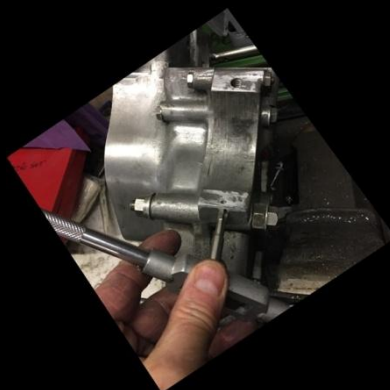
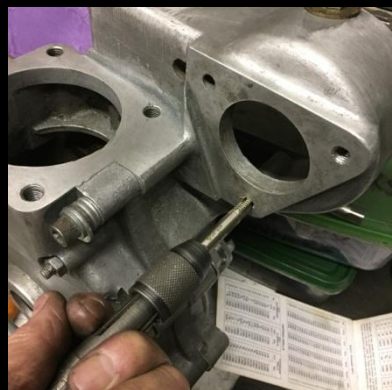
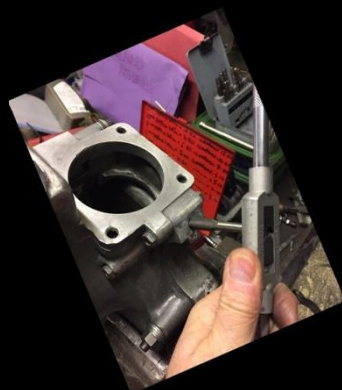
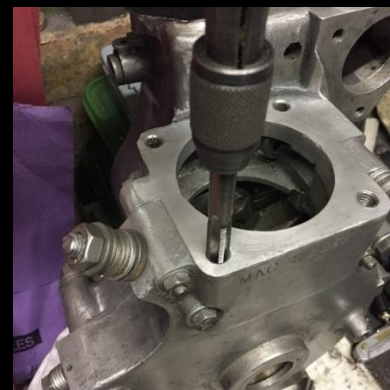
On Thursday 20th December, I managed to get back into the workshop and do a bit more to the MAC Crankcases. I 'chased' all of the threads & re-tapped the 'stripped threads', as well as cleaning-up the remaining clogged-up & dirty thread holes. As you can see in the photos below (some before & after images) showing the 'Milled - Faces' of some of the engine flanges (engine stud-bolt holes). This detail allows a little more room for a Ring Spanner to fit the relevant nut &/or bolt head.

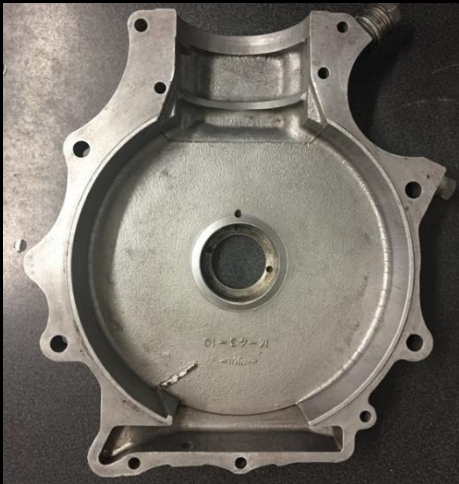
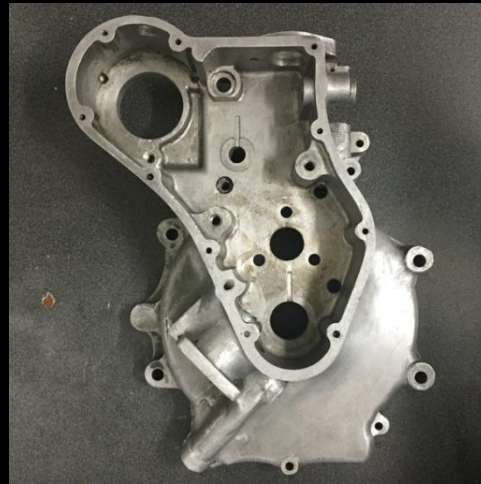
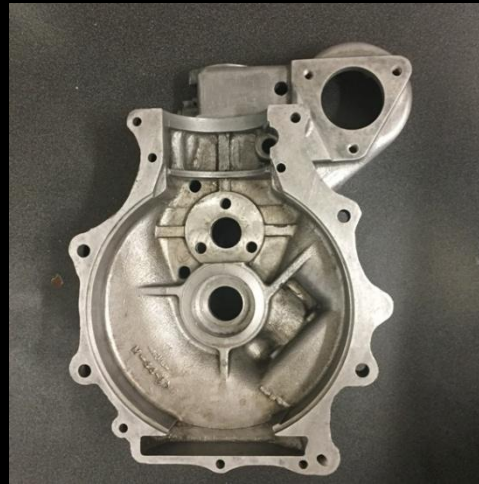
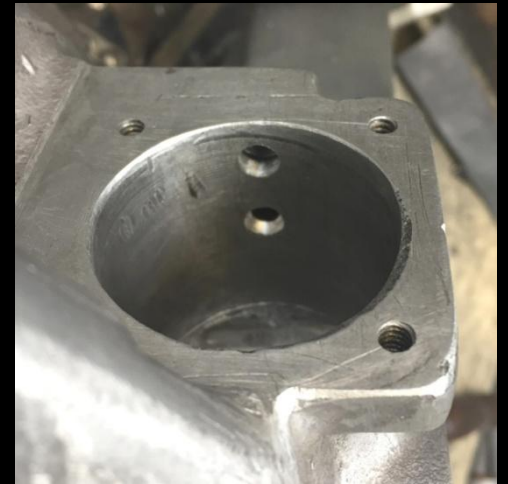
The end photo (above right) shows the slightly larger (drilled-out) Oil-ways to match the Venom Pump Oil-ways. Well, that's the Plan.

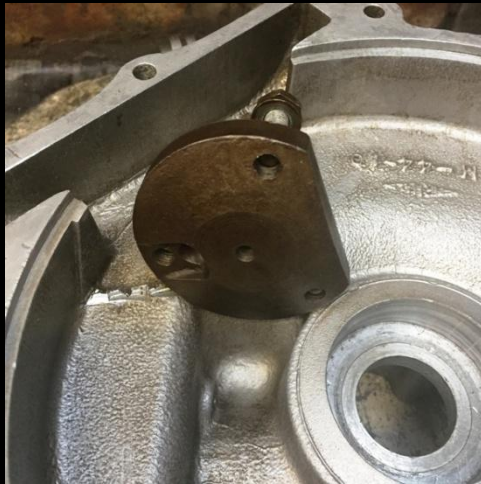
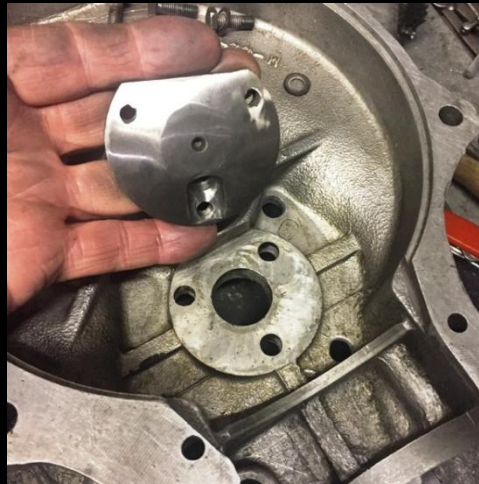
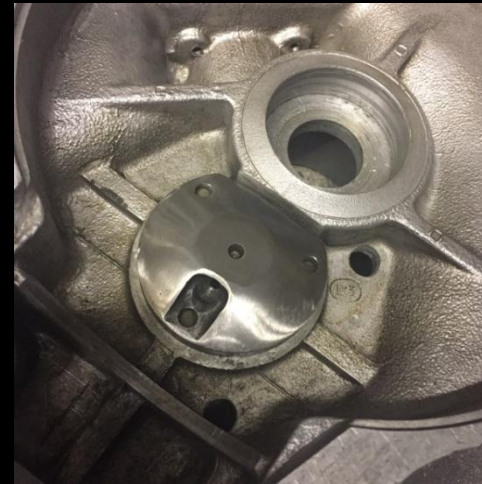
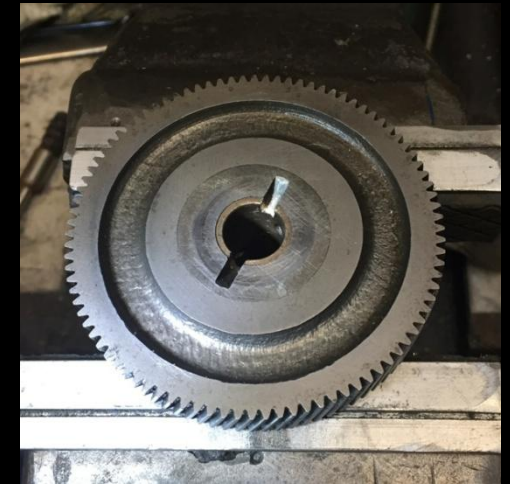
The first three photos below; show the Intermediate Gear Spindle, before & after polishing.

The end photo (above far right): Shows the modified oil feed to the Camshaft Brass Bush, this modification allows 'pressurised-oil' to be 'directed' to the Camshaft Face, where it rests (& runs) against the inner crankcase 'Face'.

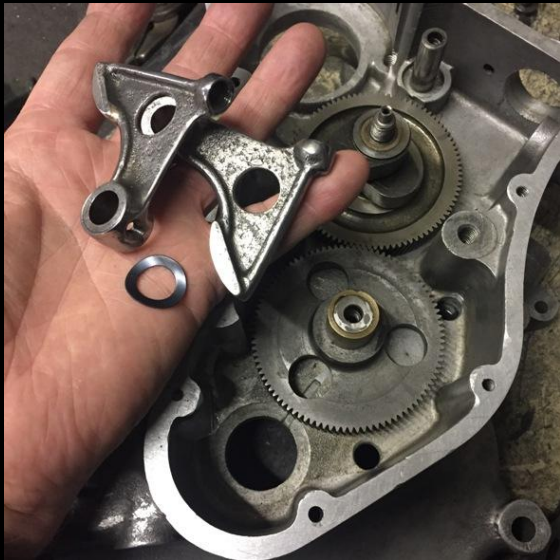
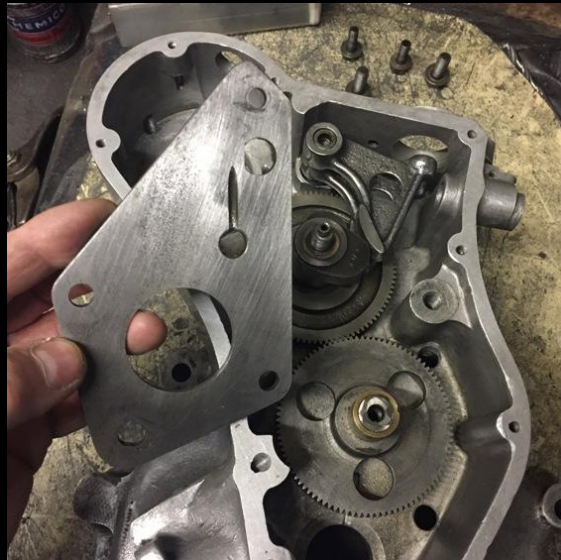
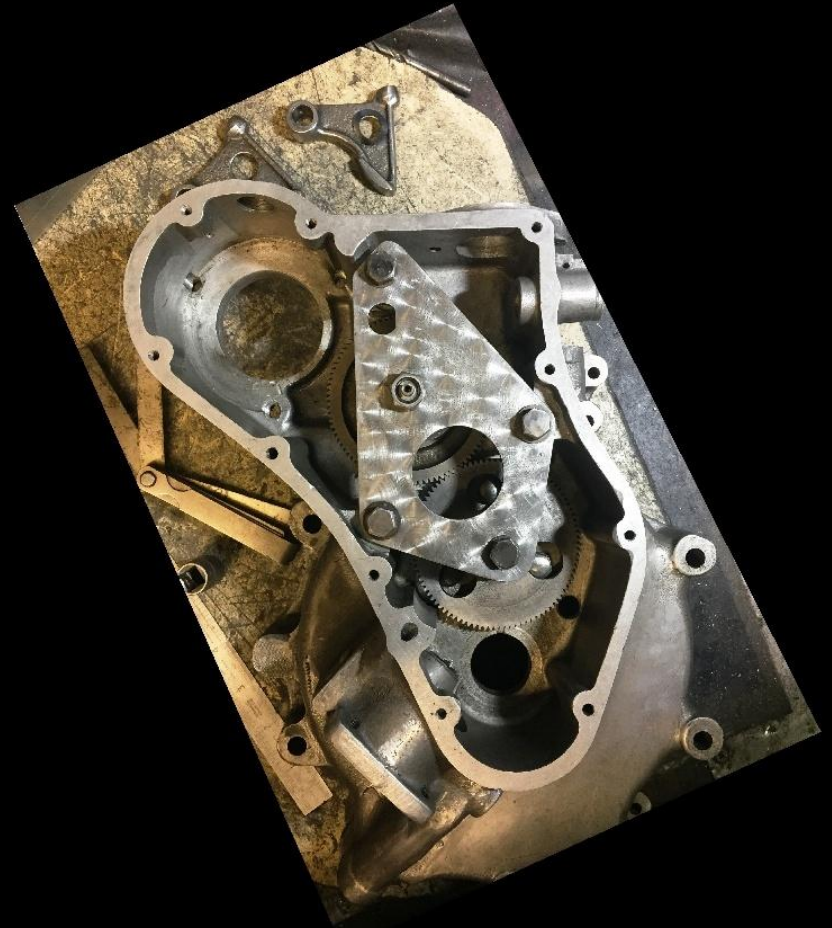
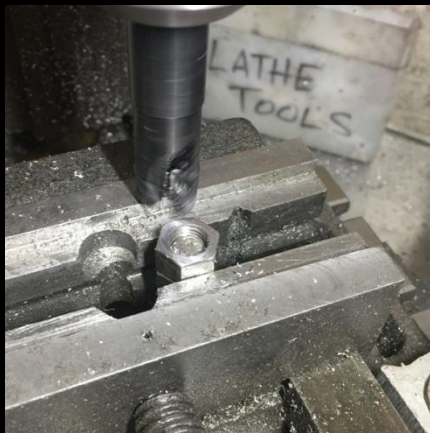
The next job was to 'Set' the 'End-Float' on both Camshaft Pinion & Intermediate Gear Pinion. A SIMPLE JOB (one would think), but quite fiddly. The previous end-float on both of these pinions was in excess of 'Ten Thou" each pinion. The Velocette 'Good Book' states; 'End-Float' should be no more than 0.0015" (i.e. one & a half thousandth of an inch in 'old money').

Note the new Bellville Washer (first photo below left) next to the two Bottom Rockers – aka Cam Followers. This Bottom Rocker Thrust Washer (Veloce Part No. M216) rests next to the Crankcase and takes care of the end-float between the pair of Bottom Rockers (pivoted on the Bottom Rocker Spindle) and the Timing Gear Steady Plate.

This bit of the rebuild took me ages to do because after fitting the Gears & Timing Gear Steady Plate (Veloce Ltd Part No. M199/2) and checking the end float (with Feeler Gauges) the next stage was to remove the whole lot again and make the necessary adjustment (to each Pinion) before re-fitting the whole lot back together again and to re-measure and re-check the remaining end-float.

As you can imagine, this process involved numerous attempts to get said end-float to the required measurement. *i.e.* "Timing Steady Plate On, Measure and then plate off again, re-adjust. Plate back on again, re-measure, etc. etc. Job Done! 0.0015 end-float achieved (but with an embarrassing number of attempts).

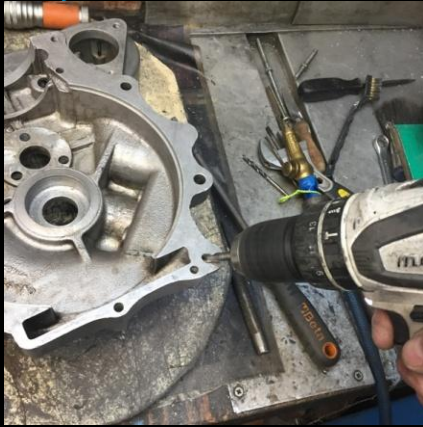
The first photo (left) shows the Return Oil Way drilled-out from $\frac{1}{4}$ " diameter to 6.5mm (larger diameter than the original oil way by 0.059"). This modification (together with the 'mod' in the next two photos right) is intended to help get more oil from the bottom of the engine back to the Oil Tank – quicker.

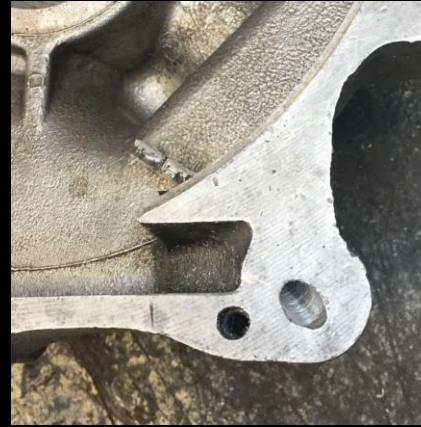
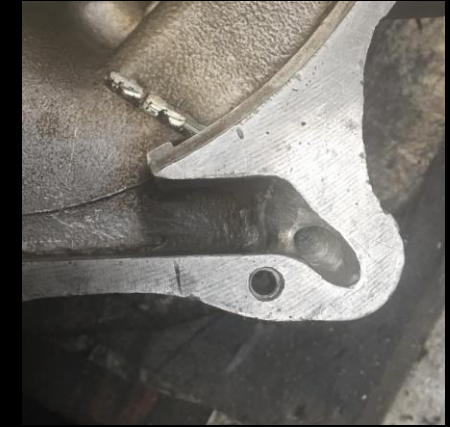
The photos right: shows the detail of the modification mentioned above re; bottom oil pickup area.

As can be seen; material has been removed from the 'off-side-crankcase', so that 'drained engine oil' can be picked-up from both sides of the bottom of the crankcase (instead of just the near-side-crankcase).

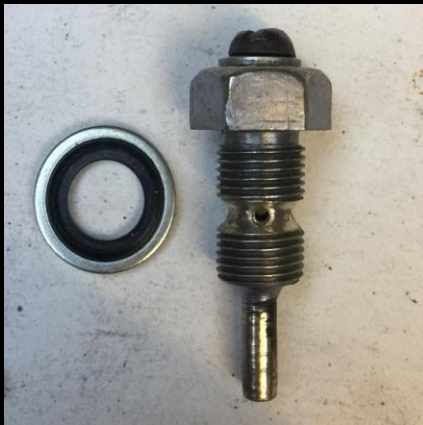
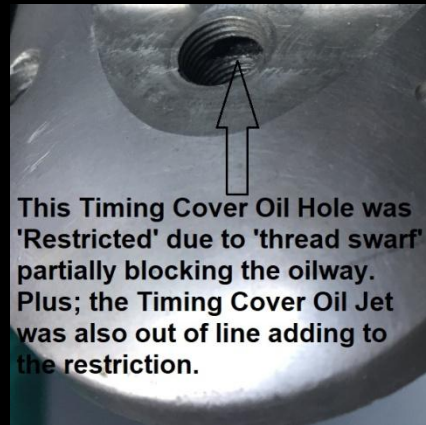
This Timing Cover Oil Hole was 'Restricted' due to 'thread swarf' partially blocking the oilway. Plus; the Timing Cover Oil Jet was also out of line adding to the restriction.

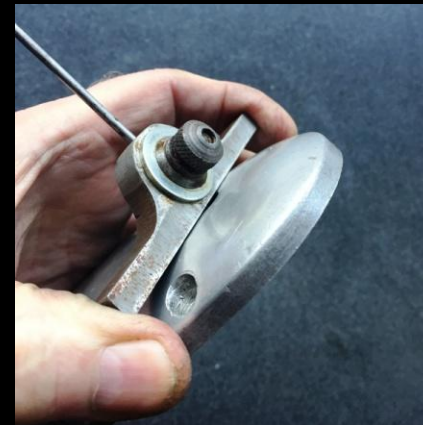
The photos left show the Timing Cover Oil Jet (Veloce Part No. M212) which feeds the Crankshaft Big End, as well as the corresponding Timing Cover 'drilling' where it fits.

I'm surprised that any oil ever reached the vital engine components, as there was only a very small aperture exposed. I used a Depth Gauge (end photo left) to find the 'oil hole centres'.

I enlarged the oil hole in the Timing Cover by removing 'thread swarf' & have widened the groove because said 'Oil Groove' didn't line-up properly with the 'Oil Hole' in the Timing Cover.

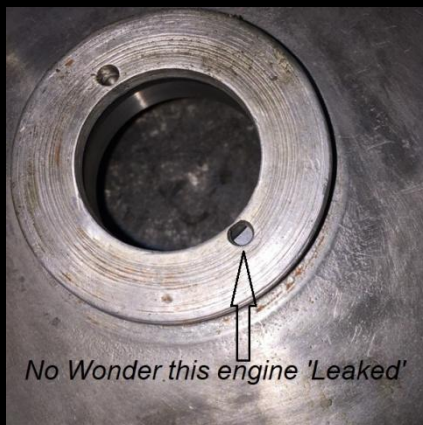
No Wonder this engine 'Leaked'

These 'extra' holes (photo left) 'drilled' into the drive-side-crankcase (by previous owner) annoy me & surely cannot help engine oil-tightness.

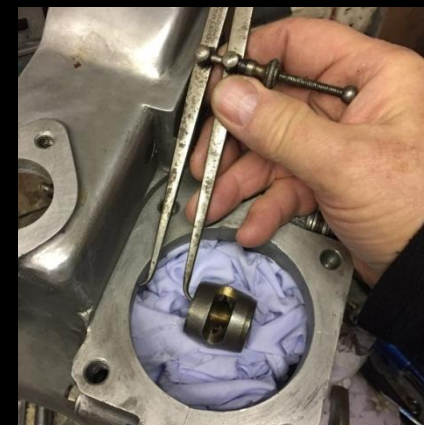
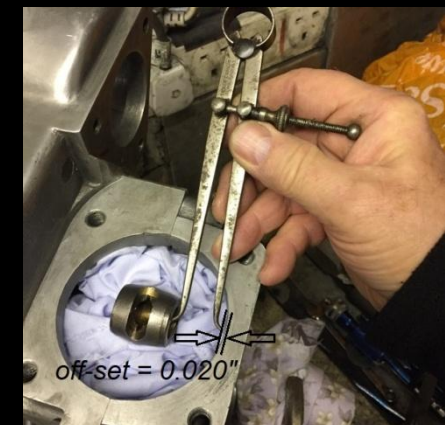
The two photos right; show the gap being measured between the Con-Rod Small End and the Cylinder Barrel aperture. There is a difference of twenty-thousandth-of-an-inch". This means the crankshaft main bearings needs to be re-shimmed; i.e. 0.010" shim being moved from the near-side main bearing to the off-side main bearing housing (to centralise the Con-Rod in the 'Cylinder Bore'.

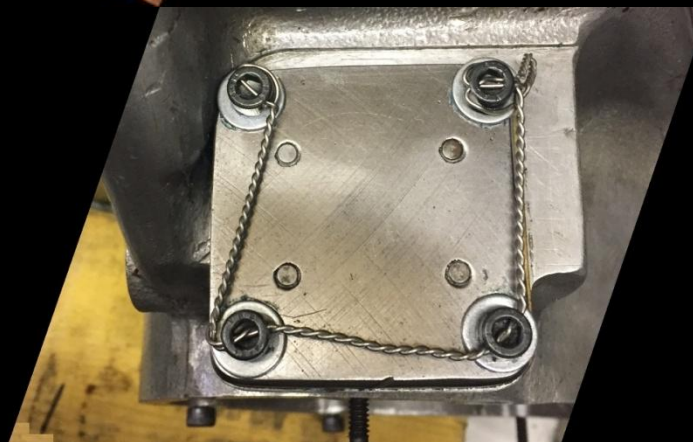
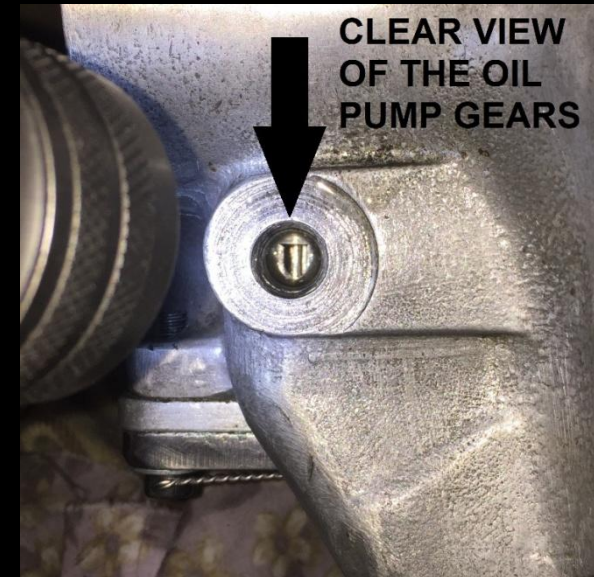
Photo above right:

This photo shows clearly the Oil Pump Feed Gear seen through the Oil Inlet (i.e. The Oil Feed Pipe that goes from the Oil Tank to the Engine).

And also . . . on the other side of the Pump Housing, the Oil Return Gear is clearly visible too.

This confirms to me that I did the right thing; drilling-out the oil-ways, ensuring that the Venom Pump 'Oil Ports' line-up properly in the MAC cases.

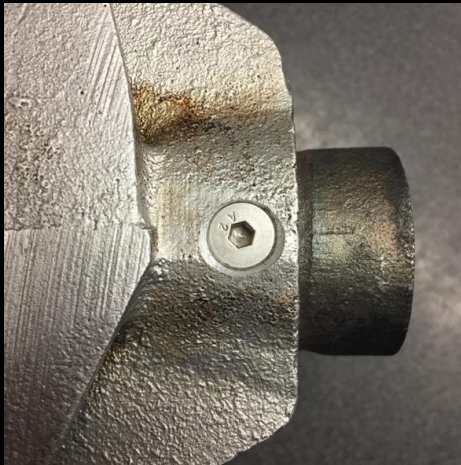
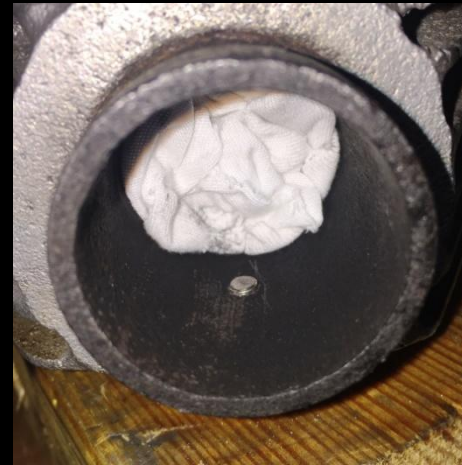
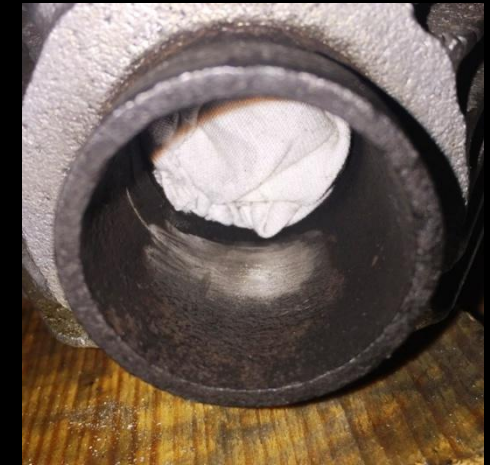
The Cylinder Head & Exhaust Flange was drilled, threaded & secured by this Counter-sunk Allen Pin (photo left).

The next photo (nearest right) shows the *Allen Pin* protruding into the inner-part of the Exhaust Flange (admittedly, not by very much), but nevertheless I felt the need to remove this miniscule thread to get rid of a potential '*Hot Spot*'.

(Photo far right) shows the culprit ground-level, which will undoubtedly have no measurable or significant improvement on exhaust gas-flow whatsoever.

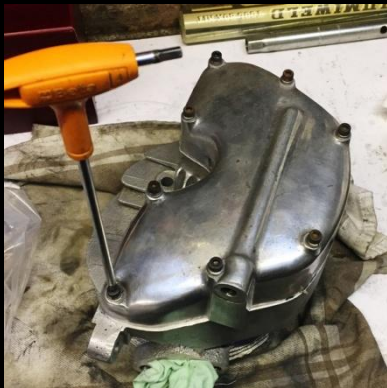
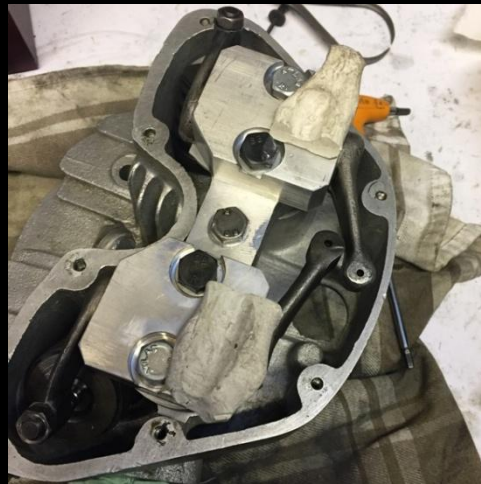
The next job for today was to check-out the Rocker Pedestal modification (both photographs on the left). I used 'white Plastercine' placed onto the top of the new Criterion Rocker Pedestal and bolted-down the Rocker Cover.

I did this to check-out how much room there was between the inside of the 'Cover' and the top of the new Rocker Pedestal. This also provided me with an opportunity to see how close the original 'Oil Hole Jets' corresponded with the new 'Oil Feed Drillings' in the Criterion Pedestal.
