Velocette MAC 350cc

Rebuild Project Part Two

November 2018 to November 2019

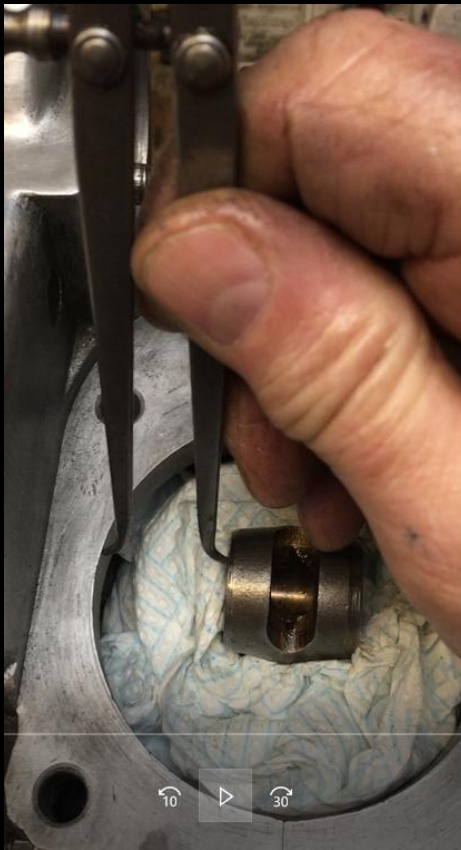
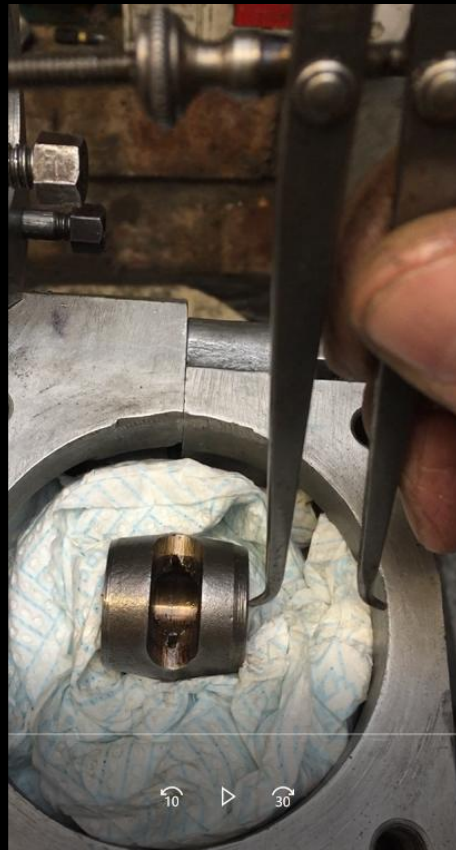
Photos Left: Con Rod 'Dead Centre'.

After re-assembling the engine 'Crankcase Halves' yet again (following re-shimming of the Main Roller Bearings for the final time), I then 'Bolted' said cases together and checked the position of the Connecting Rod in relation to the Cylinder Barrel Bore once more.

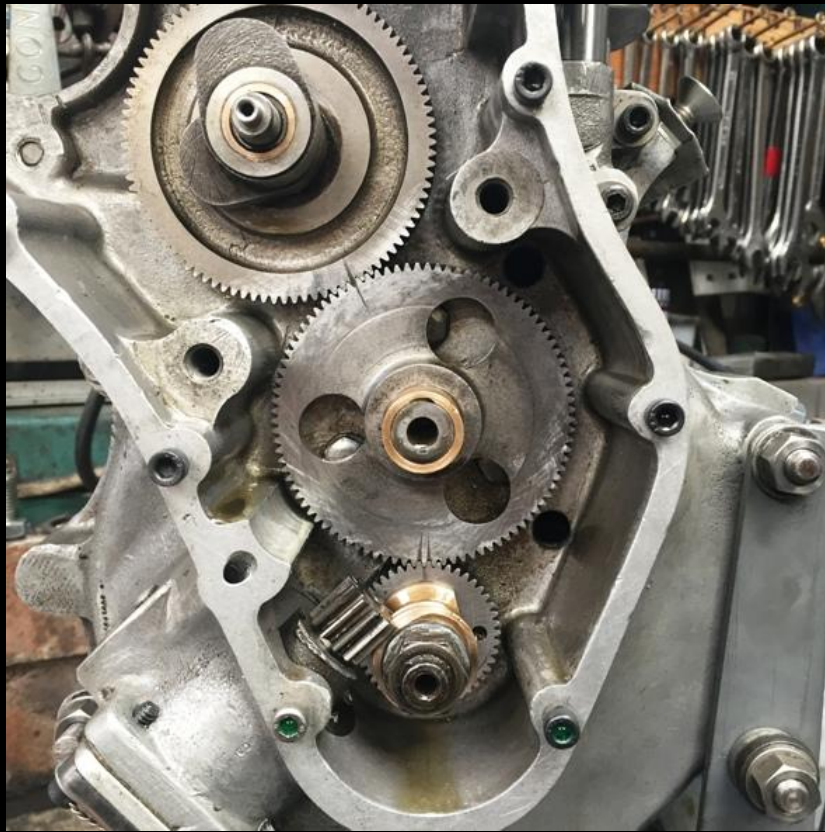
1st Photo (Left) shows the 'New' Valve Timing Marks – 'Set' - with the aid of a Timing Disc attached to the near-side Crankshaft (as above page) and a Dial Test Indicator for Valve movement. Tappets 'set' at the prescribed 0.053" Inlet & 0.052" Exhaust in order to take into account the effect of the 'Quieting Ramps' on Bottom Rockers / Cam Followers. RESULT!

The Good Book says the M17/8 Cam Timing is listed as; Inlet opens 45° BTDC & closes 55° ABDC. The Exhaust opens 65° BBDC & closes 35° ATDC. As stated above, I managed to get the Opening of both Inlet & Exhaust to these tolerances / settings (SPOT ON) but the closing was out by the amount listed on the above page (But, I'm still happy with these results).

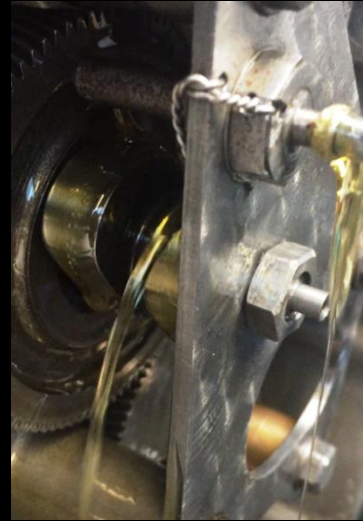
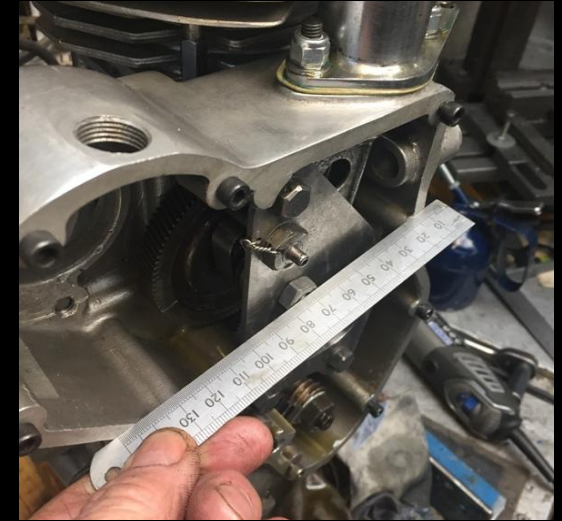
The middle photo and end photo above; shows the Oil Quill that lubricates the Cam 'Lobes', being 'Tested' with an oil can, and the Cam wheel spindle nut (Velo part No. M244), that I 'Milled Flat', being checked across the timing cover sealing face with a steel Rule.

The photo right; show the Cam steady plate oil jet nut (also Velo part No. M244, again *milled flat* being checked). This Mod should help reduce the oil loss from both 'Quill' oil jets by reducing the gap between Timing Cover & the head of these M244 Nuts (where oil usually escapes passed ill-fitting nuts and timing cover).

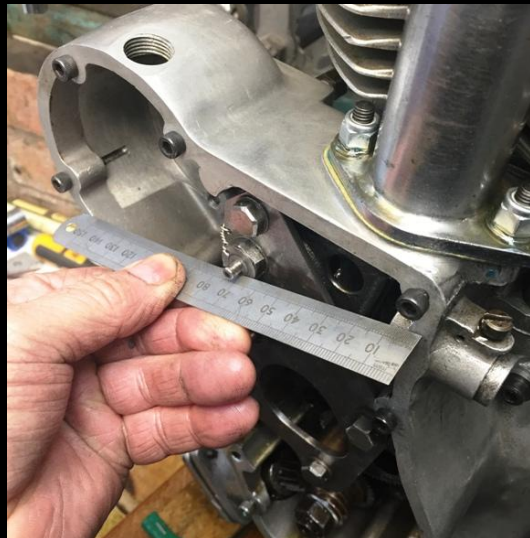
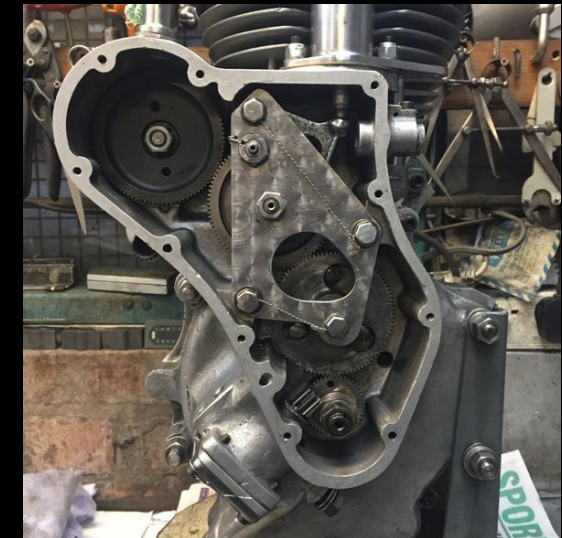
The end photo right; shows a better view of my modified *Timing gear steady plate*. This mod allows improved access to the three Intermediate gear spindle bolts (that are used to set the 'Backlash' between all three Pinions).

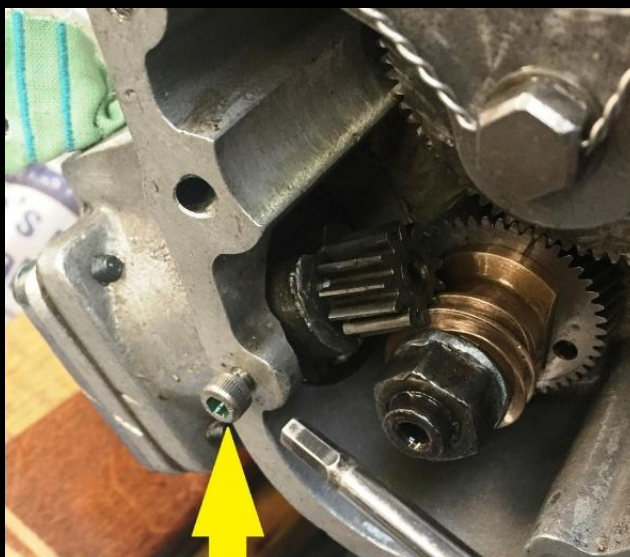
**CAUTION: LIMITED SCREW LENGTH
1/2" maximum due to Oil Pump Body**

1st Photo Right: Caution: to all of you Velo 'M' Series Engine Builders . . . I discovered the bottom-left thread (arrowed) only has a small amount of space between the gasket Face & the Oil Pump body ('half-an-Inch' long maximum thread length). Therefore, if you use a longer screw – it will make contact the Pump body and either (a) damage the pump &/or thread. Or, (b) will not be able to seal the Timing Case at this particular fixing-point due to the screw bottoming-out.

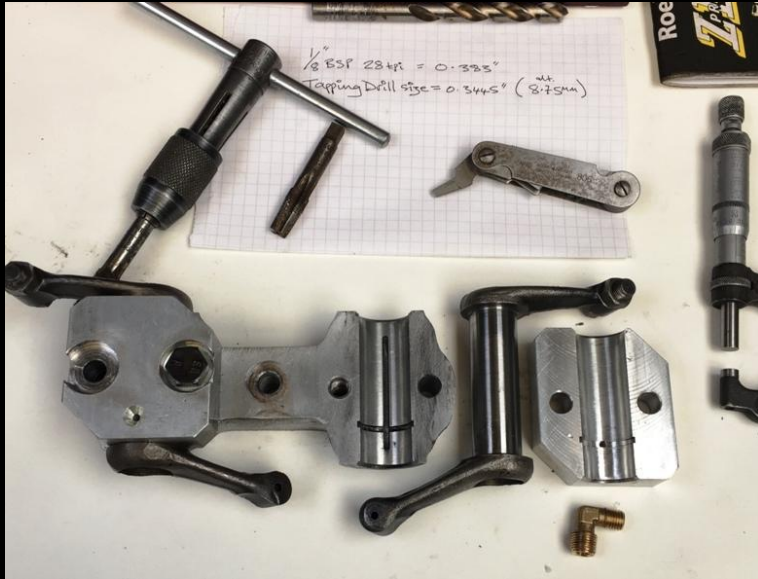
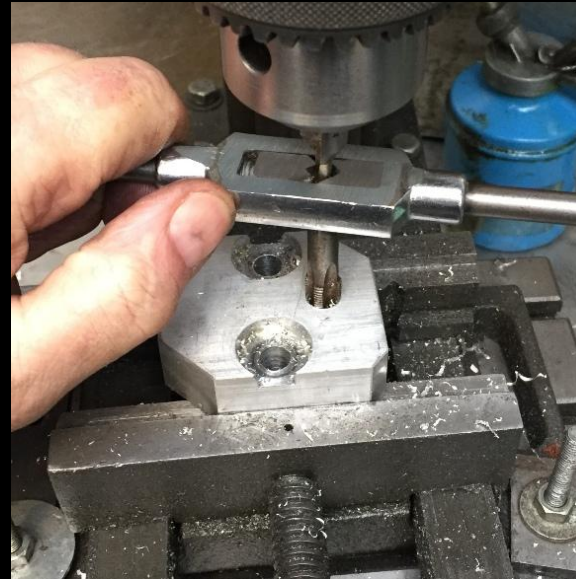
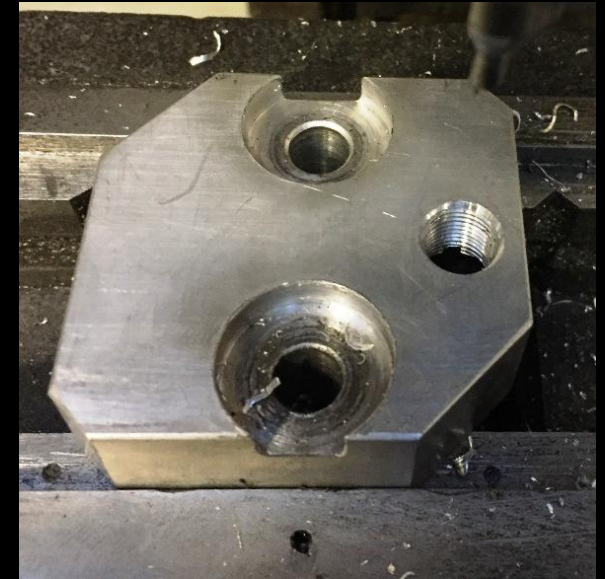
Photo right: shows the modified Rocker Pedestal bolted in-place onto the Head, ready to check the Rocker Cover 'Oil Feed Alignment' using Engineers Blue Marking paste.

As can BE seen; I have also removed the 'sharp corners' off each of the bearing tops and reshaped 'same' with a polished radius finish.

After some thought on the matter; I eventually decided to modify the Criterion Rocker Pedestal by reducing the 5/32" gap between the existing 'Rocker Cover Oil Jet Feed Drillings' and the top of the new Pedestal 'Rocker Shaft Oil Feed Holes'. The idea being to 'Bridge this Gap' and get the Oil Jets to fit as close as possible over these 'Lubrication Holes'. To this effect I drilled&tapped each cap 1/8" BSP to accept two brass countersunk fittings (photos below).

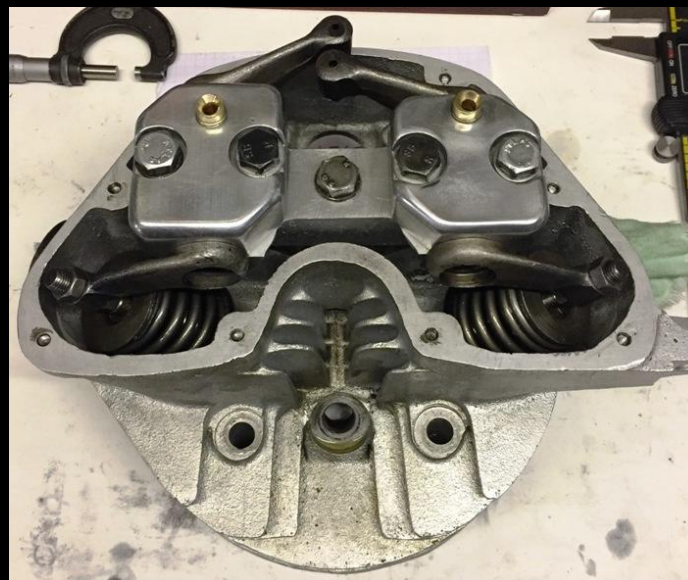
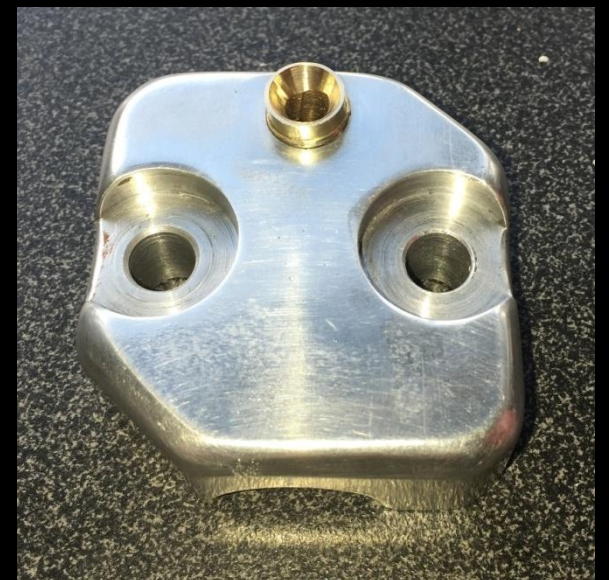
COME-ON ! You've got to admit . . . it does look 'pretty' now it's been modified and polished.

However, more importantly these improvised brass 'Oil Jet Tubes' should provide a more direct oil feed with greater pressure to the newly ground Rocker Shafts (more than the original Velo set-up).

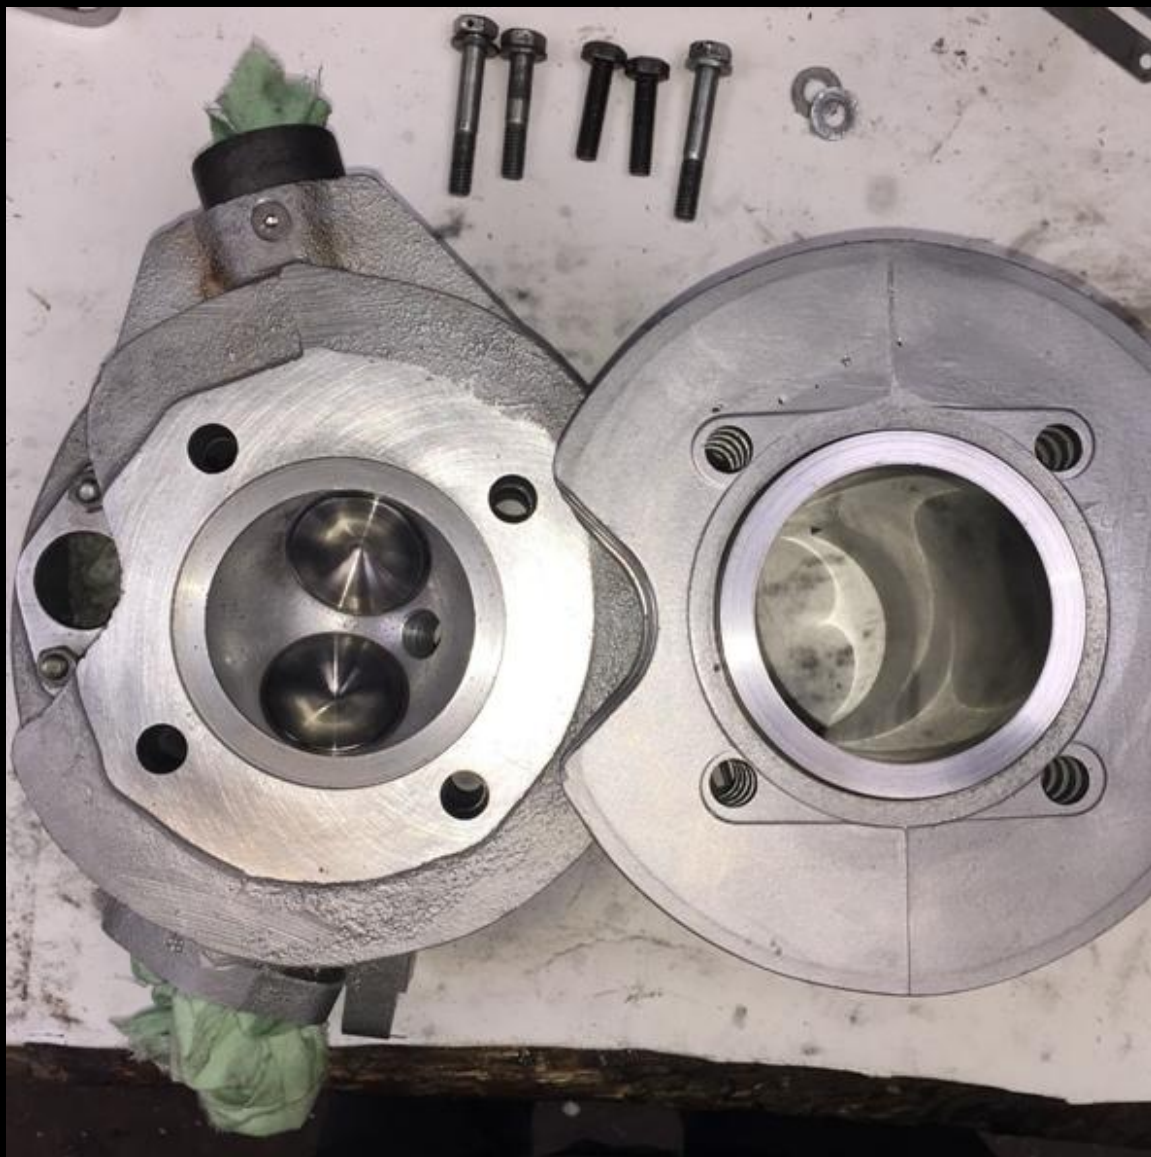
Photo below: shows the results of ('quite-a-lot-of-time-spent') 'Lapping' the Cylinder Head & Cylinder Barrel together. I've 'Lapped' these two components together several times now to get the required fine finish & super flat-surface (in order to be able to assemble my engine without fitting the usual Copper Head Gasket). And so, to ensure there is a gas-tight seal at this point, the 'Mating-Surfaces' need to be as near perfect as I can get them. I'm pleased with the result . . . but only time will tell if this was a worthwhile modification.

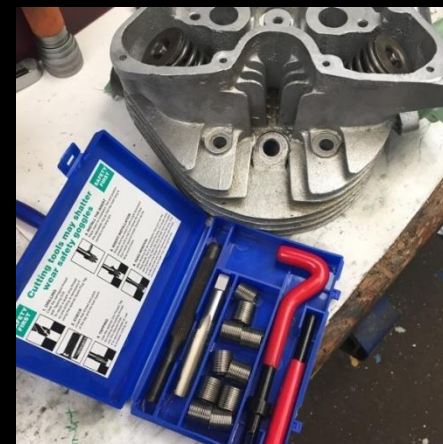
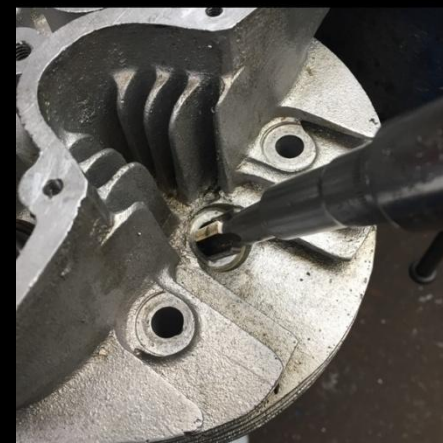
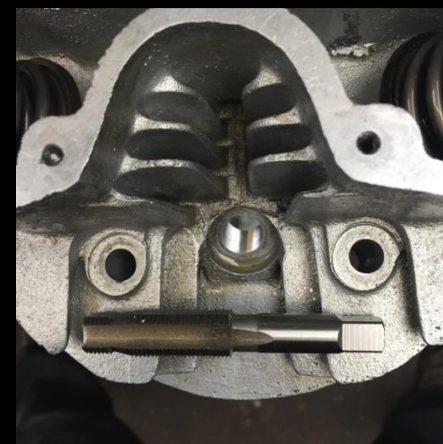
The three photos to the right: show the spark plug hole being re-threaded and 'Helicoiled'. This action was needed because of the amount of wear & tear found in this sixty-four year old engine (the original spark plug thread was in very poor condition). BUT . . . not any more, No More Loose, Wobbly Spark Plug.

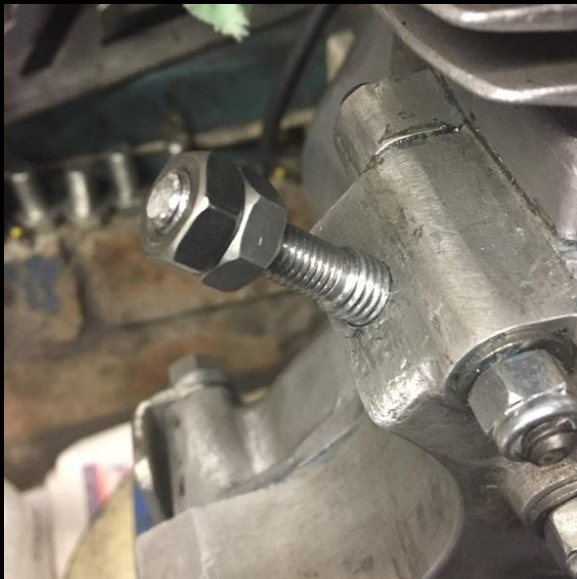
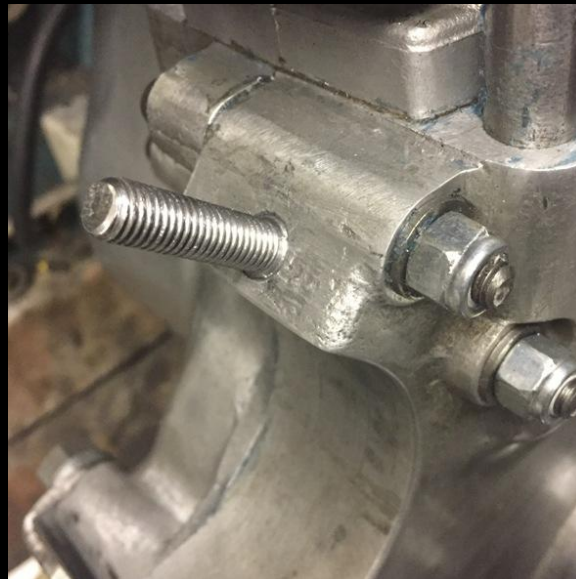
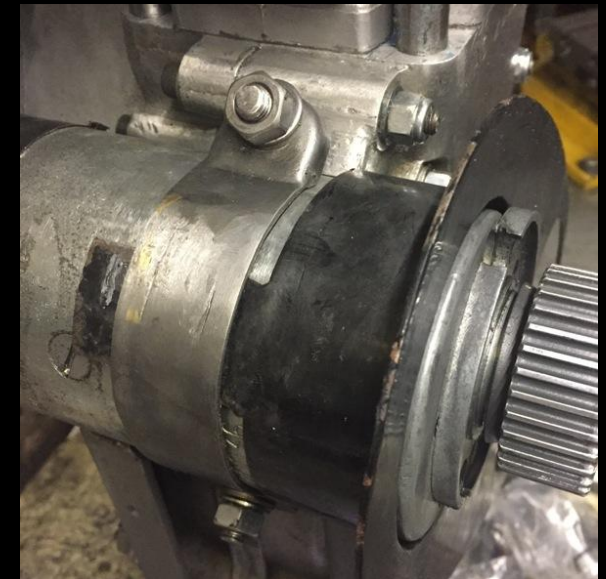
Photo left; the item immediately below the blanking plug is a 10mm threaded 'Stud' – this was reduced at one end and threaded to accept a 5/16" BSF Nut. The original 5/16" *Stud* that secured the top Dynamo Strap had been stripped and 'bodged' previously, so it was necessary to drill-out the old thread and re-tap to a larger diameter (obviously using a *course* thread in the aluminium casing).

The three photos below; show said dynamo fixing Stud fitted into the new thread.

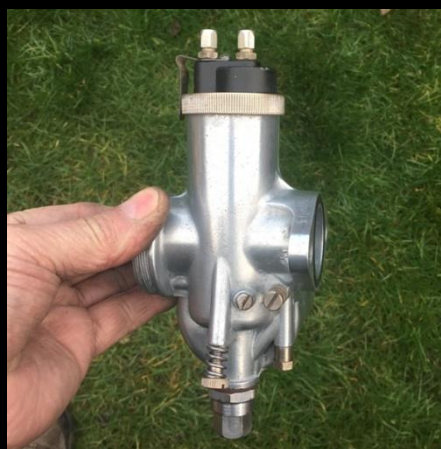
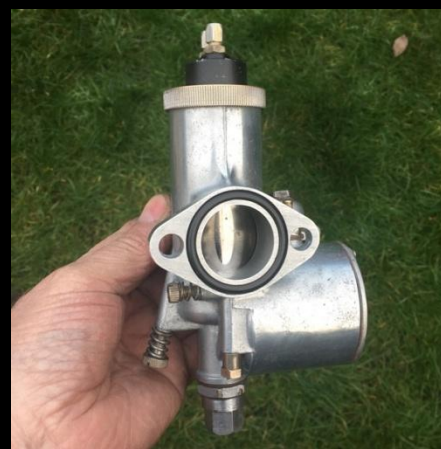
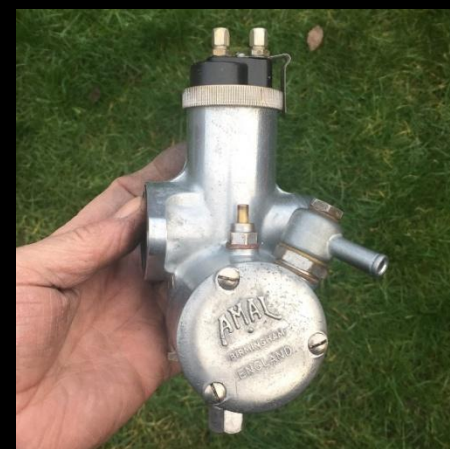
The final three photos below show the fully assembled reconditioned Amal 389/14 Carburetter ready for refitting to my MAC engine. The following 'Jets' are presently fitted; 260 Main Jet. 106 Needle Jet. 30 Pilot Jet. It looks like it has a 'C' Needle fitted, but is difficult to see exactly due to wear on the top of the Needle. I need to buy a new Needle anyway – just to make sure.

I will obviously have to use '*These*' as a starting point and adjust as necessary. However, I am open to advice from anyone who has already done similar work to their MAC and who through their experiences can suggest a suitable 'Carb Set-Up' for this configuration. This '389' is now looking as good as NEW!

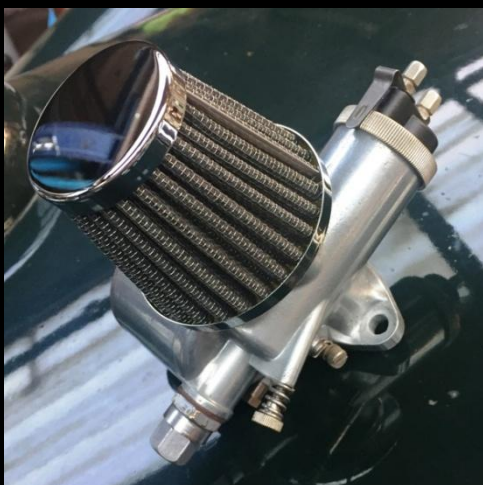
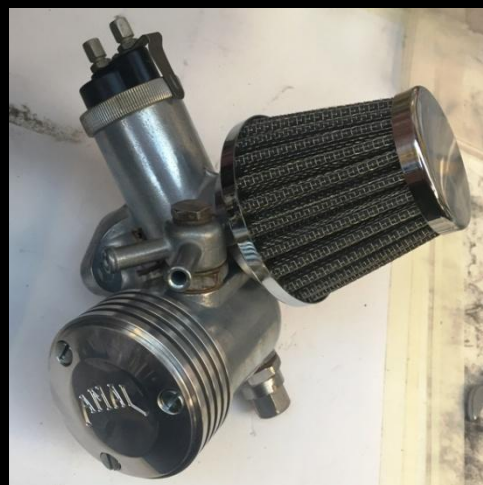
The final two photos (left) are of my 'Ready to Go! Blinged-Up' reconditioned Amal 389 (inch & eighth) Monobloc Carburetter.

It's now been treated to a new 'Float Chamber Extension Tube' and Full-Flow Air Filter, and is now just waiting to be put back into service.

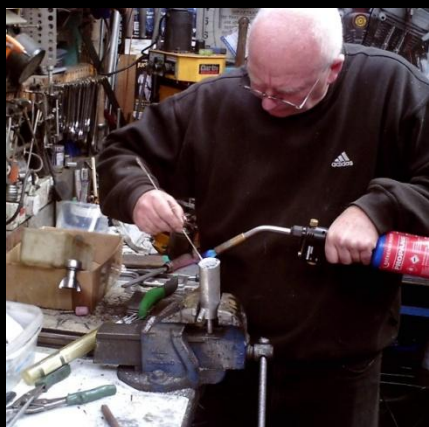
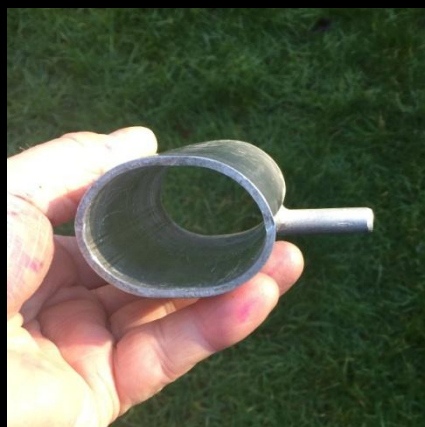
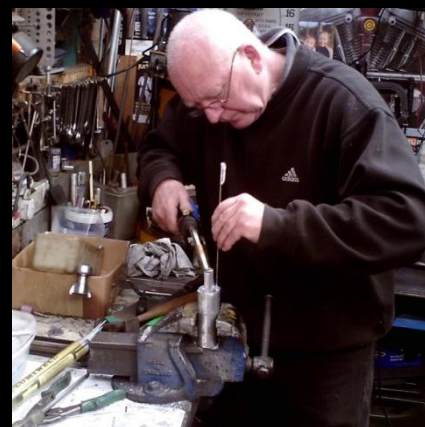
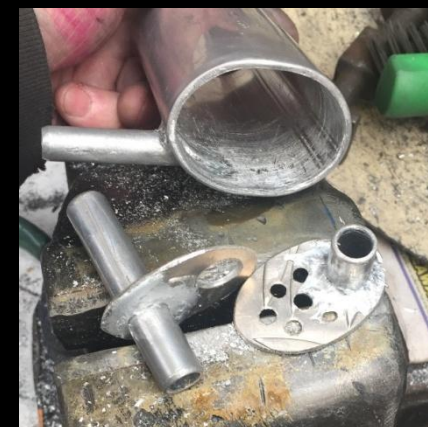
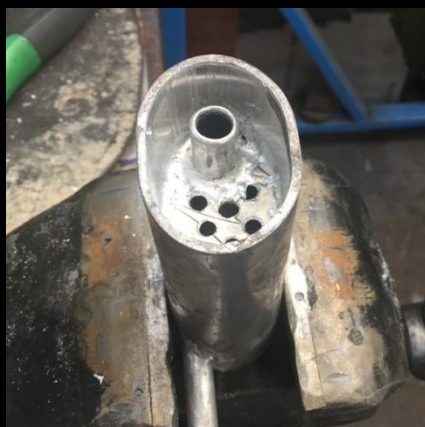
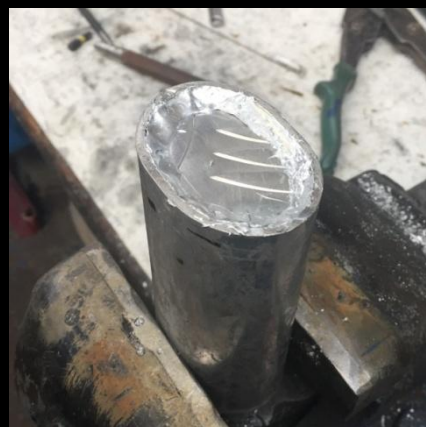
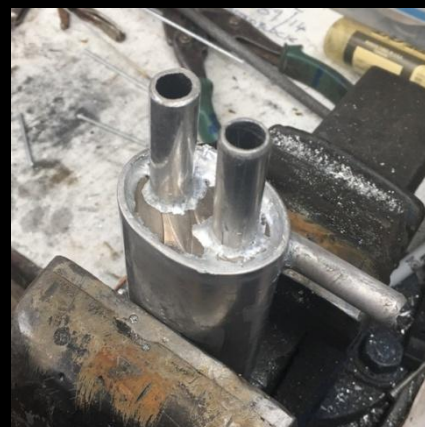
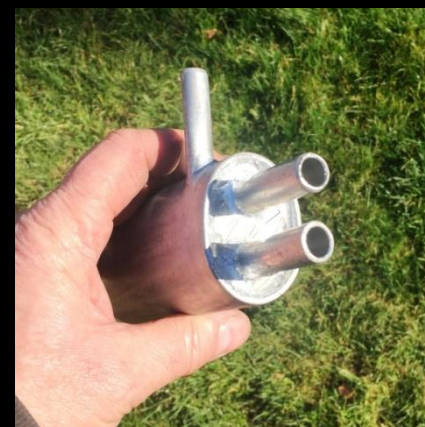
My aluminium Oil Separator unit was soldered-together using Lumiweld.

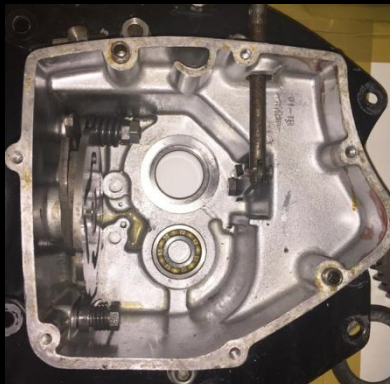
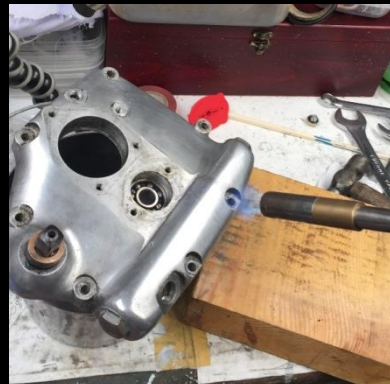
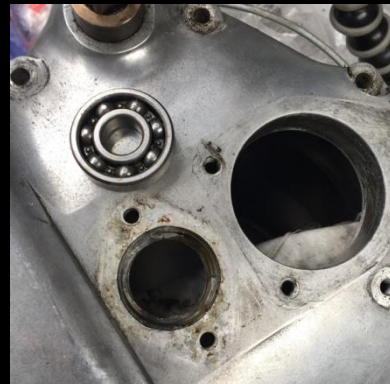
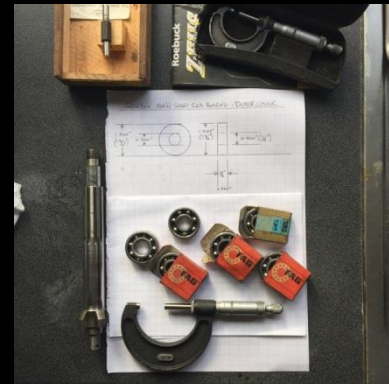
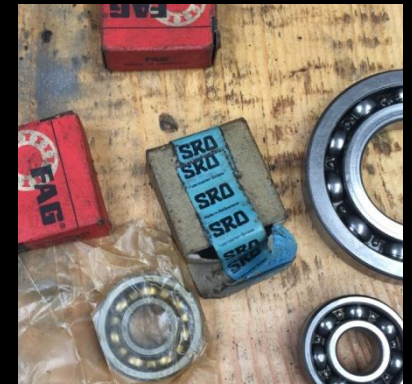
March 2019: Gearbox *dismantled* ready for inspection (with the help, guidance & expert eye of Mr Rick Essex). What did We find? Well, we discovered that '*ALL of the Internals*' ARE in really good condition. I was pleasantly surprised and positively reassured when I looked at the gear-clusters, gear-change selector-forks & change-mechanism (and bearings, etc.) as it appears that quite a lot of these internals had been replaced prior to me purchasing this MAC. To say "*I am pleased with the result*" is somewhat-of-an-understatement (after all of the *trials'n'tribulations* & extensive work already done on the engine and rest of the bike).

I managed to find some *New-Old-Stock* Bearings in one of my *Boxes of Bits* that match the outer cover bearing, making this gearbox quite an inexpensive repair.

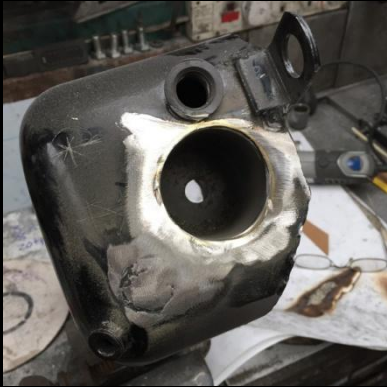
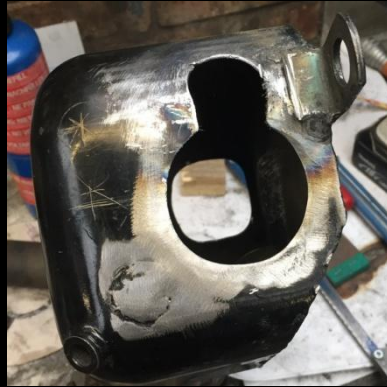
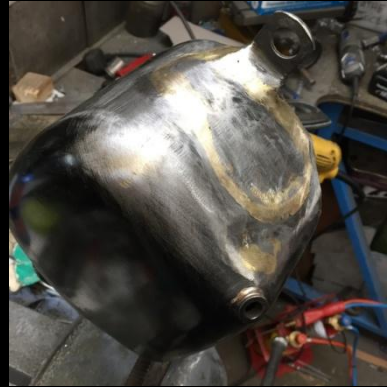
Whilst waiting for a few Gearbox parts . . . I started work on a bit of re-modelling of my Venom Oil Tank that I am going to fit onto my MAC (instead of re-fitting the original MAC Oil Tank). The two photos on the right (below) show a comparison between the MAC & Venom Oil Tanks. The Venom Tank has a 'Top Hat' Anti-Froth Breather tower on top. The MAC has a longer Filler Neck. One reason for modifying this Oil Tank is to discard the original Velocette Oil Filter all together, in favour of fitting a Remote (Canister type) Oil Filter (to be mounted under the Seat). With this in mind, I literally 'Cut-out' the original oil filter 'Tube' and welded a blanking plate onto the top & bottom of the Oil Tank.

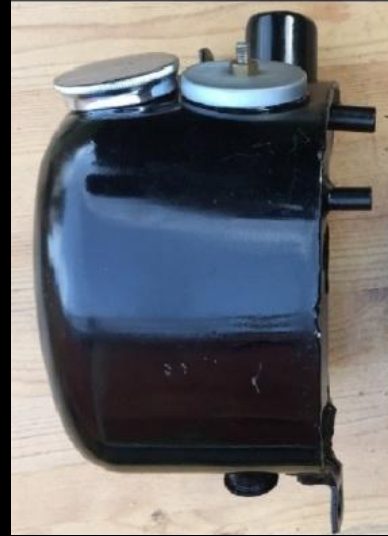
Venom Oil Tank
with top hat Anti-Froth Breather

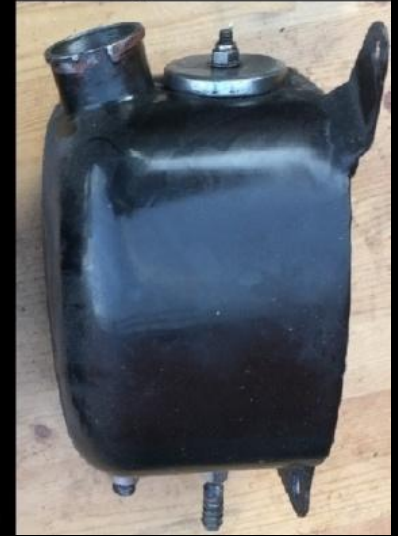
& MAC Oil Tank
with longer Oil Filler Neck

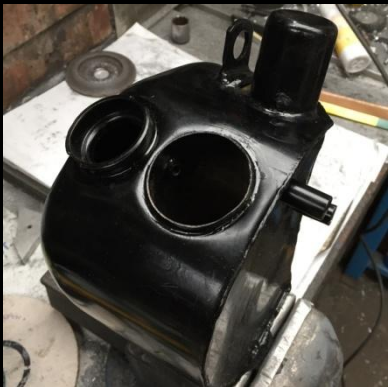
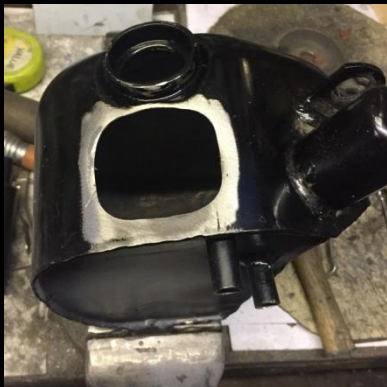
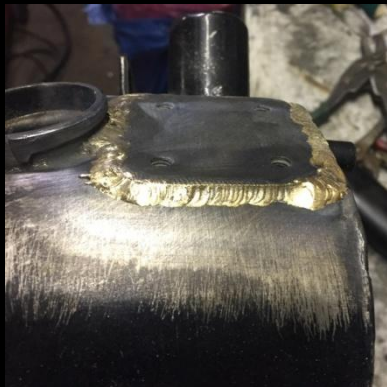
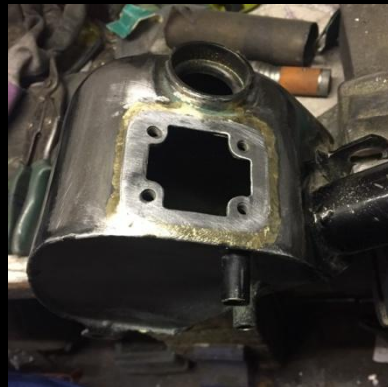
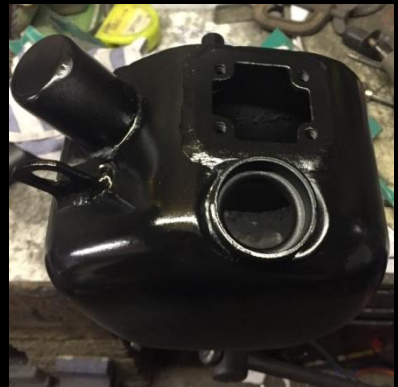
I then fabricated a 'threaded' flat plate & bronze-welded it to the top of the Tank, to act as 'Base' for a removable inspection cover (which will facilitate cleaning (last 3 photos below right)). This removable 'Cover' will also be where the 'New' Oil Return Pipe fitting will be located. Well . . . that's the Plan!

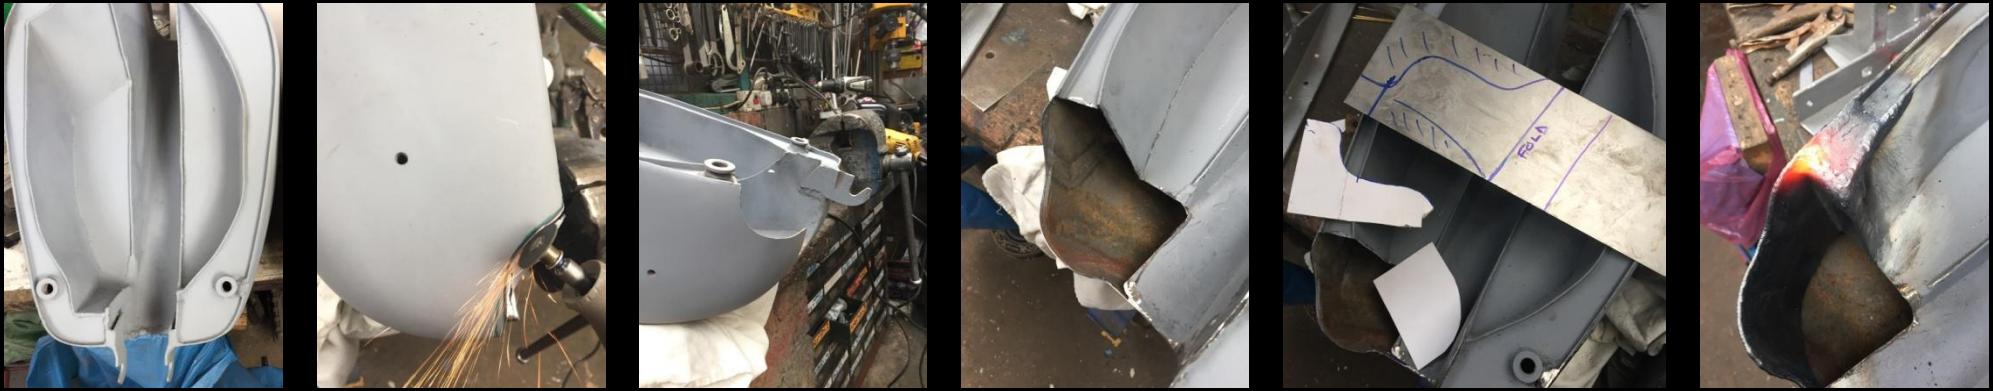
First Photo (below left) shows the 'Under-side' of the standard petrol tank (before modification work). This is a copy of Rick's Tank – that was done to accept a larger carburettor & longer inlet manifold. It was his idea that inspired me to do the same to my MAC Tank, as I had decided I wanted to extend the MAC Manifold.

The main problem with fitting a Longer Inlet Manifold is that the Carburettor fouls the Standard Petrol Tank. This Problem (re: carburettor to petrol tank clearance) is usually rectified by 'Raising' the Brackets at the rear of the Tank. This does the trick, but looks wrong (as the Tank is no longer level and slopes forward). I've seen several such modifications but don't think much of this particular option. The solution I chose (or should I say "Copied") was my preferred option. I 'Cut-out' part of the Tank (on the under-side) and re-fabricated this part of the Tank to 'make sufficient clearance' for the extended Carburettor to fit without 'Fouling' said Petrol Tank. BUT . . . I can't take the credit for the initial idea as it was Rick who pioneered the way for me and modified his Tank first.

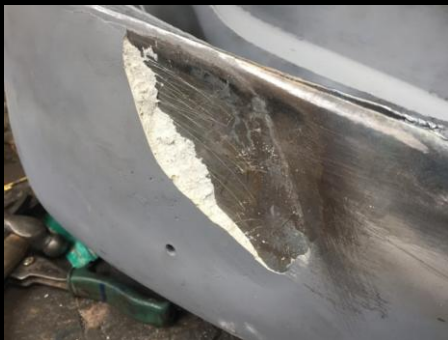
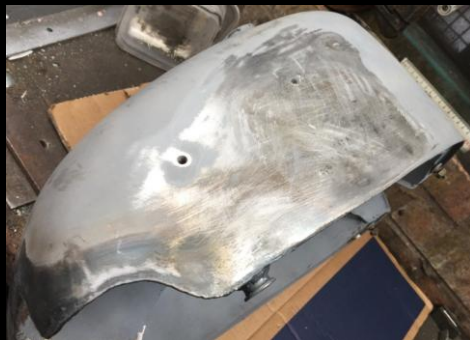
First photo left: unfortunately, when I started welding a 'Load of Body Filler' fell off the Tank, exposing a massive 'DENT' in the side of the Petrol tank. Bummer . . .

This Venom Petrol Tank looked in really good condition when I first saw it (in its 'Grey Primed State'). So, as you can imagine, it was quite a shock when half of the 'Filler' Fell-Out! You can clearly see the extent of the damage.

Fortunately, I have a range of home-made 'Dent Removing Tools' especially manufactured for removing such Dents in Petrol Tanks (and a modicum of skill & experience in panel beating). Second photo left: shows the side of Tank after 'panel beating' session. I am quite pleased with the result.

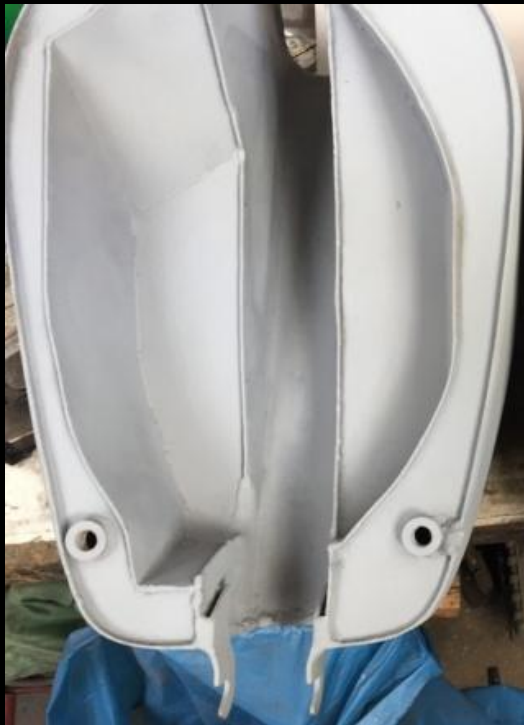
The photo left: shows the under-side of the original (Standard) Venom / MAC Petrol Tank (unmodified).

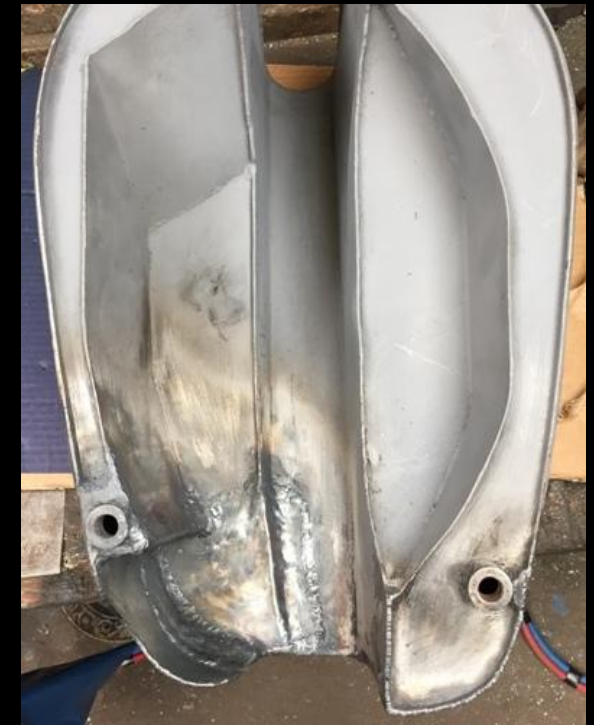
The photo right: shows the modification to the carburettor-side of the Tank, which also included moving the off-side Petrol Stop Tap a Tad further forward (than standard).

You can see in the photo on the right that I have completely removed the Rear Mounting Bracket 'Lugs'.

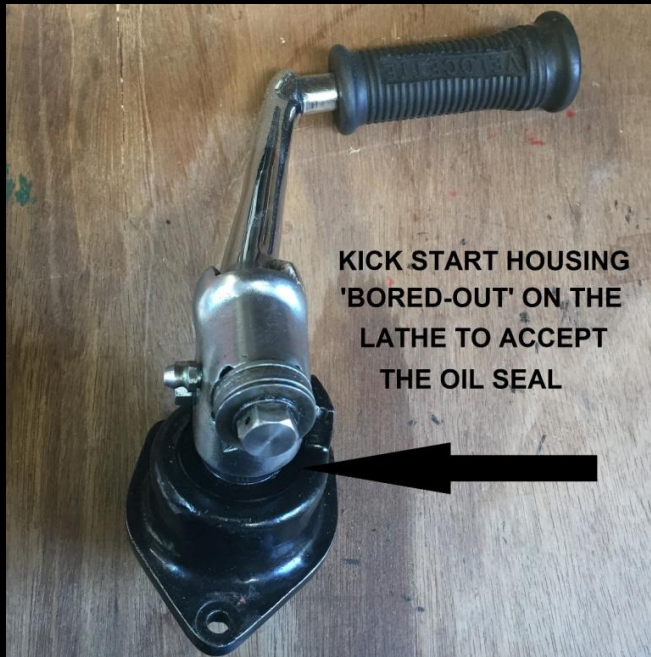
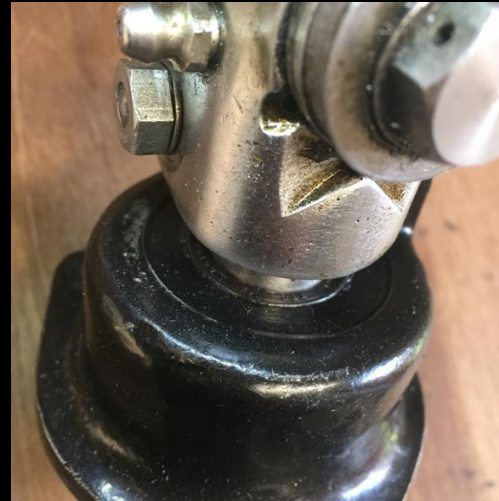
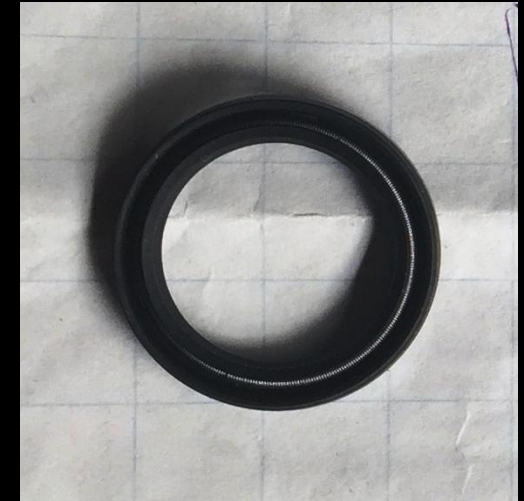
The Kick Start Housing was 'machined-out' by my good friend Rick Essex on his Lathe (quite some time ago now) to accept an Oil Seal on the Kick Start Shaft. The middle photo shows a 'close-up' of the fitted Oil Seal. The end photo (right) is a picture of the Oil Seal used. Great Job – much appreciated.

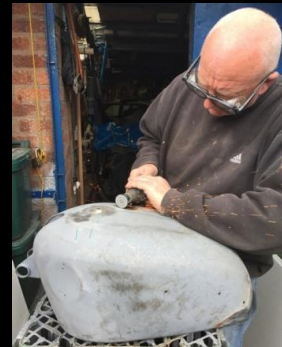
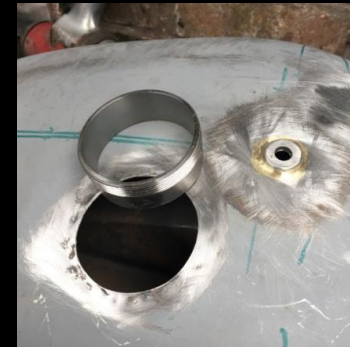
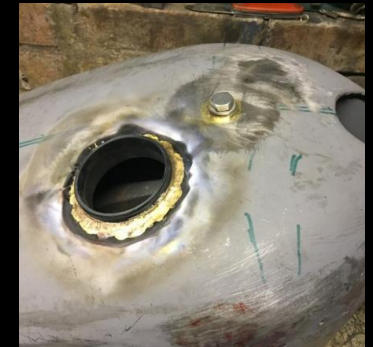
The final welding job (on the MAC Petrol Tank below) now completed; i.e. welding the steel screw-threaded filler neck (ready for the Monza Petrol Cap). Last week I bought a Thruxton-style 'Cruciform-shaped' Rubber Mount for 'Under-Tank' mounting (from Stafford Bike Show 27/04/19) as I have permanently removed the welded-on Rear Fixing 'Lugs' from the back of the Tank.

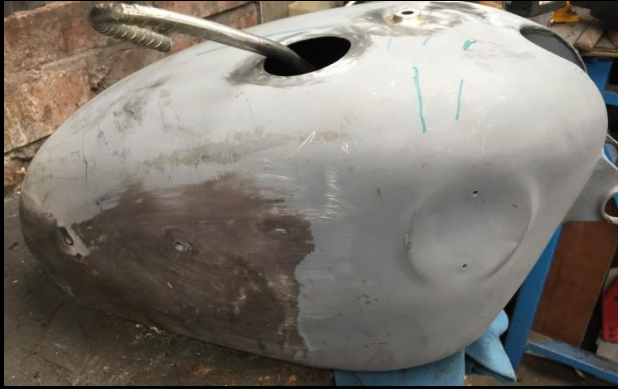
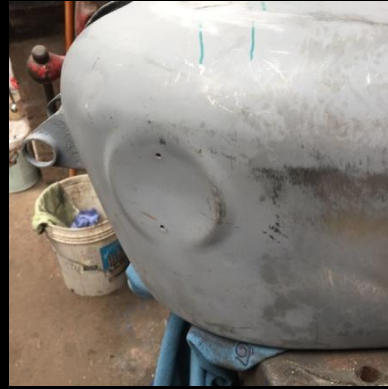
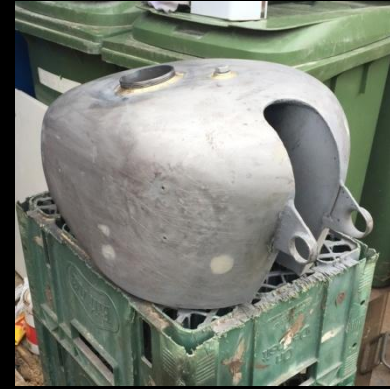
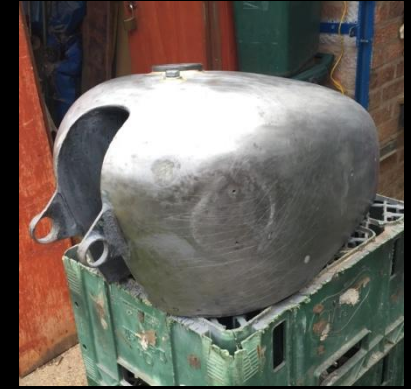
The first two photographs (below left) show the Tank before 'panel-beating-out' the raised areas (where the Velo Badges are fitted to the Tank).

The two photos (below right) show the Tank after panel beating.

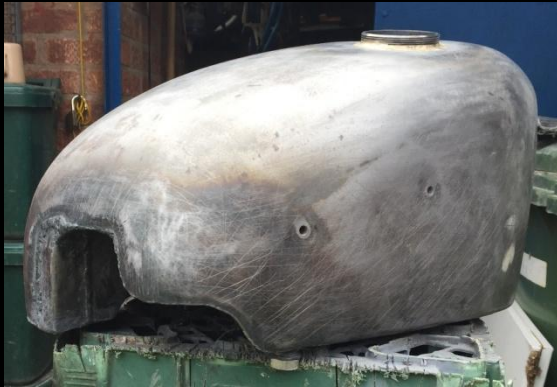
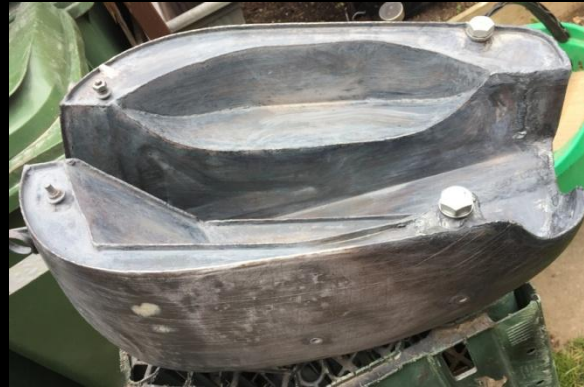
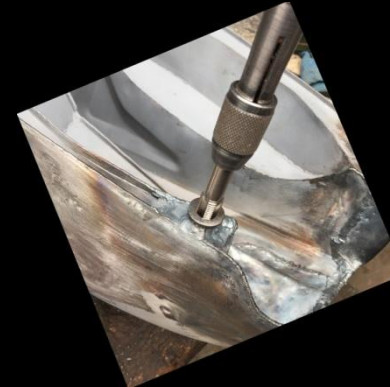
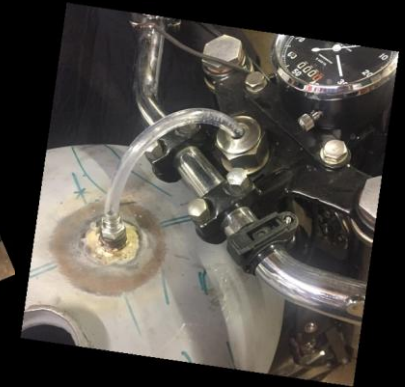
Photos below: show the Tank with ALL paint totally removed, ready for final preparation.

Petrol Tap fitting 'Re-threaded' & new Tank Breather (option one).

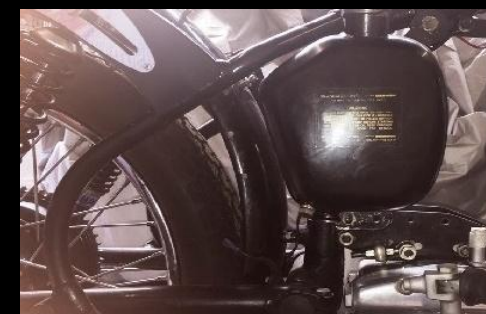
top photo: original tank position

First photo (below left) shows the Venom gearbox, fitted in place, ready for measuring-up the new position for the modified Oil tank. I will be using a couple of Rubber Spool Mounting Brackets (like the ones used on British Leyland Mini Exhausts). These two exhaust mountings to be modified fitted to the back of the Tank (as in the 3rd photo below).

The steel plate (seen in the second photo below) was divided into two parts and then folded (90 degrees) at both ends. One plate will be welded onto the Oil Tank and the other steel bracket will be attached to the Rear Frame Tube, with the rubber mounting spools in between each bracket.

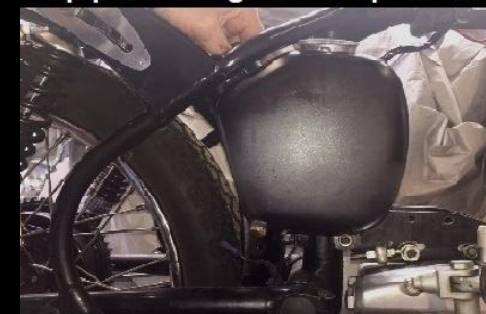
bottom photo: new tank position

I will 'Cut-Off' the original top & bottom fixing brackets (in favour of the new rubber mountings) and fit a third rubber mounting spool (to the top rear-side of the tank), to make this Oil Tank totally rubber mounted and fully *isolated* from ALL direct metal contact. See new Tank Brackets being made (middle photos below) 'Fitted'. And, the forth photo (below right) shows the new rear mounting bracket, that I fabricated & welded to the Tank. This is then bolted to the rear mudguard stay, via the third Rubber Mounting Spool. The end photo (far right) shows the Tank bolted in place.

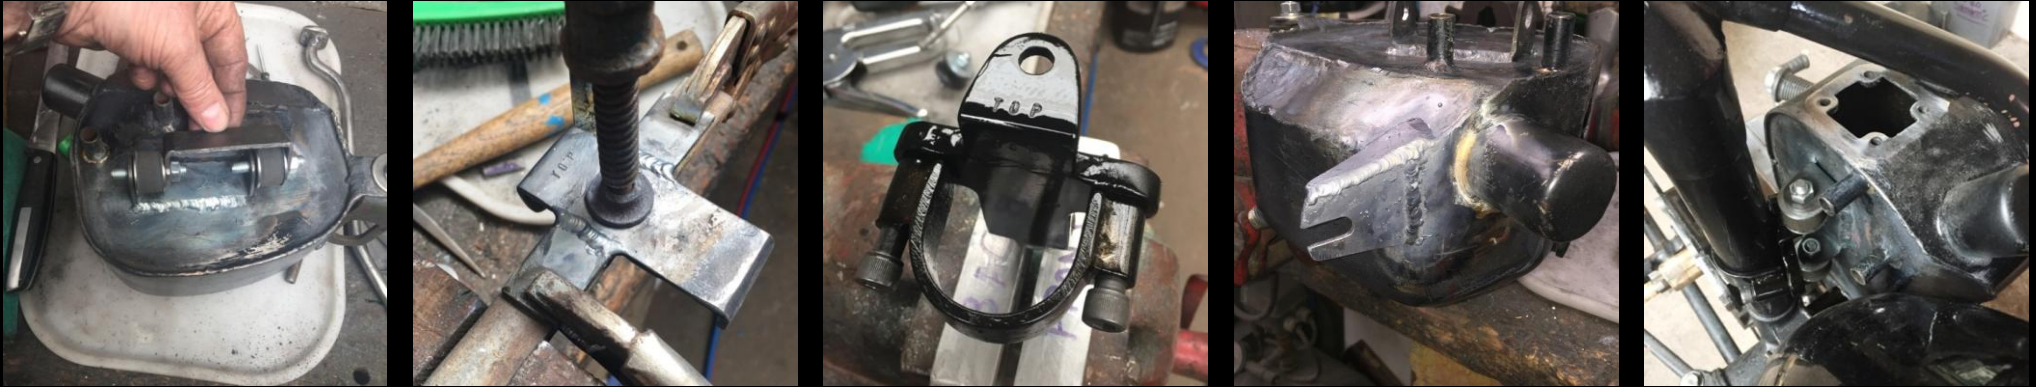
The first photo below left; shows the new position for the main oil feed pipe (& non-return valve) that carries oil from the oil tank directly to the engine, via the oil feed pipe. This Oil Feed Pipe now passes between the Swinging Arm & the Gearbox (instead of the usual 'outboard' position) – tucked out of harms way.

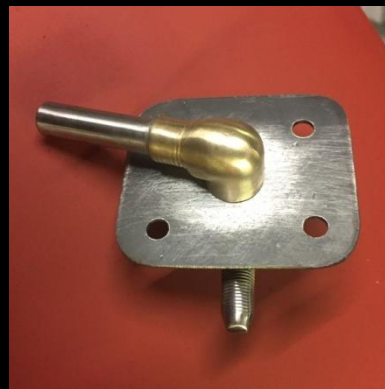
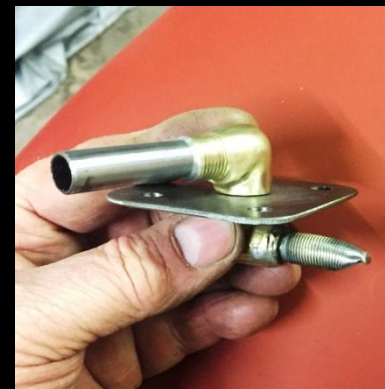
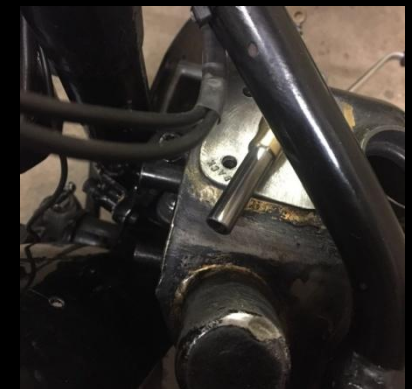
The final photos on this page (below right) show the detachable inspection 'Top Plate' with my home made Oil Return Pipe fitting bolted in place. The end of the pipe that is 'inside' the Tank has been made so that oil is directed downwards slightly (as it returns to the Tank).

The final photo (below) shows the plate, just placed in position (for a final repositioning check).
