Velocette MAC 350cc

Rebuild Project Part Two

November 2018 to November 2019

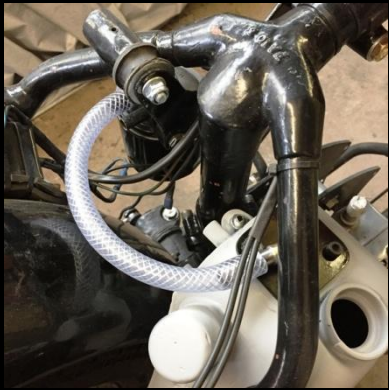
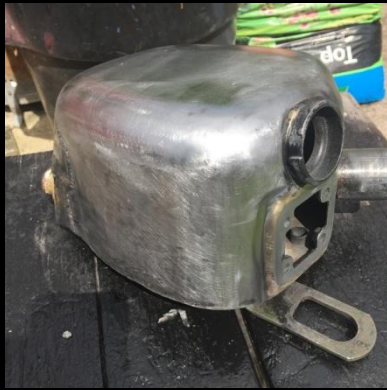
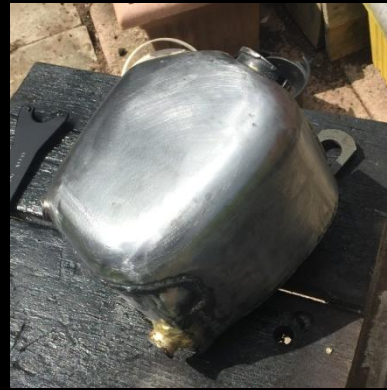
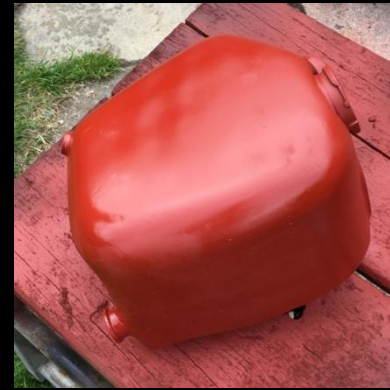
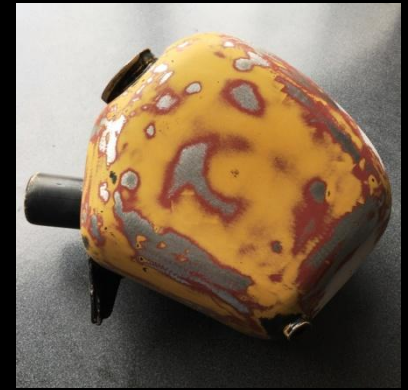
First photo above: shows the *Rubber Mounted* Remote Oil Filter position and return oil pipe.

The next four photos (above) show the Oil Tank in various states of *Preparation*. From bare metal, to 'Primed' and then 'Flatted', followed by several coats of different coloured Primer, each coat filling in the many tiny imperfections, scratches and dents (see also photos below).

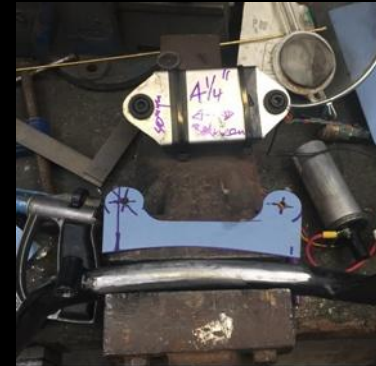
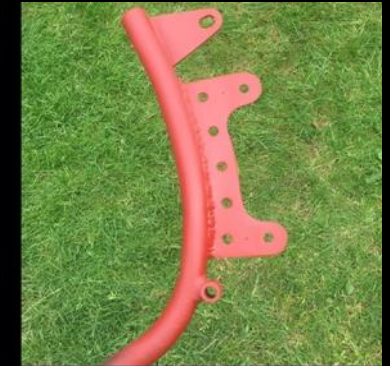
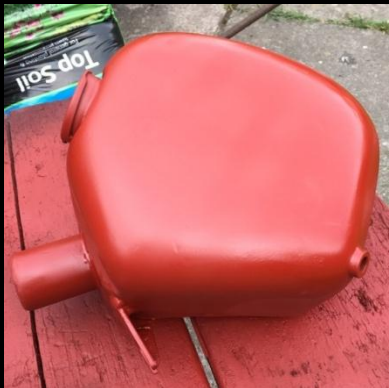
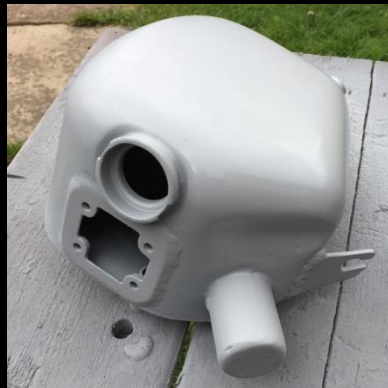
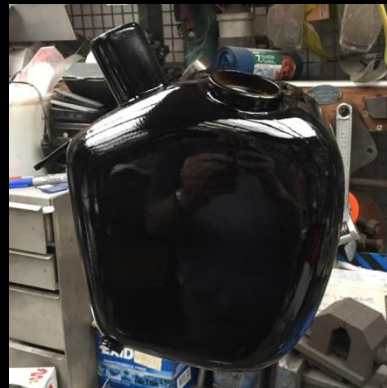
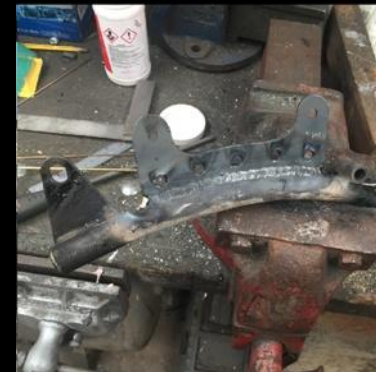
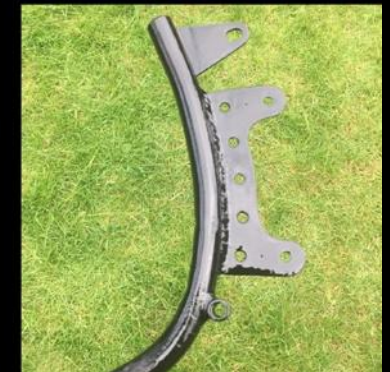
The Four photos to the right show a new bracket, made especially to mount the Ignition Control Module (for the Contactless Coil Ignition system fitted).

The *blue cardboard template* was used to make a bracket (right) to fit onto the rear mudguard Stay, to allow for the Ignition Module to be rubber mounted and isolated from engine vibration.

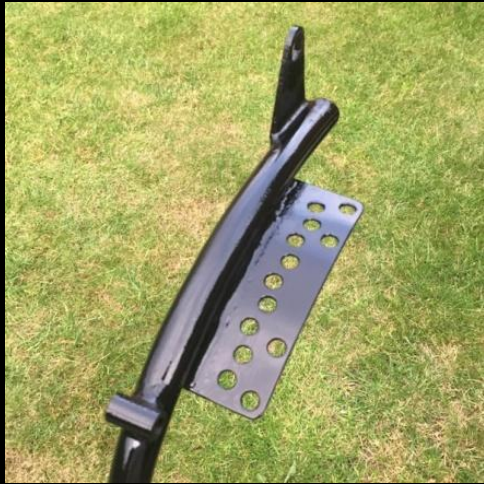
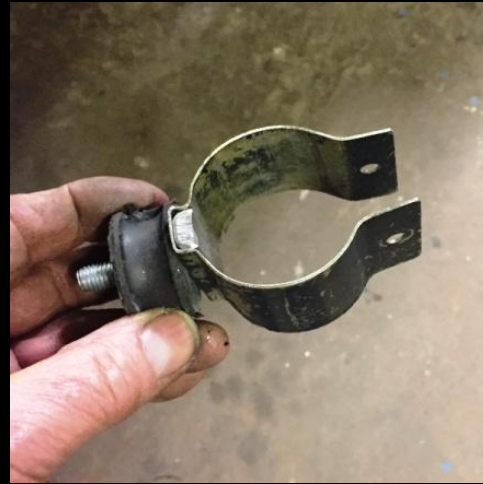
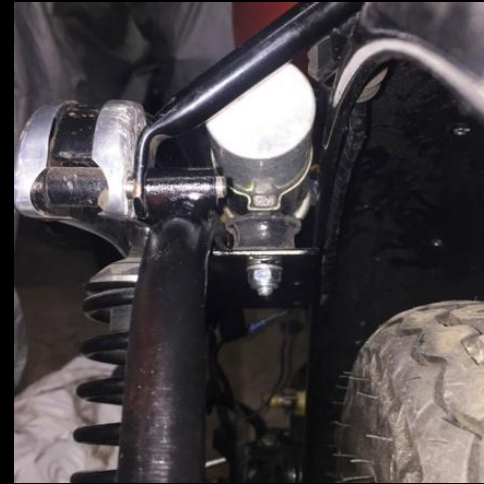
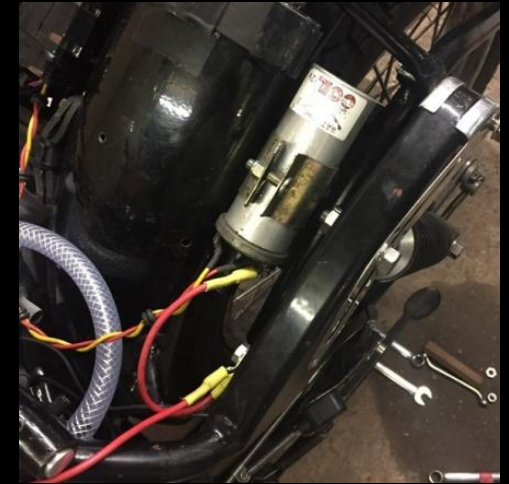
As you can see in the four photos below I have welded a bracket onto the near-side rear mudguard stay, with multiple drilled holes, to maximise adjustability options. One of these holes will accommodate the modified Coil Bracket (2nd photo below), and using yet another rubber mounting spool to isolate the ignition coil from vibration (see both end photos below right).

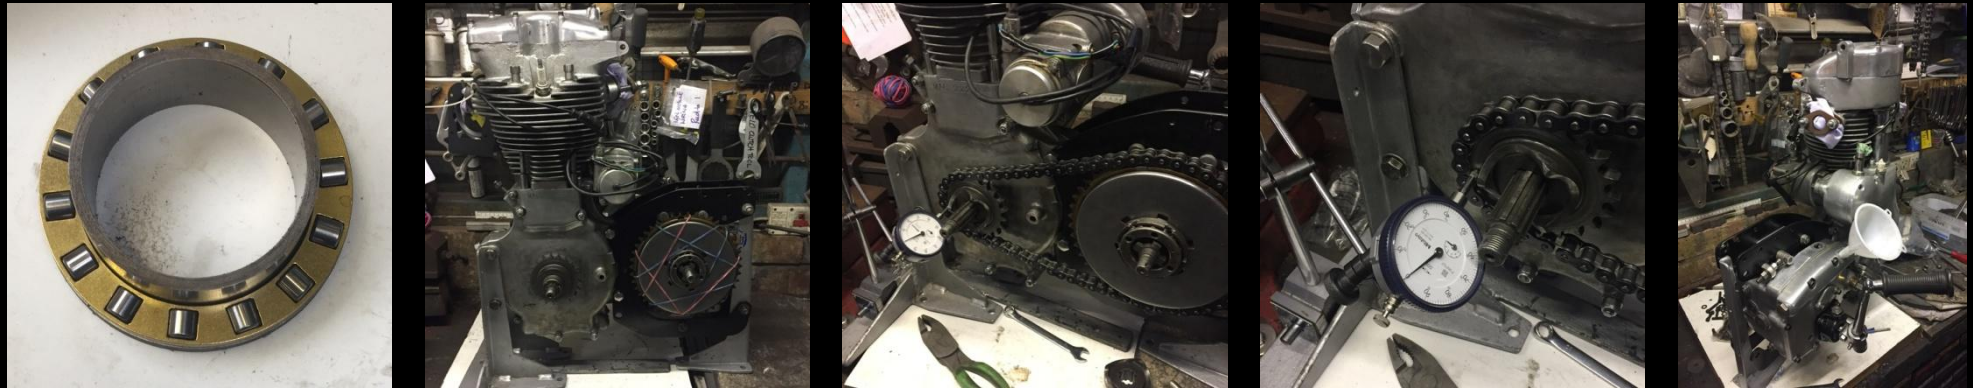
The 1st photo below; shows the new Roller Clutch Thrust Race that I have fitted (as supplied by Veloce Spares Limited, Huncote, in Leicestershire). The second photo shows the Assembled Clutch held together with a series of Elastic Bands. The assembled clutch and drive sprocket was then fitted with the new primary chain (*with Split Link*). Once the two sprockets and chain-run had been 'Lined-Up' accurately I used a dial gauge to identify the distance between the inner face of the Sprocket & the Crankshaft in order to make the required distance piece (*Shim*) needed to keep the primary chain in-line.

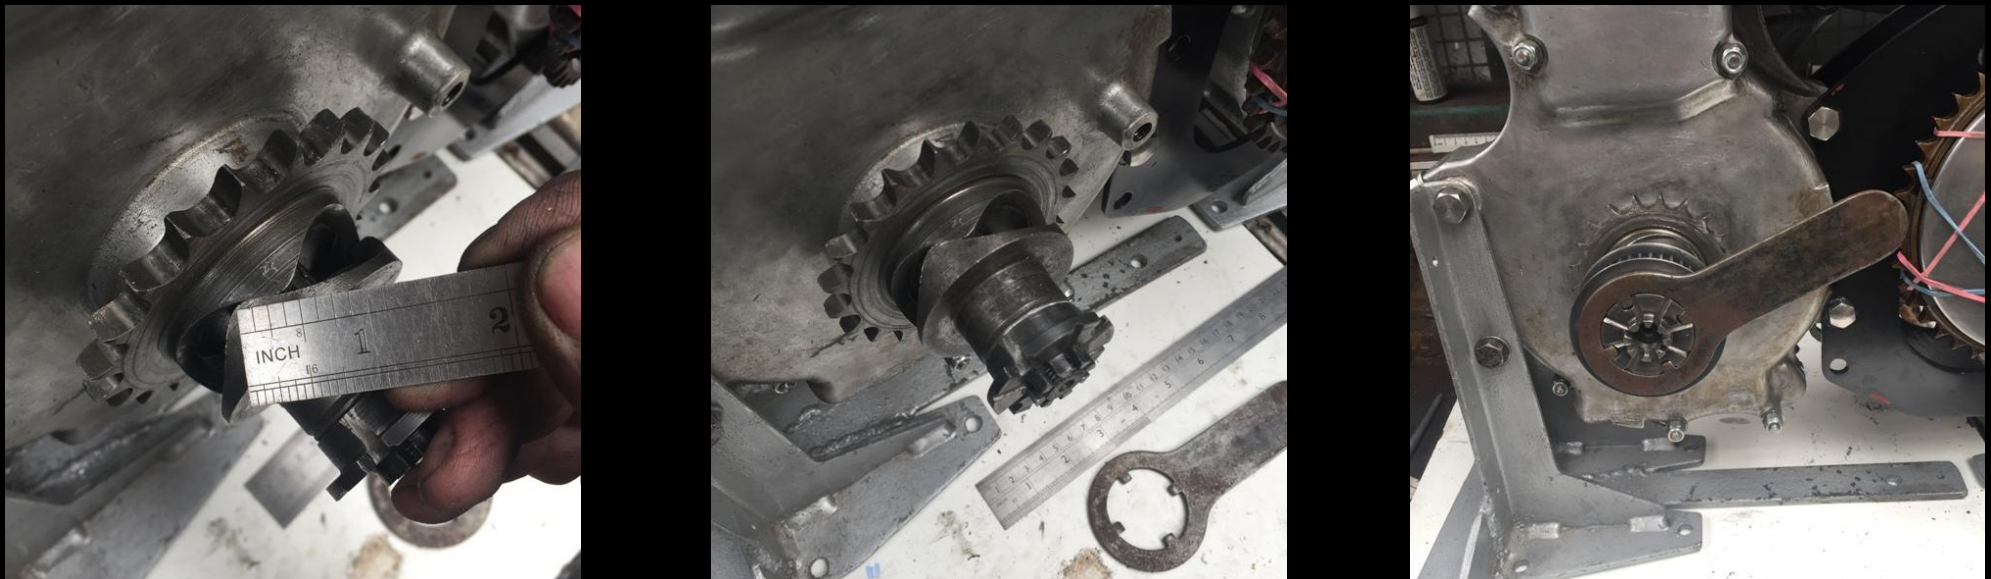
With the new shim made & fitted (and re-checked again for accuracy), I was then able to set the Shock Absorber to the correct position in order to make a suitable spacer, to be fitted between the outer part of the Shock Absorber Clutch (M91/3) and the castellated nut (M93 Shock Absorber Spring Collar) that secures the Shock Absorber Spring (M90) in place. The end photo shows the Velocette Tool (A229 Shock Absorber Nut Spanner) being used to tighten everything up for the final measurement check.

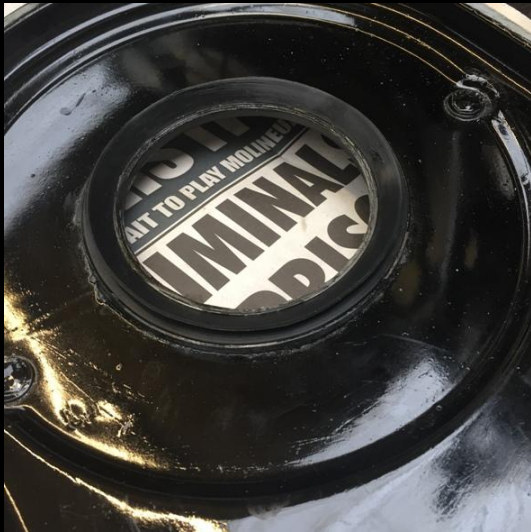
Photo left & below: show the new Nitrile Rubber Seal fitted to the inside of my MAC Primary Chain Case (supplied by Veloce Spares Ltd.), plus another Nitrile Seal for the Gearbox to Chaincase Seal too.

These new 'Nitrile' Seals replace the original Velocette Felt & Cork Seals and are much more efficient and less problematic than the originals. When the old type of Seal *'failed-in-use'* it usually caused clutch drag and other problems because the clutch could not disengage properly due to restriction cause by the damaged / fouled seal. There should be no such problems NOW though!

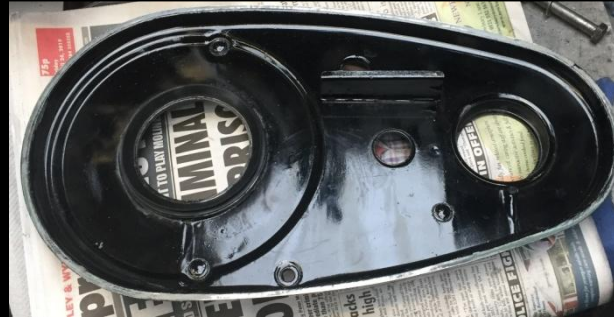
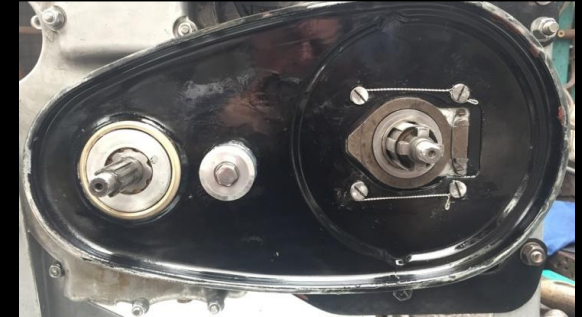
Chain Case Fixing Pins lock-wired into place

Clutch Assembly, Drive Sprocket & new Primary Chain fitted (with Split Link (photo below) Split Link Lock-wired (for peace-of-mind).

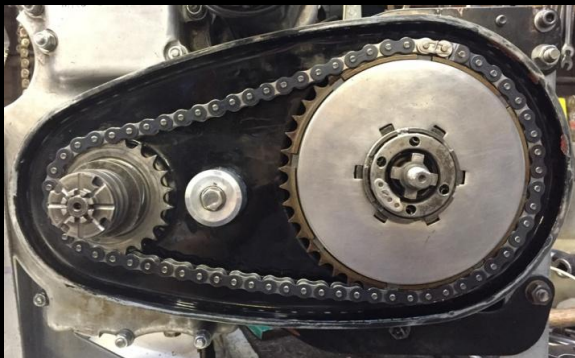
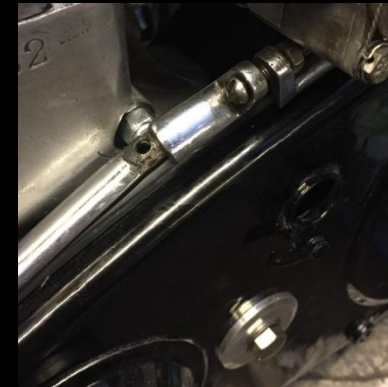
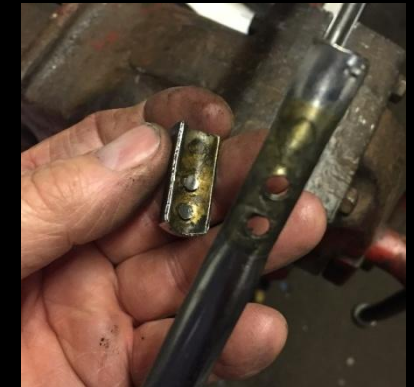
And, just when I was thinking everything was going nicely together & to plan . . . The Chain Case Strap Assembly (MAS16 / 2) *'Snapped'*. This was caused by a combination of 'Old Age' and suffering a 'Hard Life' (and Yes! Before you say anything, I am referring to both the Bike and to Myself). I obviously applied too many 'Newton Meters' to this 1953 fixing Strap bracket, and "SNAP" . . . Off it *Popped*. My solution was to Drill & Tap the broken bracket and to re-attach it to the 'Strap' with a couple of screws (see photos on next page below). I then finished-off the job by Silver-Soldering these two components together, ensuring this problem does not happen again in the future. It is an extremely strong repair (although the Chrome finish is now tarnished).

Drilled & Tapped to 4mm thread (x2, below). The Two screws held the whole lot together ready for the Silver-Solder to be applied. The screw-heads were then filed flat to provide a smooth finish ready for the New Seal profile. Although this little repair was quite annoying, I was lucky in one sense – that this happened in the workshop and Not when I was out-&-about on a 'Ride-Out' somewhere.

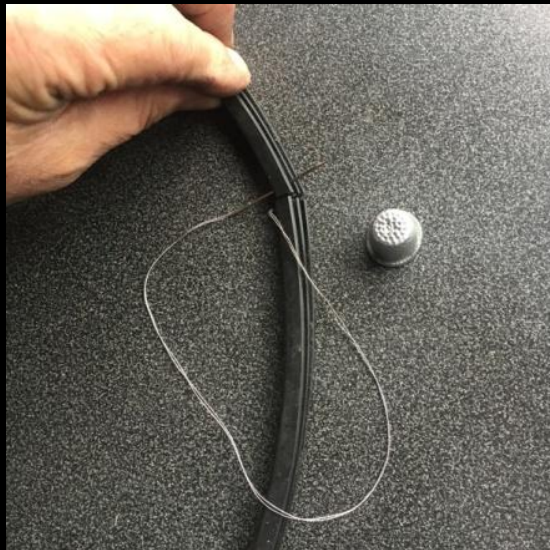
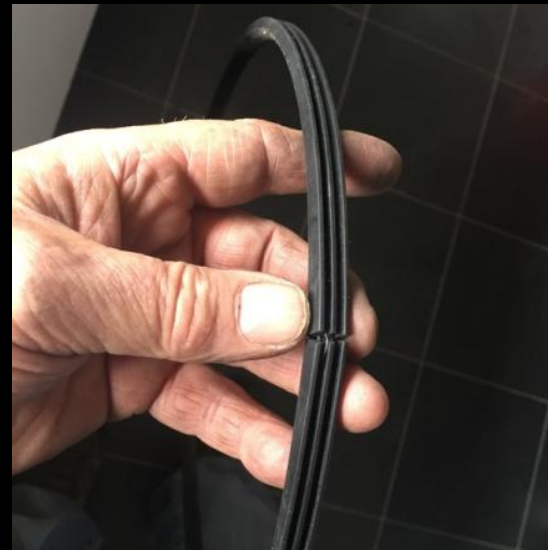
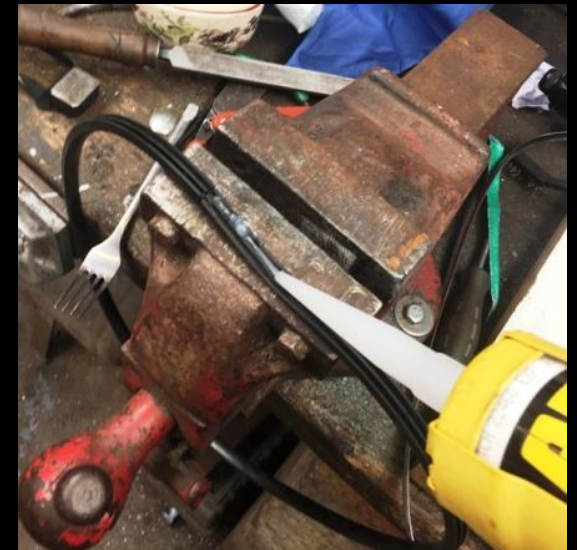
My very good friend & Velo Mentor Rick suggested that I used a 'Needle & Thread' to join the two ends of the Chain Case Joint Moulding Rubber (F284 / 2) together, to 'Aid' assembly. He also suggested I used RTV Silicon Sealant in the 'Grooves' of the Joint Moulding Rubber – to effect a reasonable 'Seal' to this usually trouble-some area of a Velocette engine (see the three photos below). It all went together really well. Much better than the first attempt & *Job Done!*

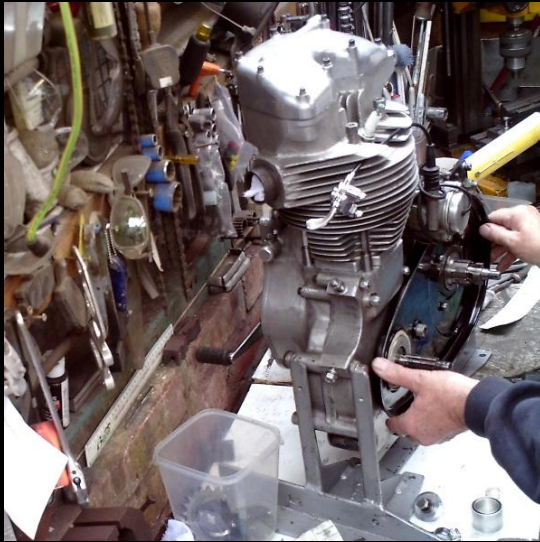
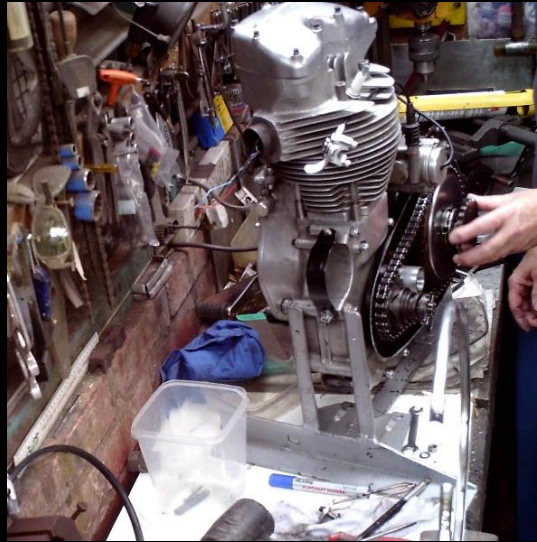
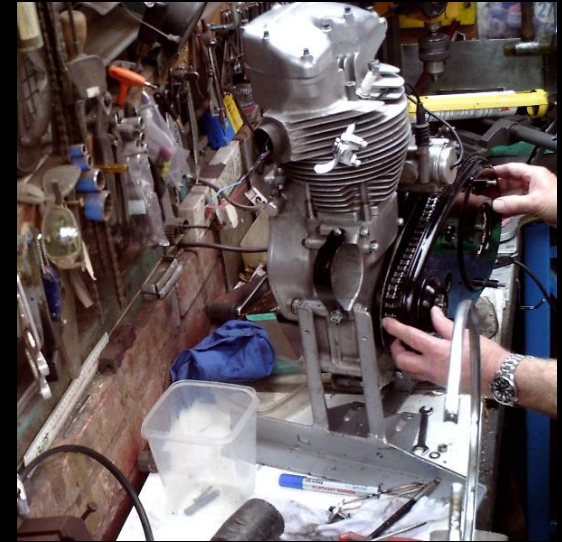
Inner Chain Case, Clutch Assembly & new Primary Drive Chain fitted again. Followed by the Outer Chain Case Cover, hopefully, for the final time.

The repaired and much stronger Chain Case Strap was 'Re-Fitted' again, but this time without mishap or any other problems.

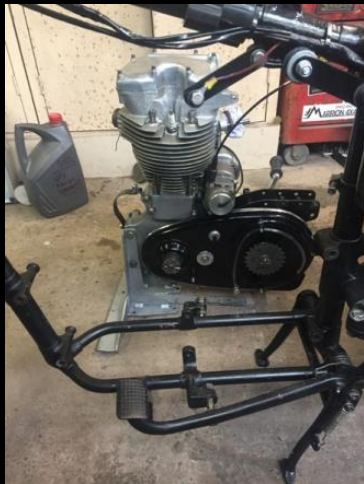
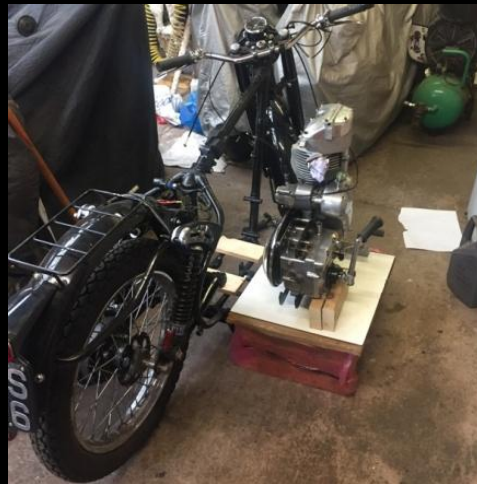
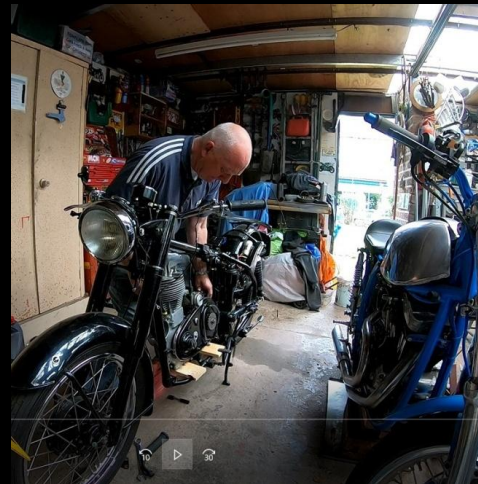
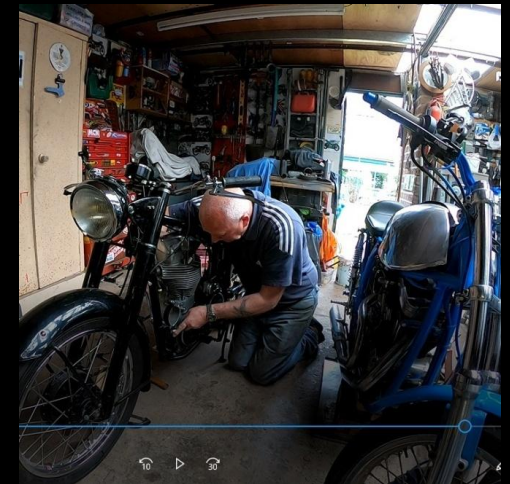
The Engine & Gearbox went back into the Frame really easily, and without issue (I am pleased to report). Yet another step closer & 'Good Job Done'.

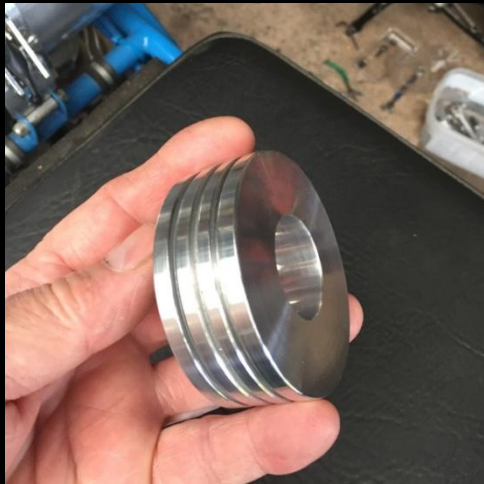
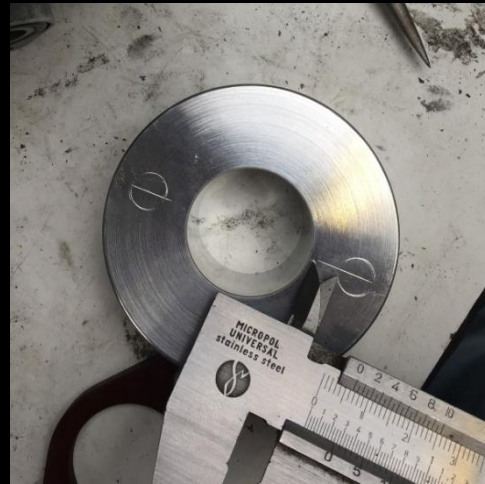
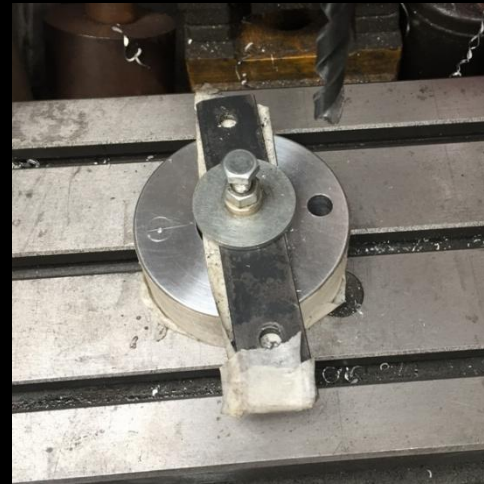
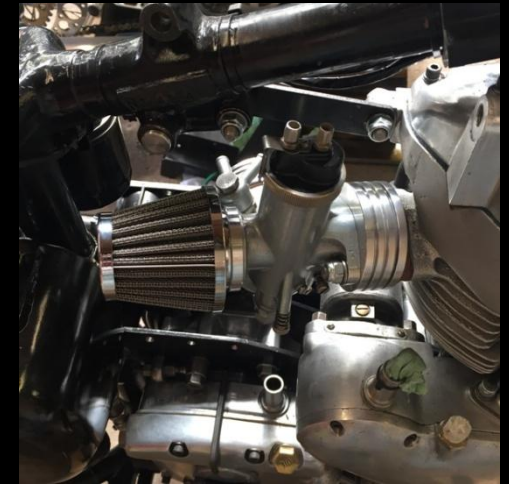
Photos above: showing-off my New Carburettor Inlet Manifold Spacer (expertly 'turned' by Rick Essex). All I had to do was drill the manifold Bolt Holes (obviously in the right place) to finish-off this new extension-tube modification. I think it's looking great now and I'm hoping it ALL works just as well too.

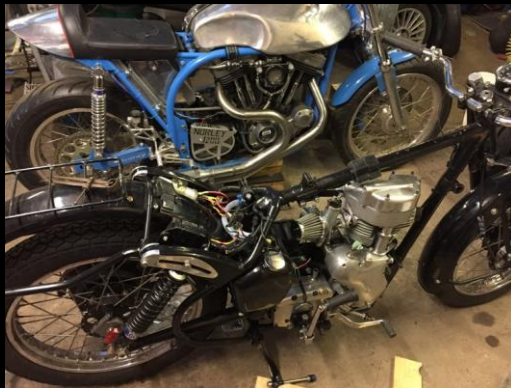
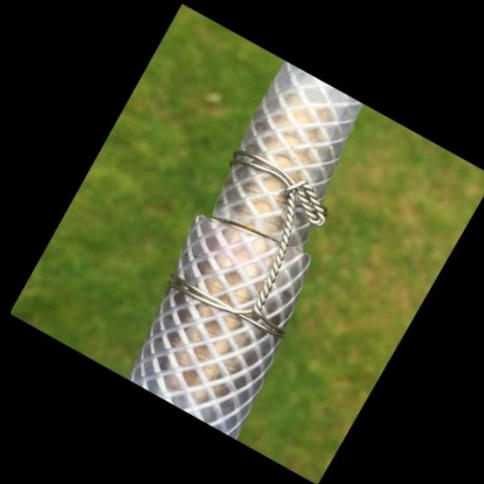
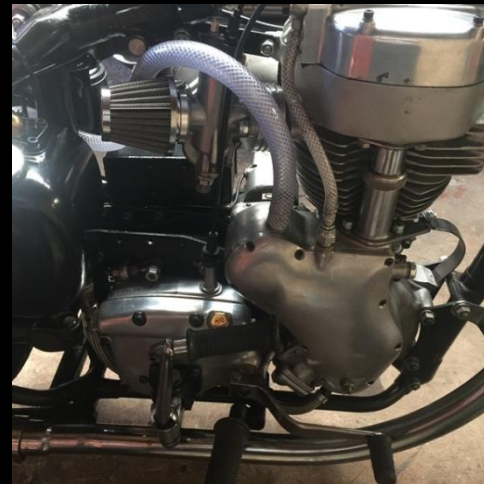
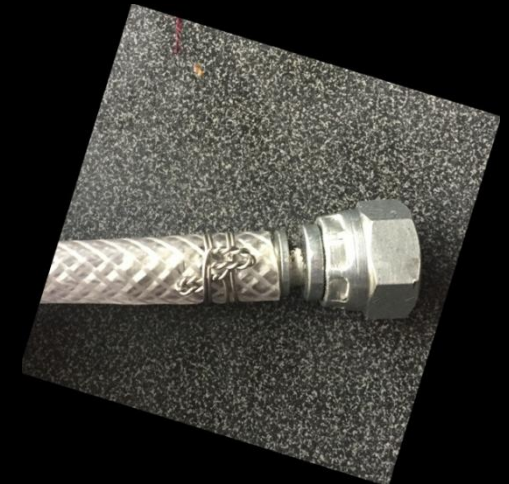
The Photos below show the reinforced plastic hose that I have decided to use for the engine breathers & oil feed pipes (as you can see in these photographs, I have lock-wired them onto their fittings – as usual).

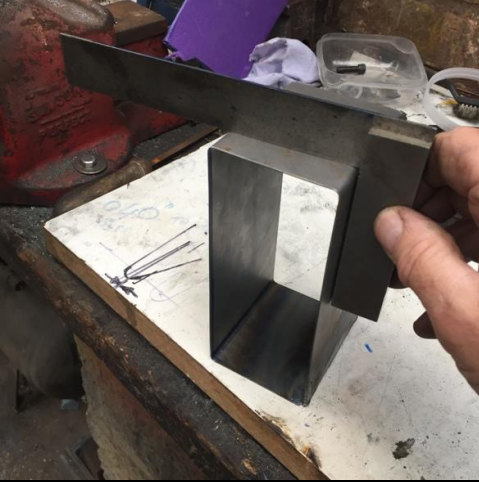
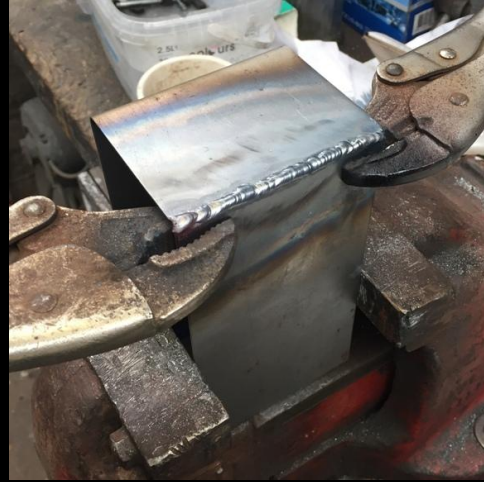
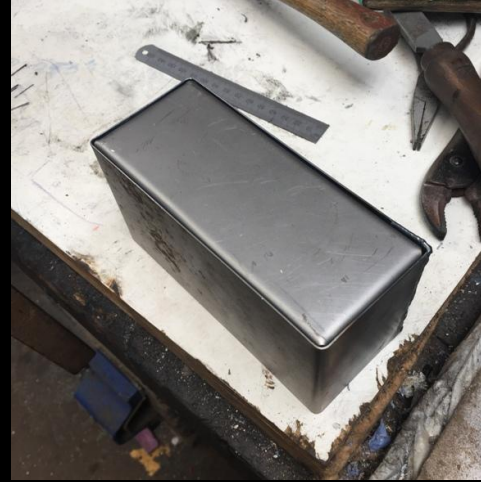
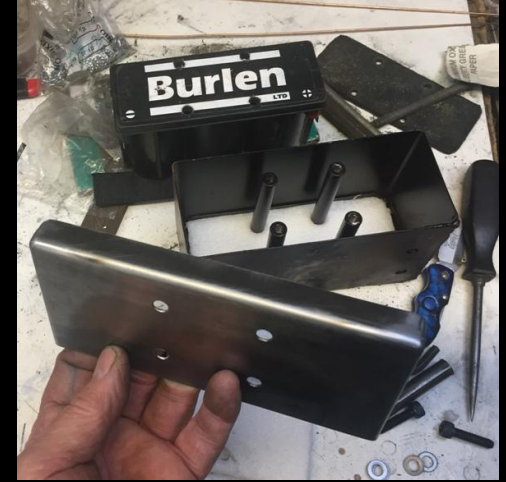
The following photos below: show the fabricated Battery Box (version 2) being made – to accommodate the Burlen 6v Battery.

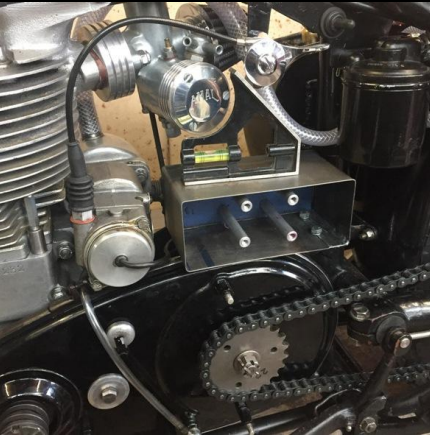
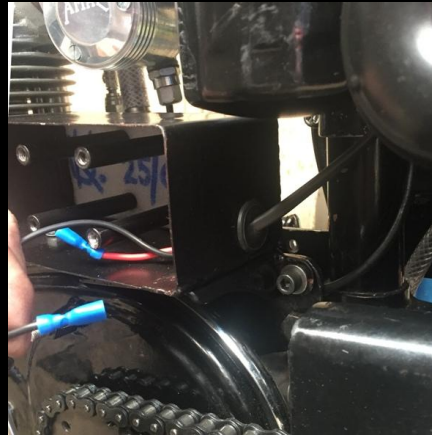
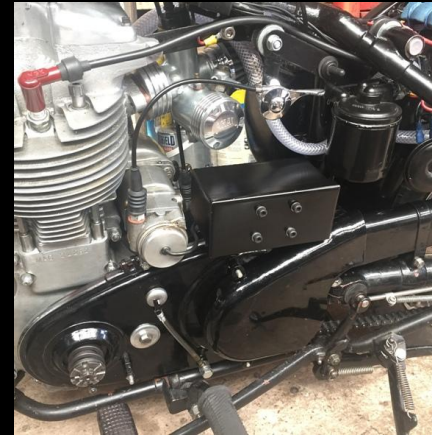
As you can see from the first three photos below: I decided to mount the Burlen Battery 'Horizontally' instead of the more conventional method of mounting the Battery in a vertical position.

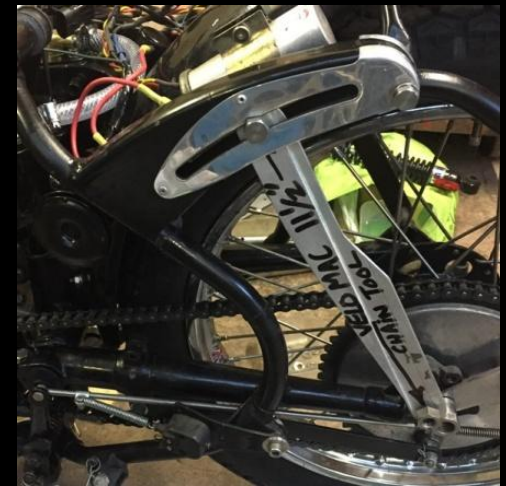
The end photo (above right) shows the factory method used for setting the Rear Drive Chain Tension. With the Shock Absorbers removed, a 'Strip of Metal' with two holes drilled at 'Eleven & a half Inch centres'' is then used to get the correct position of the Swing Arm to Frame, in order to set the correct chain tension.

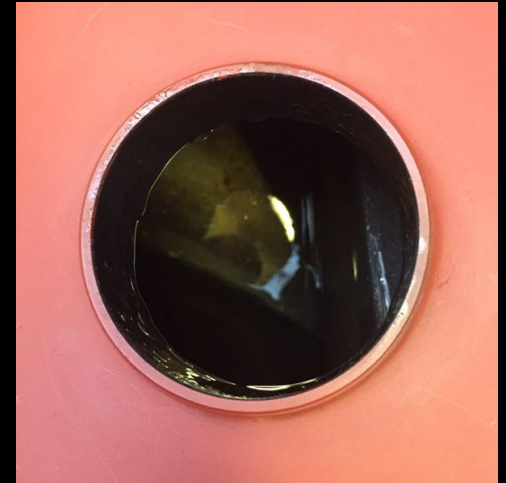
TANK CURE was used to 'Seal' the modified Petrol Tank. The instructions were easy to understand and were followed to the letter. You can see the results through the Filler Cap aperture (end photo below right). Just look how *shiny and clean* the inside of the Tank is *Now* the inside of the Tank is covered in this 'Cured Resin'. This Tank is now rust free and hopefully 'future-proofed' against anticipated possible changes to Petroleum based Fuels (in the future?)

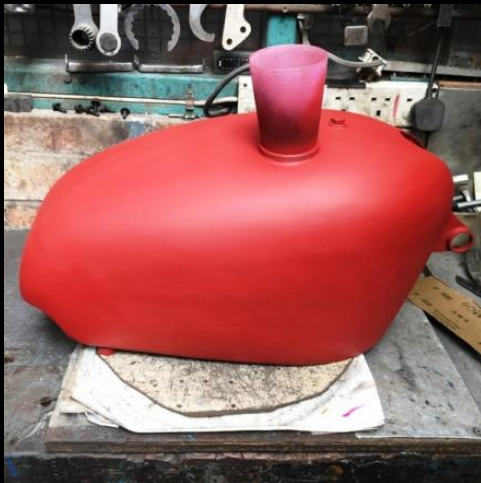
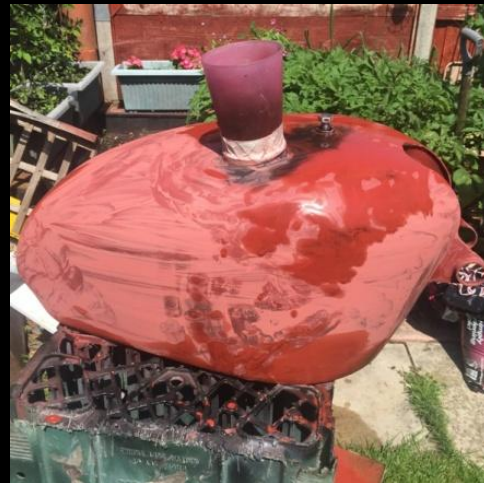
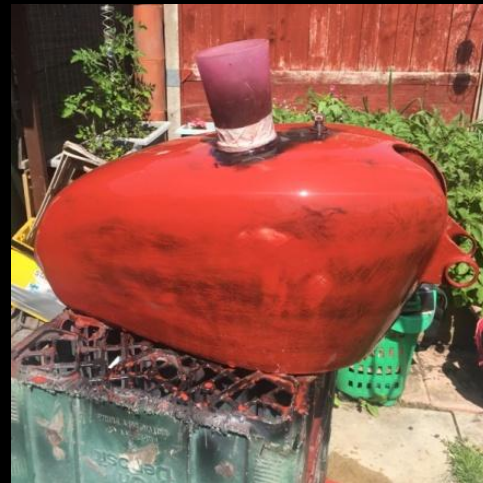
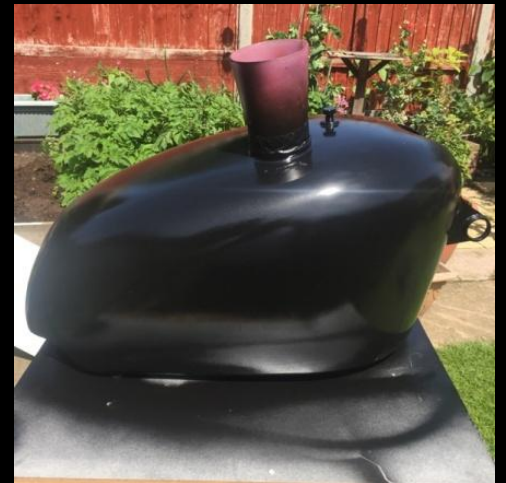
Friday Morning (28th June) before going to work I took advantage of this fabulous warm weather and 'Flatted-the-Tank-down', then washed it off and put a single covering-coat of black paint onto the Tank – just so that it looks a bit more presentable – when I attend the Velocette Owners Club Annual Rally.

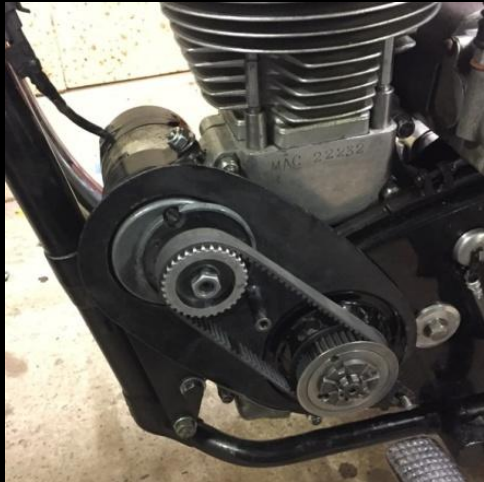
1st photo below left: The Dynamo fitted (together with toothed-belt drive) and it is now ready (for tomorrow) to be 'Fired-up' for the first time following the complete engine & gearbox strip-down & rebuild. Yeah!!!

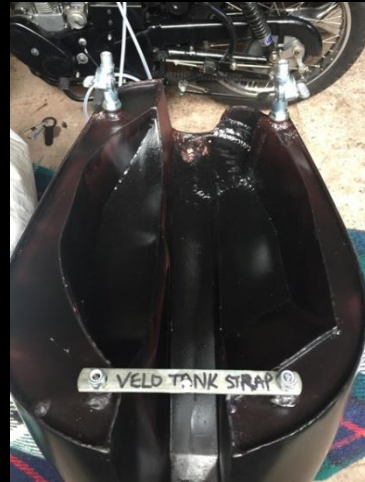
2nd photo below left: The underside of my modified MAC Tank, complete with Front Tank Strap and brand new Petrol Taps. The Tank Strap is designed to stop the base of the Tank from 'Flexing' (at the front of the Tank). If this Tank Strap is not fitted, there is a real risk that the Tank may develop 'Fatigue Cracks' along the Seams of the Tank, causing fuel to leak.

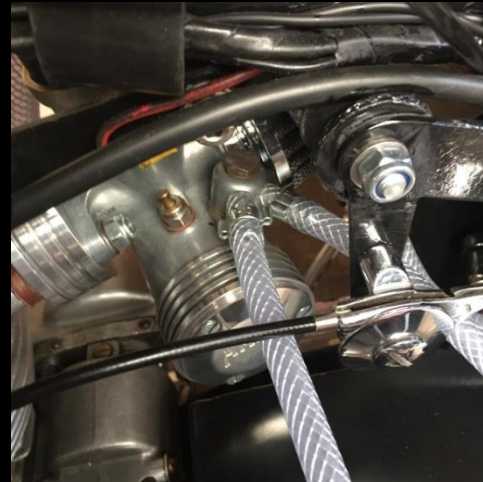
3rd photo: shows the new reinforced plastic petrol hoses fitted to the Carburettor. End photo: My Work List.

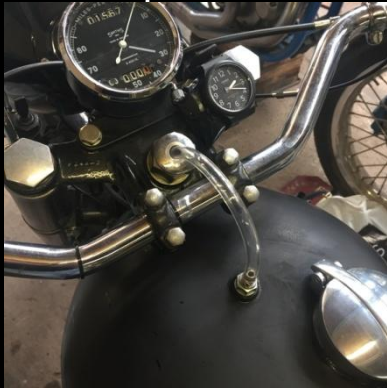
Photo 1: Option One.

Photo 1 (above) Option One showing the position of the petrol tank breather as tried & tested on Sunday 30th at the Velo National Rally. Photo 2 (above) shows Option Two, with a Banjo fitting allowing a parallel fitting for the breather-pipe. Photos 3 & 4 are similar to option two, but using smaller diameter piping (3mm dia.) black plastic pipe, instead of 1/4" clear plastic pipe that was previously fitted. I think option one is more efficient, but I think option three is less obtrusive and blends in well with the black bodywork of my bike. At the moment, I am 'Trialling' option three 'Breather-pipe' which also appears to be working well.

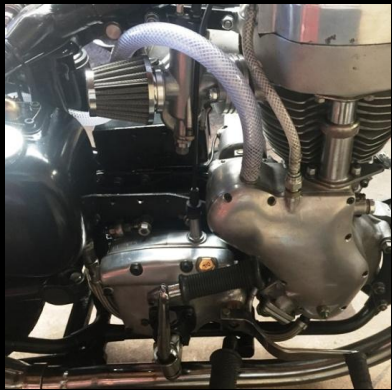
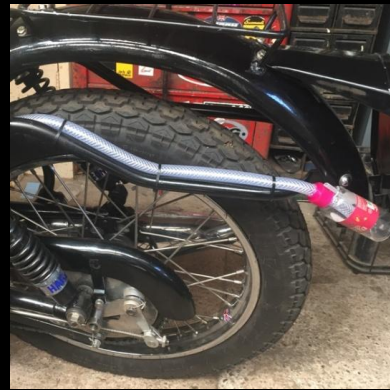
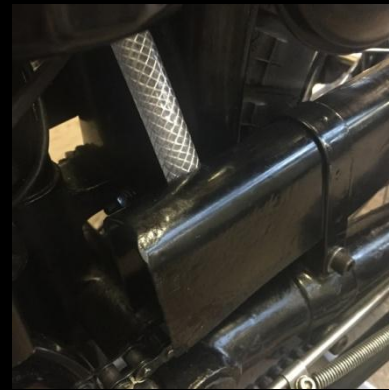
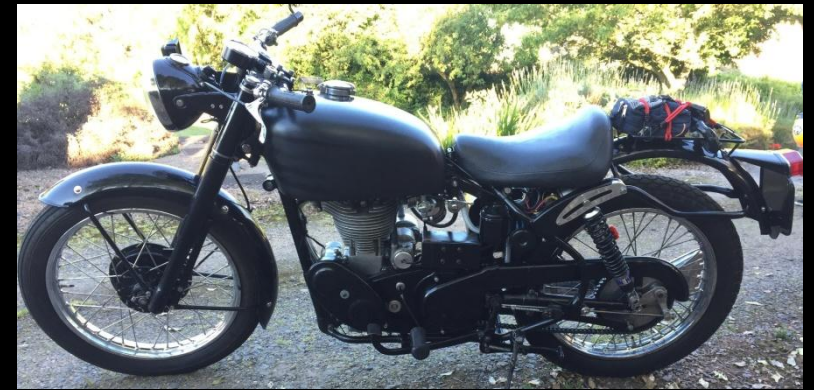
The BIG Breather Pipe: i.e. The Engine Breather from the top of the Timing Case (1st photo above), which was then reduced down in size as it made its way along the rear mudguard Stay to the end of the Mudguard (terminating in the little plastic bottle (middle photo above), this make-shift breather 'catch-tank' was fitted to see how much 'Oil Mist' was produced by this new engine. And the 3rd photo (above), as there was very little oil mist produced, I decided to shorten the Engine Breather Pipe & re-direct it to the rear Chain-guard, where any oil mist would 'condense' onto the Rear Chain and act as a chain lubricant & appears to work well.

The last photo above right: was taken on my 3rd ride-out (Friday 5th July 2019 = another 50 miles done) and offers a good 'shot' of the rear-side of the bike. This last photo shows the rear breather pipe has been moved and placed in the less obtrusive position (than that of the inaugural 'Run' on Sunday 30th June 2019).

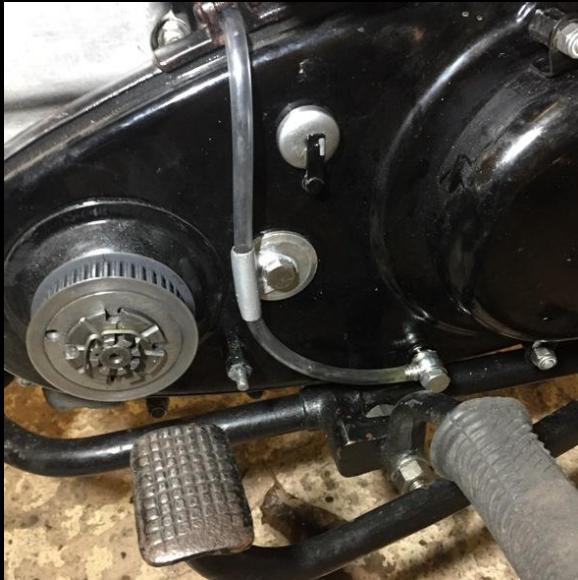
First Photo Left: This is version #3 of my Chaincase oil level indicator Tube. As can be seen in this photograph, the clear plastic 'Tube' is now directed forwards and is held in place via a purpose-built 'Guide'. Using this method it is easier identify how much oil is in the Chaincase.

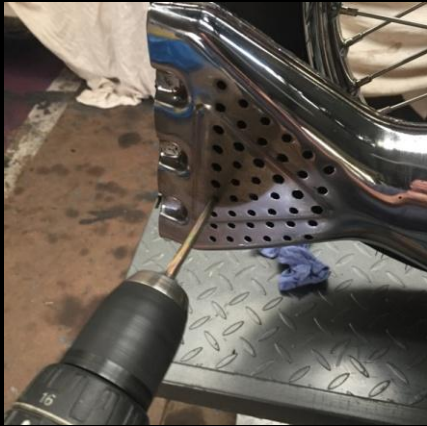
First photo Left: To help get the exhaust gasses out a bit quicker (not to mention the slight increase in sound . . .) I drilled-out the 45 Holes in the end of the Fishtail Exhaust Silencer from 4.5mm diameter to 6mm diameter. This modification was listed in an old VOC Magazine (ironically the club magazine is also called 'Fishtail' and comprised of 45 pages in that edition too).

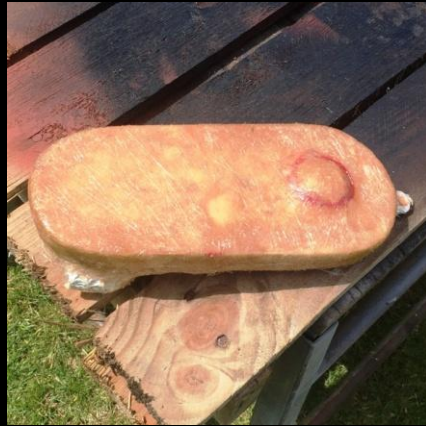
Second photo (immediate left) is my homemade Fibre Glass (GRP) Dynamo Cover which is intended to replace the alloy one that I made earlier. But, in the meantime (at least for the rest of this summer) I intend to get a few more *Miles on the Clock* before doing anything else to my new GRP cover.

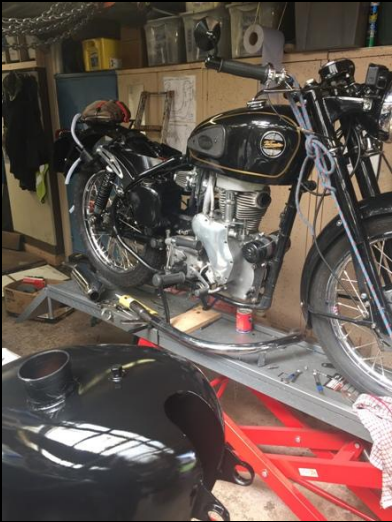
1st Photo Left: Exhaust & Silencer removed, ready to 'Re-Seal' exhaust system (because of slight 'Popping-Sound' on throttle-back). Also, finally . . . I managed to fit the Oil Separator that I made ages ago. This was 'Trialed' on the 8th August on the Shropshire Velo Riders Outing at the Tally Ho Pub in Boulden. It worked, (after a fashion) but the 'Oil Pipe' collapsed when it got hot and the tight turns (route of the pipe) caused them to close up – as the pipe softened – thereby nullifying any engine breathing advantage. So . . . Version Two of my New & Improved Oil Separator / Breather Box to be built soon to replace *Version One*.

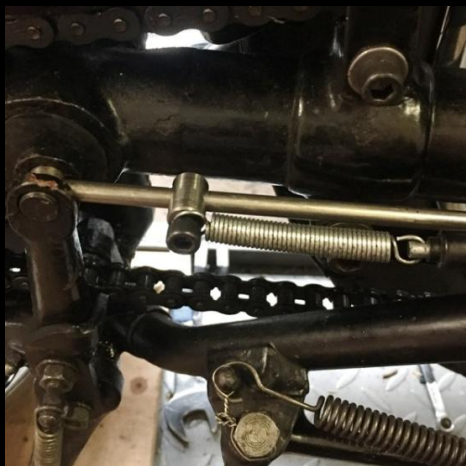
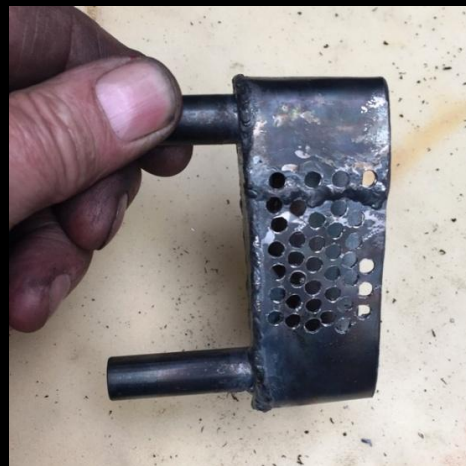
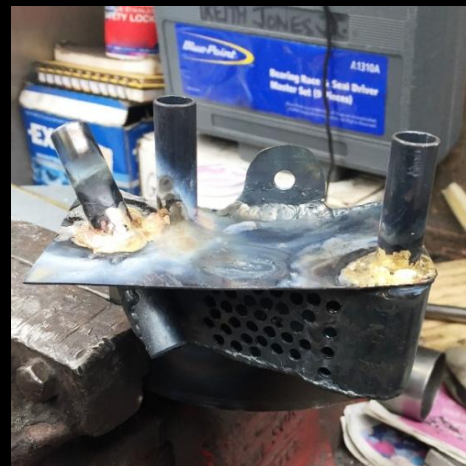
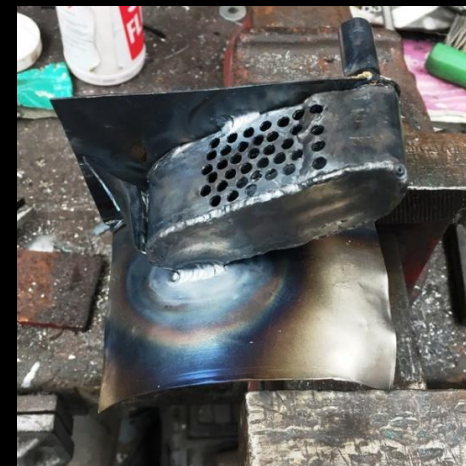
I've used exactly the same principle as the first 'Separator Breather Box', but it's fabricated in steel (not aluminium). 2nd photo above shows the internal part of the *Box* welded-up as a separate 'self-contained-unit' where the 'Engine-Breathed-Air' goes into the Top Tube - hits a 'Deflector Plate' and condenses & separates Oil particles from the Oil Mist. This 'Condensed-Oil' then flows down to the lowest part of the box where it re-enters the Oil Tank. The separated oil mist is then pushed-out of the 'Holes' drilled into the top of the separator box, which in turn is Pushed-out to 'Atmosphere' (or, in my case – it is directed to my Rear Chain).

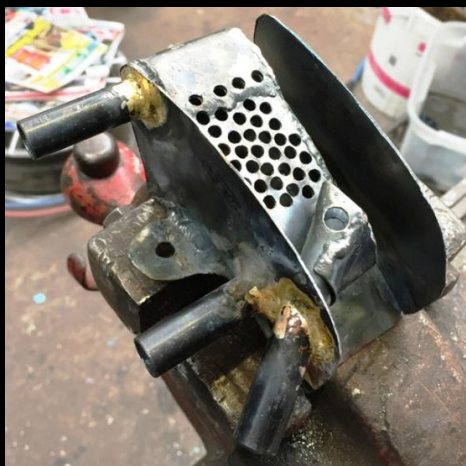
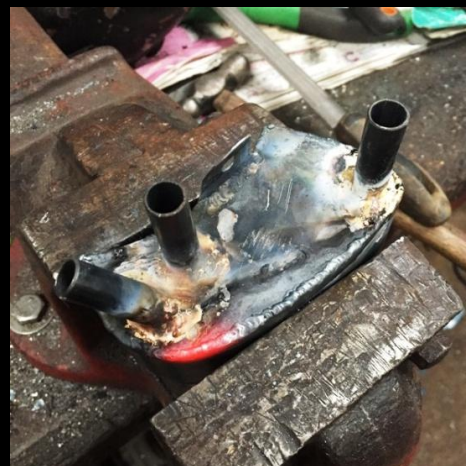
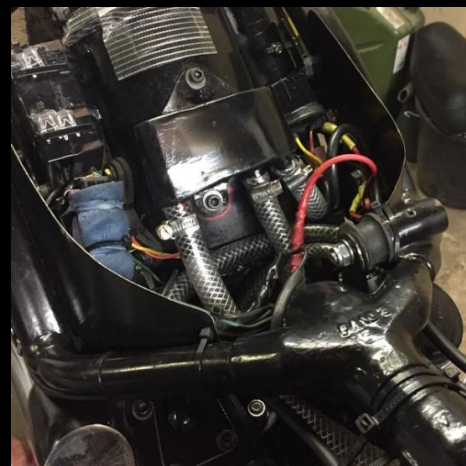
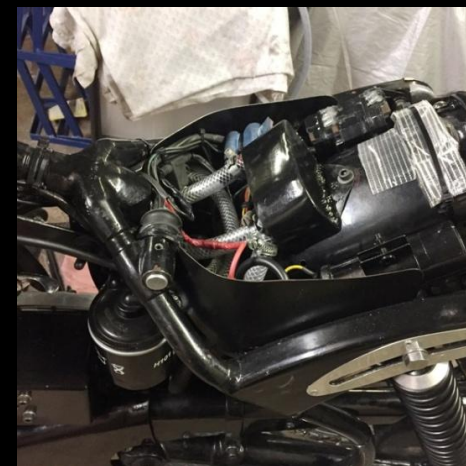
Version Two Oil Separator / Breather Box is mounted directly to the rear mudguard (see last two photos above right) and is more efficient than *version one*.

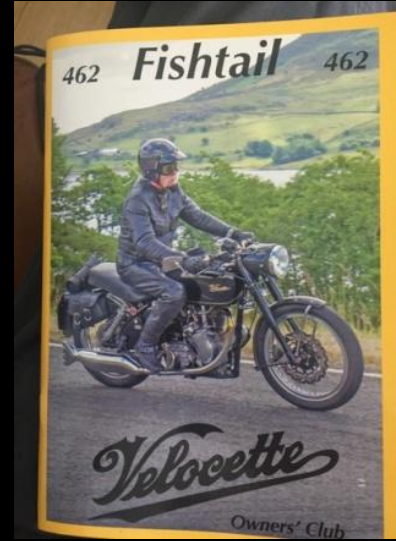
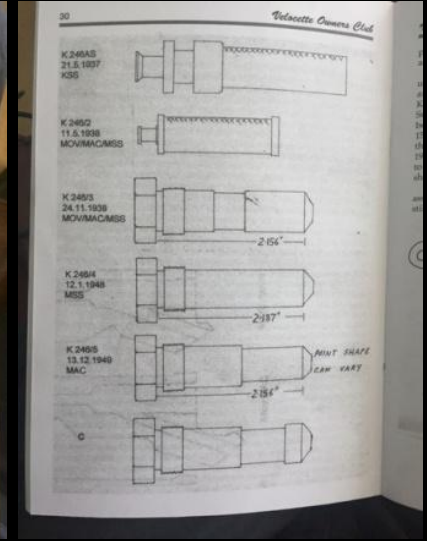
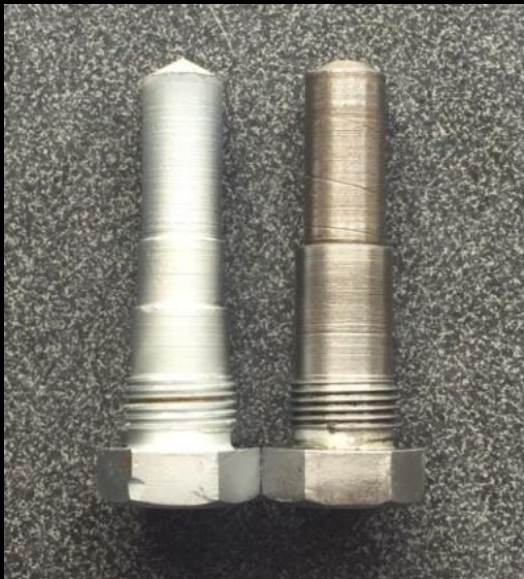
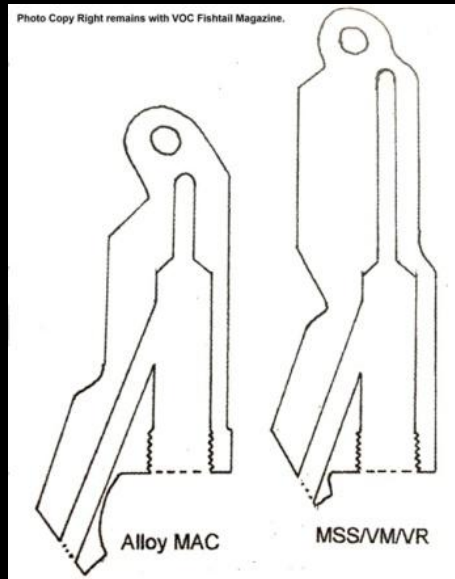
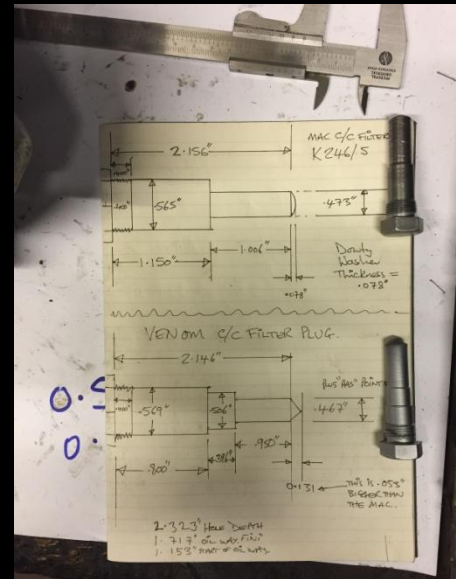
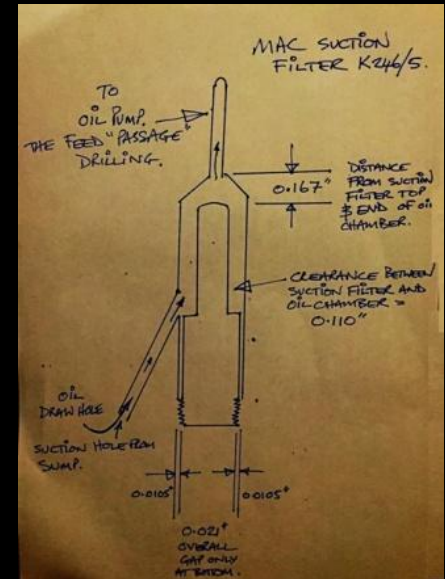
I discovered that the 'Myth' of having only 0.020" gap between the Suction Filter Plug (Velo part# K246/5) and the Plug Chamber (leading to the Pump) was 'just that' – a myth. After measuring everything with depth gauges, dial-gauges & micrometers (etc) I discovered the gaps involved were much bigger than expected.

Photo number 2 (above) shows a comparison between the Alloy MAC 'Oil Chamber' drilling and the MSS, Venom & Viper drillings. Both measured the same internal dimensions, and the angle of the drilling that enters the side of the chamber is the same on both engines (as is the hole size from crankcase 'Sump' to 'Oil Chamber' where the Suction Filter Plug 'Lives' (0.125"). After measuring the lengths of both Filter Plugs I found a 'Gap Difference' of 0.167" on the Top of the Filter Plug and a side gap of 0.110" between the reduced part of the plug at its narrowest point. The Step from standard plug diameter to the reduced diameter of the plug ends just a fraction below the entrance side drilling from the Sump (into the Oil Chamber).

It was pointed out to me that "... late Velocette engines were built without any filter plug ... and blanked off by gearbox filler plug BK40". I've taken Colin's advice (and that of my good friend Rick) and cut-off the Filter, at the point where it reaches the 'lowest part of the diagonal side drilling' & inserted several small but powerful Magnets into the working end of My Filter Plug. (See photos below).
