Velocette MAC 350cc

Rebuild Project Part Two

November 2018 to November 2019

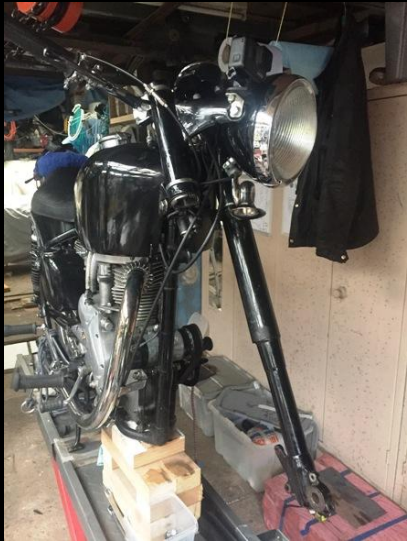
I also found a leak in the 'Bottom off-side Fork Slider' (photo right), where the bottom of the Fork 'Casting' is soldered to the Slider Tube.

This bottom Fork leg requires re-soldering & re-painting before reassembly.

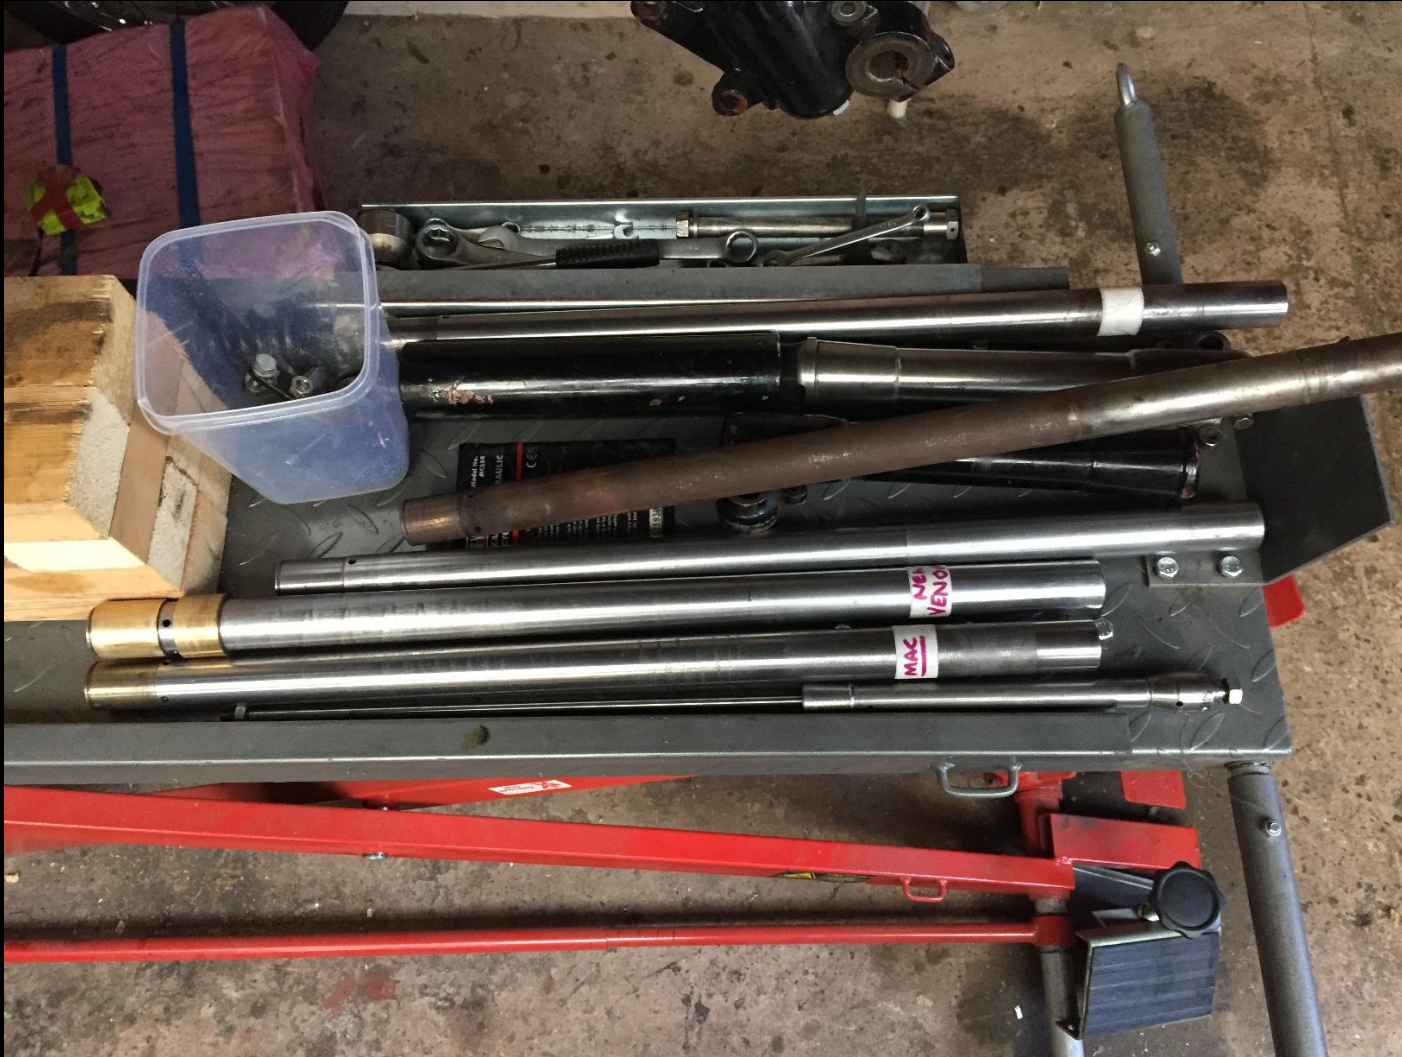
The photo below shows the assortment of fork legs that I have to work with. Three pairs of Forks, the original (knackered) MAC Forks, plus two other pairs of Velocette Forks. One pair of well worn Venom Fork Legs (original but too worn & rusty for use), plus; another pair of Old stock / New Venom Fork Legs; that came with the bike, all wrapped-up by the previous Venom owner, with the intention of replacing the worn-out 'original' Forks on the Venom.

When I bought the MAC in 2017, the Sales Advert stated; “. . . Forks Stripped cleaned and overhauled . . .” (see MAC PART ONE / Year One for details). I’m not sure ‘what was done’ to these forks . . . but their definition of “overhauled” and my definition is shall we say *‘Different’*. The actual MAC Fork Legs are in such bad condition that merely fitting bushes & seals could only ever be termed a ‘Temporary short-term Fix’ and DEFINITELY NOT a proper overall. I can confirm this because after riding my MAC around since the Engine & Box rebuild – I discovered the Forks just WILL NOT keep Oil in the Legs. An additional problem was found to be a small hole in the Soldered Joint between the bottom Slider Lug (which needs re-soldering before re-assembly). I have decided to fit the cleaned-up New / Old Stock (NOS) Venom Fork Legs (that I got with the Venom) to the MAC and hopefully my fork leg oil leaking problem should be solved.

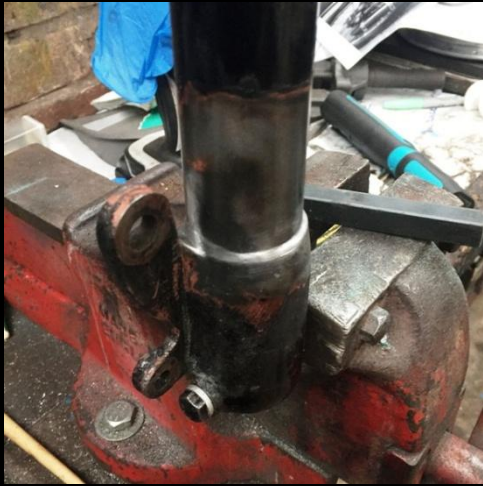
This is where the Fork Bush 'Tube' is soldered into the Bottom Casting (that the Front Wheel Spindle goes through & where the front mudguard stays are fitted to)

On the 3rd October, I thought that I had fixed the Oil Leak coming from the Soldered Joint on the Front Fork Slider (see photo left). BUT NO ! NOT FIXED !

After reassembling everything back together again, and refilling the forks, I took the MAC out for a Road Test and to my dismay – the *Effing* Fork Slider still Leaks. BUMMER!

Obviously, when I attempted my first soldering repair fix, there was too much contamination to allow the Solder to adhere properly.

3rd October 2019 (photo left)
I managed to clean-up & Solder the damaged Front Fork Slider from the MAC.

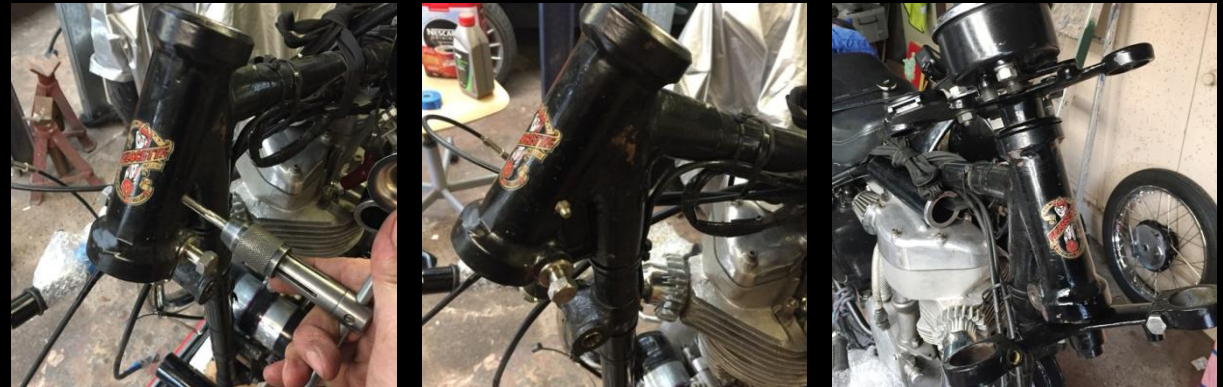
Photos below: I have 'Drilled & Tapped' the Head Stock ready to fit a Grease Nipple (as a Grease Point for the New Steering Head Bearings). New Taper Roller Bearings (Top & Bottom) fitted to the Steering Head (instead of the usual Cups & Cones Bearings, with lots of individual Round Ball Bearings to lose). These self-contained Taper Roller Bearings are a well-worth modification and help enormously with assembly-time. (& no Lost Balls).

(Above photos) This Grease Nipple modification aids essential and regular grease maintenance

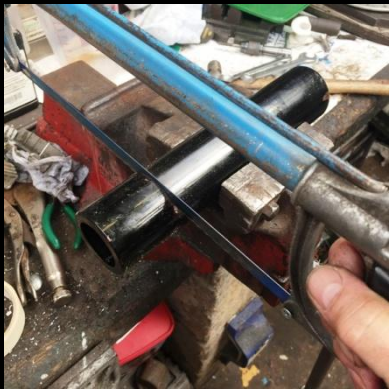
Photographs Above: Photo 1: shows the old Fork Shroud being 'Sawn-up' ready to accept the new Rubber Gaiter. Photo 2: shows the Fork Bush & Seal Fitting Tool being used (designed & made by Rick Essex). Obviously New Bushes & Seals used throughout. Photo 3: shows a specific Tool being used to aid Fork Leg fitting and correct location of Fork Leg into the Top of the Steering Yoke, again this little tool was made by Rick (many thanks to RE for the loan of these tools). Finally photos 4: & 5: show the new Gaiters being fitted into position. These Gaiters offer an improved 'dirt and moisture seal' than the original Velocette Fork Shrouds. I have fitted mine to the modified 'Shroud' by means of 'Black Cable Ties'. Jubilee Clips are the most common method to secure Fork Gaiters in place.

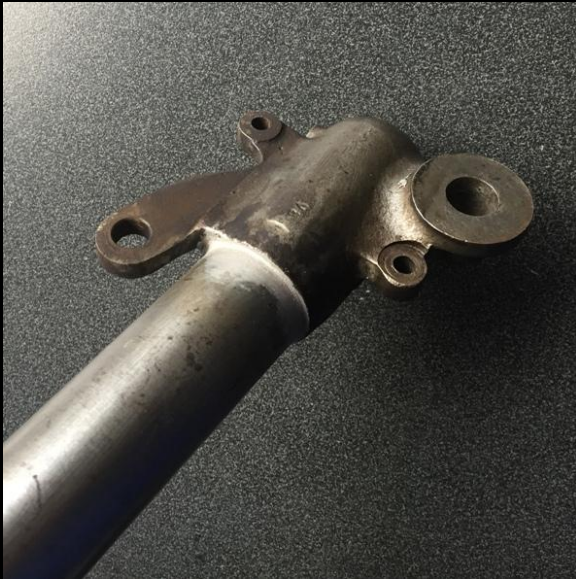
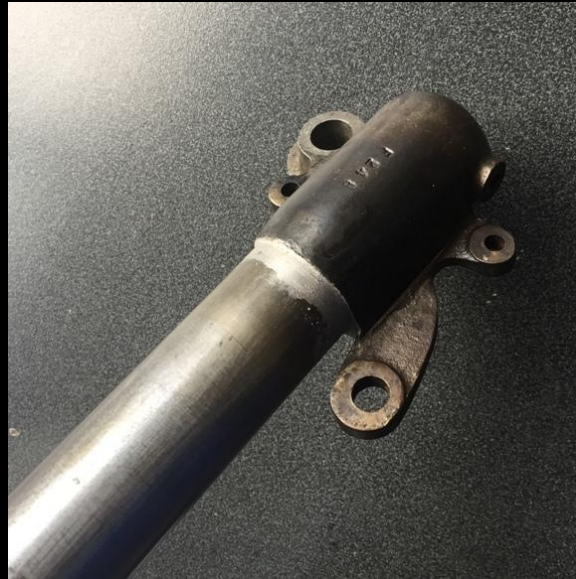
The first two images above; show the finished *Soldered Fork Leg Joint*.

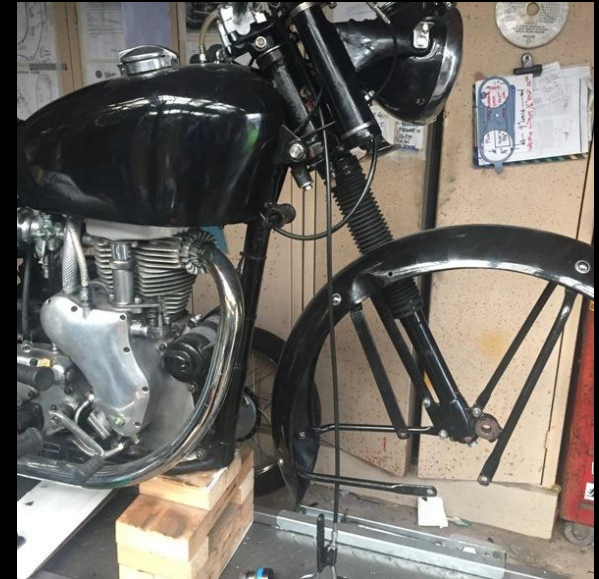
The end photo above right; shows a very sorry looking forkless MAC. That'll teach me in future to do the Job properly 'the first time'.

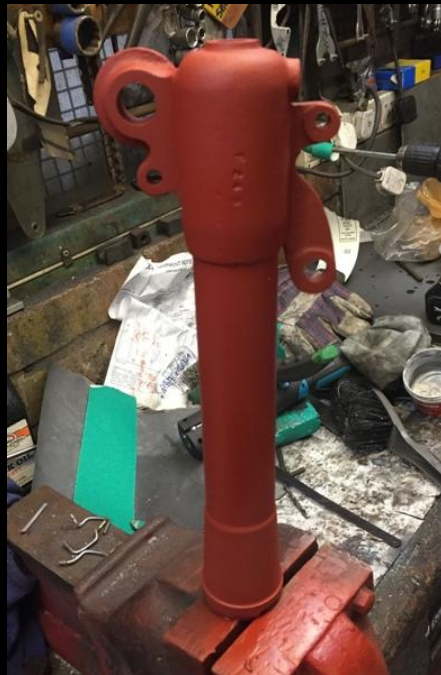
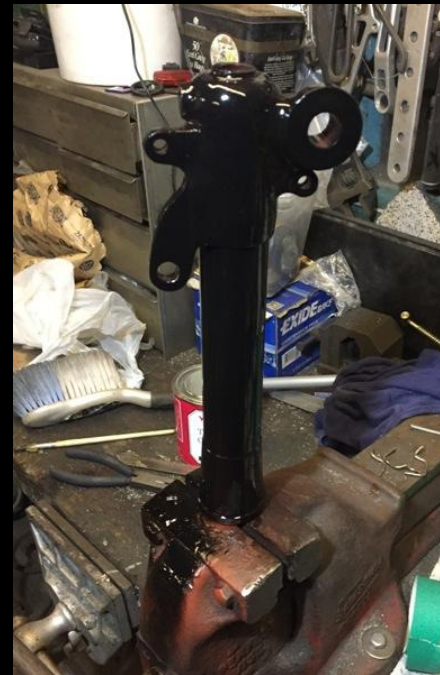
After a thorough cleansing wash, to get rid of the entire Soldering FLUX residue, I tested the Fork Slider for leaks before priming and painting with a top coat of black gloss paint (two photos on the right).

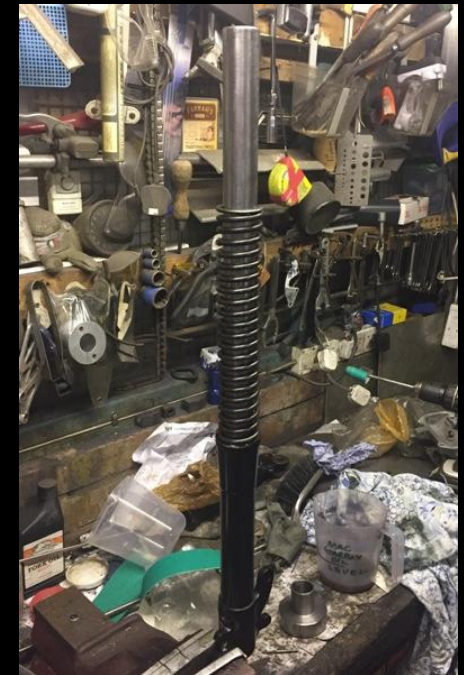
End photo right; The Leg assembled with yet another new Seal and ready to go back onto the Bike . . . yet again!
